**Section 19 Flood Investigation  
Report for July 2019 Event**

Stockport Metropolitan Borough Council

9 September 2020

**Document reference:** 414640 | 001 | E

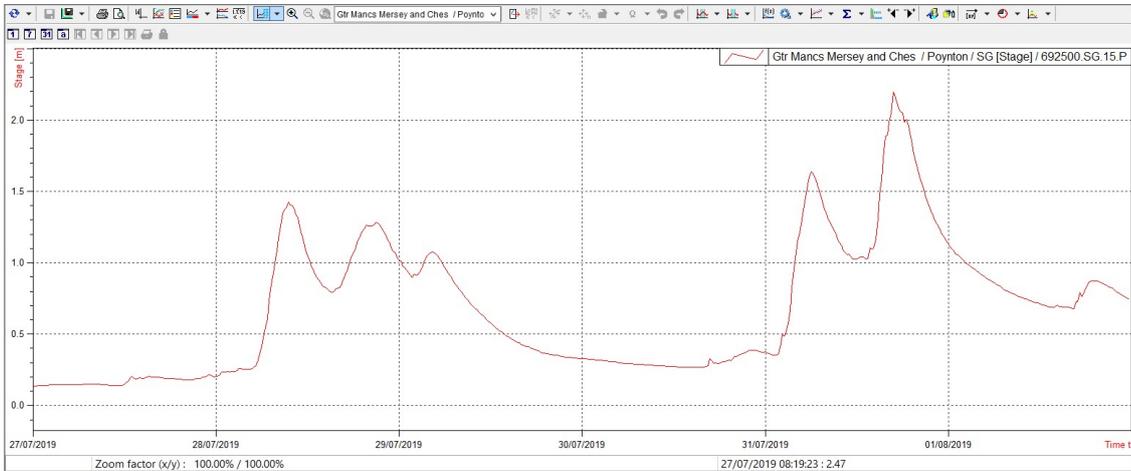
**Figure 2.6: Poynton Brook at Poynton gauge level response to 28<sup>th</sup> July 2019 – 01<sup>st</sup> August 2019 rainfall**

As a result of the rainfall on 31<sup>st</sup> July 2019 the water level at Poynton gauge reached 2.195m, the highest since records began in December 2008 (i.e. in around 11 years). Flood frequency analysis, based on rough flow estimates at Poynton level gauge, gives a peak flow for the July 2019 event of around 12 m<sup>3</sup>/s with an indicative return period of around 45 years.

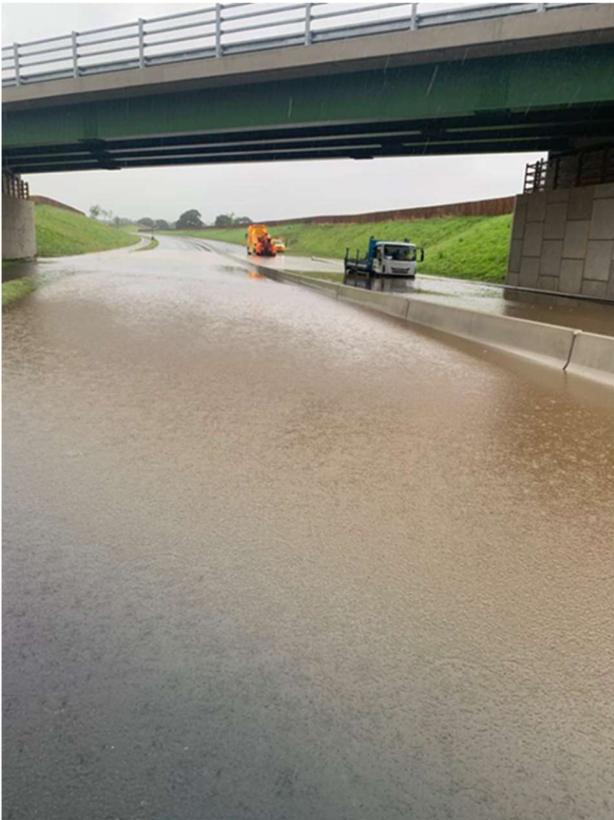
**Figure 2.9: 28<sup>th</sup> July 2019 A555 carriageway flooded at Woodford bridge, Network C.**

- Attended Network C pump station on Sunday 29<sup>th</sup> July 2019 at 15:00hrs,
- A555 carriageway flooded; see Figure 2.9.
- Both pumps had tripped but tested ok and were re-started and the floodwater was cleared.
- The pumps were noted to be drawing 31 to 31.4 Amps across all phases with overload trips set at 32 Amps.
- At the time the water level in the Network C pond was 300mm below the delivery pipe.
- It was understood the pond level had been higher earlier in the day.
- Revisited site on Monday 29<sup>th</sup> July 2019 to investigate cause of pump tripping but no explanation found; pumps running at 29 to 30Amps.

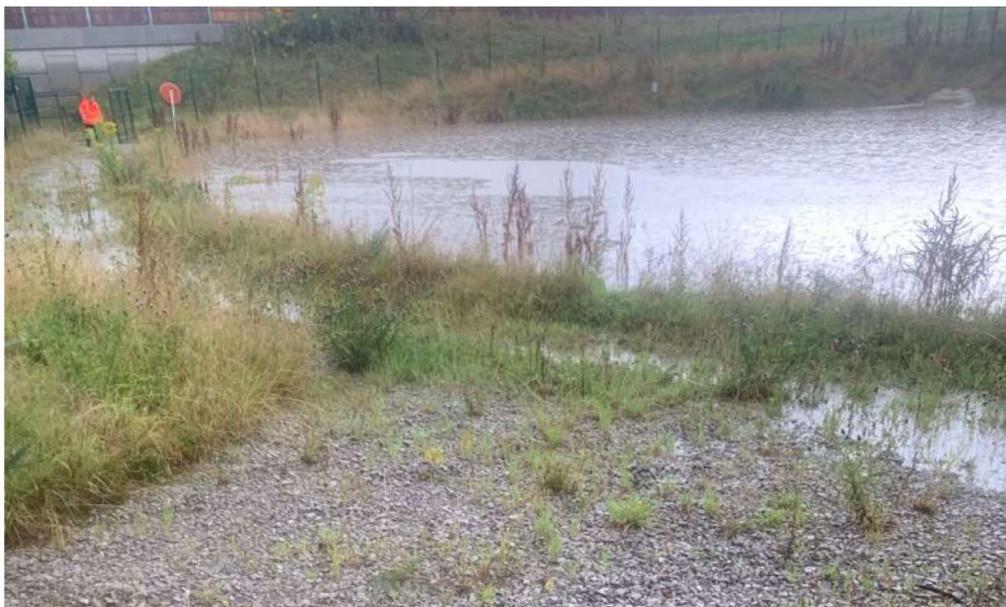
**Figure 2.10: Network C attenuation pond overflowing 31<sup>st</sup> July 2019**

- Network C attenuation pond (discharge into Lady Brook) overflowing and damaged.
- Tuesday 30<sup>th</sup> July; A555 temporarily opened at 5pm but closed later due to more rain bringing levels in tanks back up over road level (at Hall Moss Lane).
