Section 19 Flood Investigation Report for July 2019 Event

Stockport Metropolitan Borough Council

25 September 2020

Document reference: 414640 | 001 | G

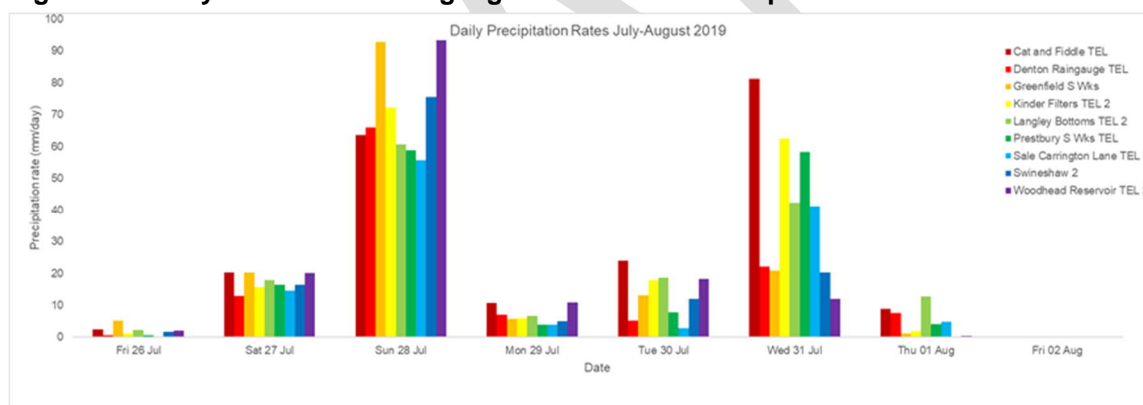
Figure 2.4: Daily rainfall totals for gauge sites local to Stockport

Figure 2.4 shows that, with the exception of Cat and Fiddle, all 1-day rainfalls were greater on the 28th than on 31st July, although some locations e.g. Prestbury received similar rainfall. Figure 2.6 shows the hourly distribution of the Prestbury rainfalls indicating that the 28th was characterised by steady but heavy rain whereas on the 31st there were pulses of intense rainfall.

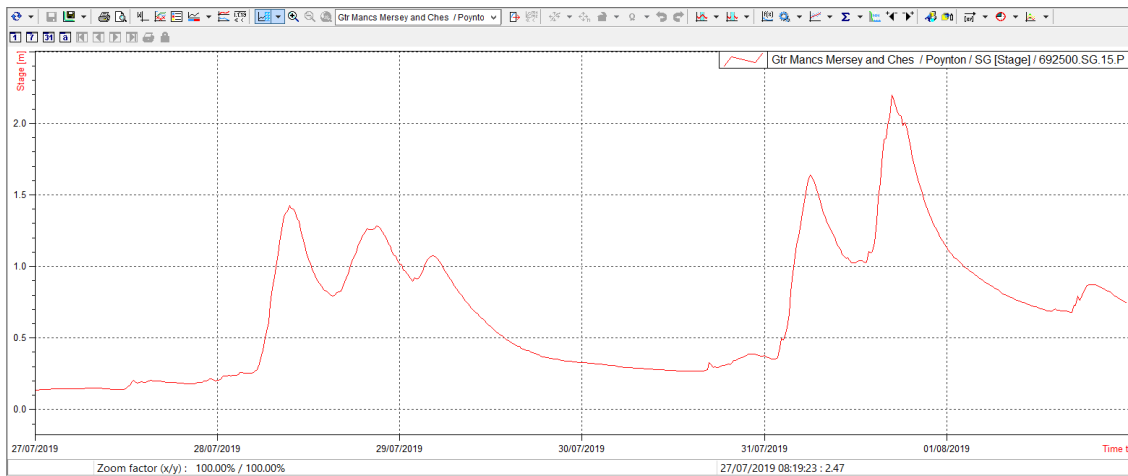
Figure 2.6: Poynton Brook at Poynton gauge level response to 28th July 2019 – 01st August 2019 rainfall

As a result of the rainfall on 31st July 2019 the water level at Poynton gauge reached 2.195m, the highest since records began in December 2008 (i.e. in around 11 years). Flood frequency analysis, based on rough flow estimates at Poynton level gauge, gives a peak flow for the July 2019 event of around 12 m³/s with an indicative return period of around 45 years.

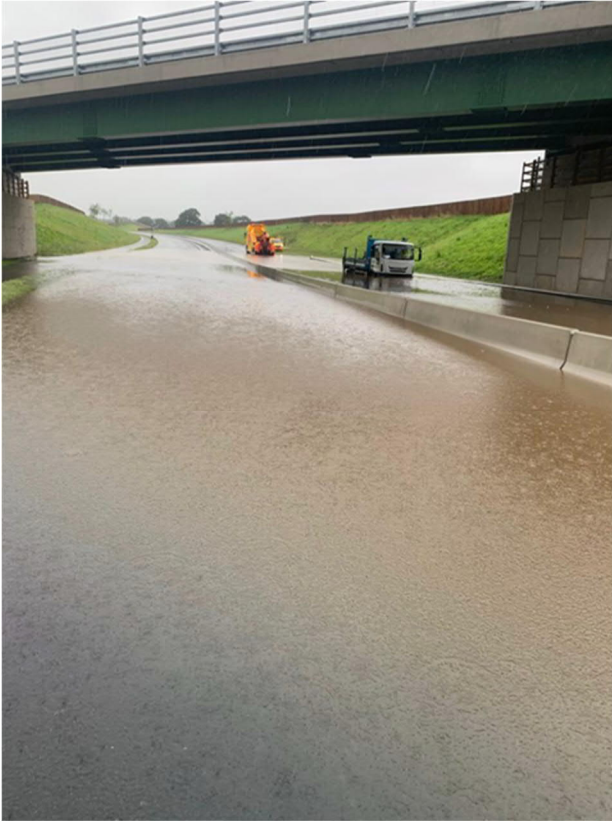
- Attended Network C pump station on Sunday 29th July 2019 at 15:00hrs,
- A555 carriageway flooded; see Figure 2.9.
- Both pumps had tripped but tested ok and were re-started and the floodwater was cleared.
- The pumps were noted to be drawing 31 to 31.4 Amps across all phases with overload trips set at 32 Amps.
- At the time the water level in the Network C pond was 300mm below the delivery pipe.
- It was understood the pond level had been higher earlier in the day.
- Revisited site on Monday 29th July 2019 to investigate cause of pump tripping but no explanation found; pumps running at 29 to 30Amps.

Figure 2.9: 28th July 2019 A555 carriageway flooded at Woodford bridge, Network C.

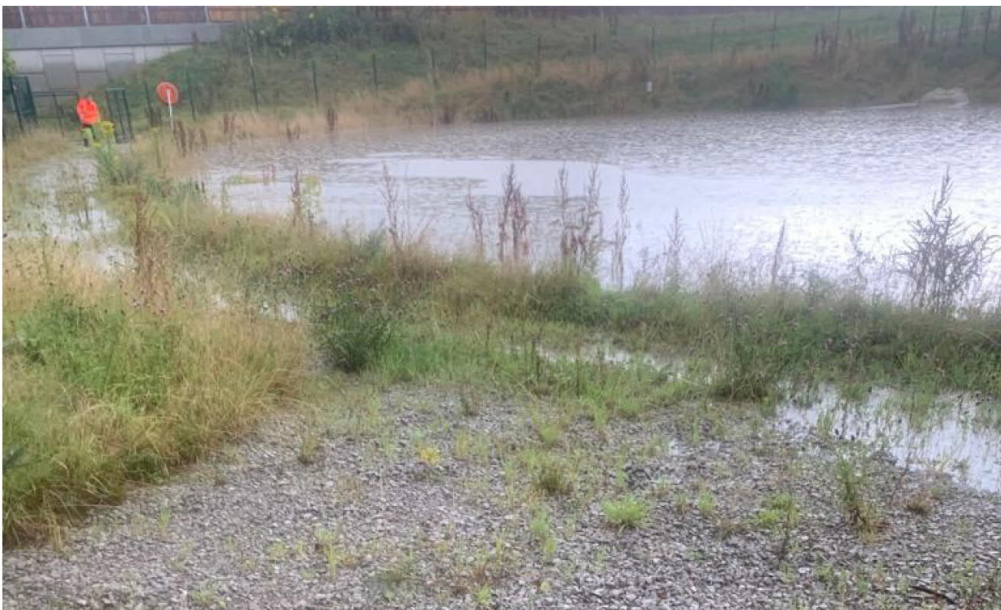
- Network C attenuation pond (discharge into Lady Brook) overflowing and damaged.
- Tuesday 30th July; A555 temporarily opened at 5pm but closed later due to more rain bringing levels in tanks back up over road level (at Hall Moss Lane).

Figure 2.10: Network C attenuation pond overflowing 31st July 2019

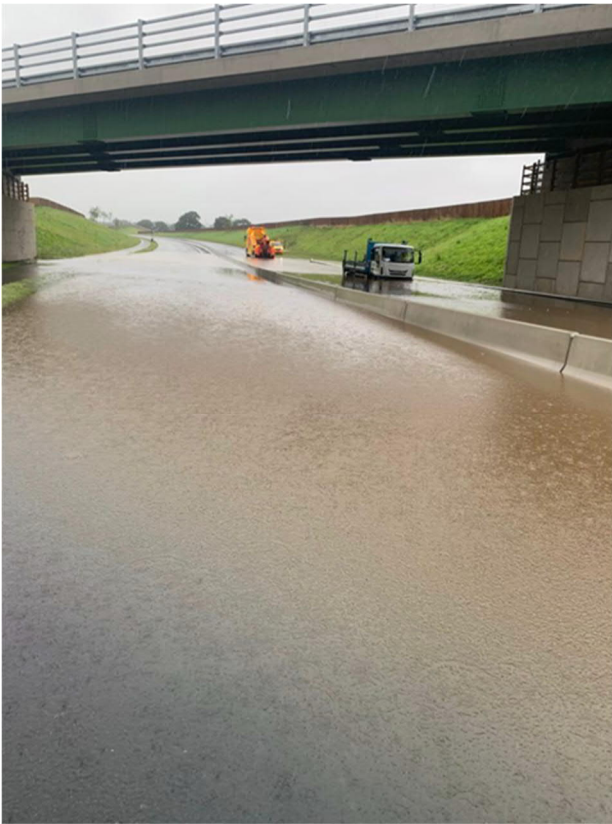
Figure B.1: 28th July 2019 A555 carriageway flooded at Woodford bridge .

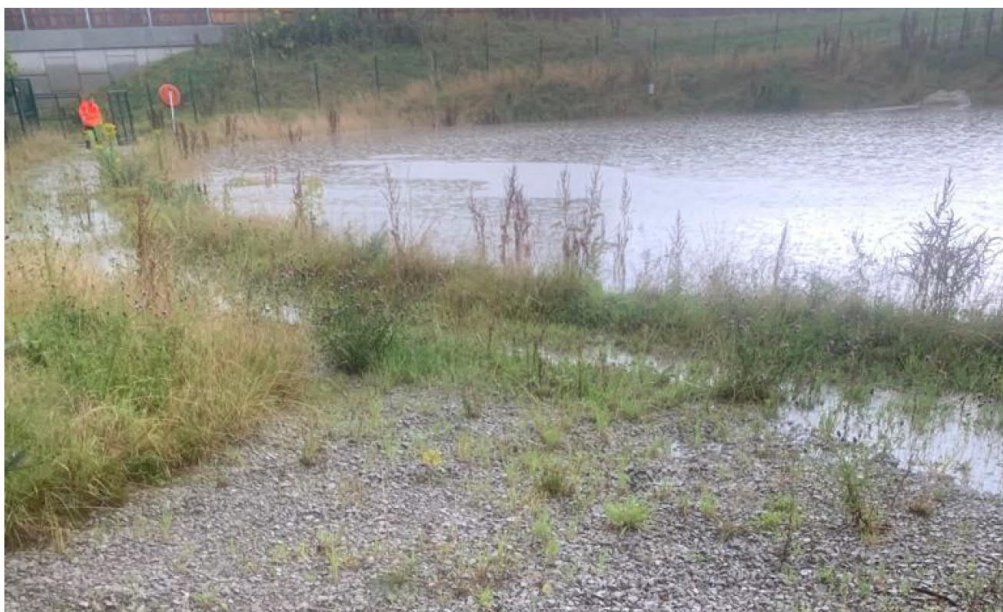
Figure B.2: Network C attenuation pond overflowing 31st July 2019

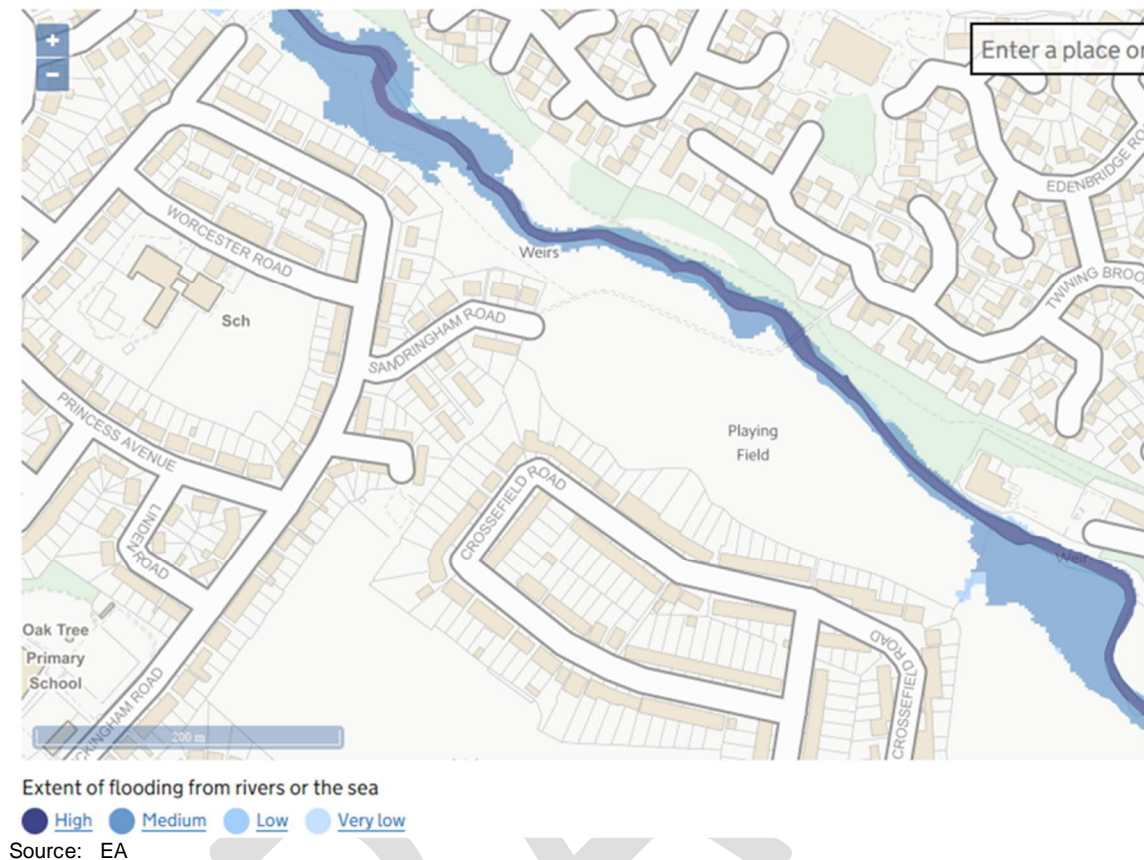
Figure E.9: Sandringham Road; EA Fluvial Flood Map

This map indicates that Sandringham Road lies in an area considered to be at very low flood risk (from fluvial sources) and this conflicts with the flooding mechanism observed from the July 2019 flood event. Accordingly, it is possible the flood modelling is in error or the watercourse was partially blocked by debris causing elevated flood levels, or possibly both. We have no evidence of blockage but note the presence of 'weirs' on the watercourse at the rear of the properties; which may have some bearing upon flood flow levels. Based on the fluvial flood mapping the Sandringham Road properties would not have been expected to flood in the July 2019 event and accordingly the modelling and mapping should be reviewed to establish whether the mapping needs to be amended. Amended flood levels may indicate a requirement to provide some flood mitigation measures to Sandringham Road.

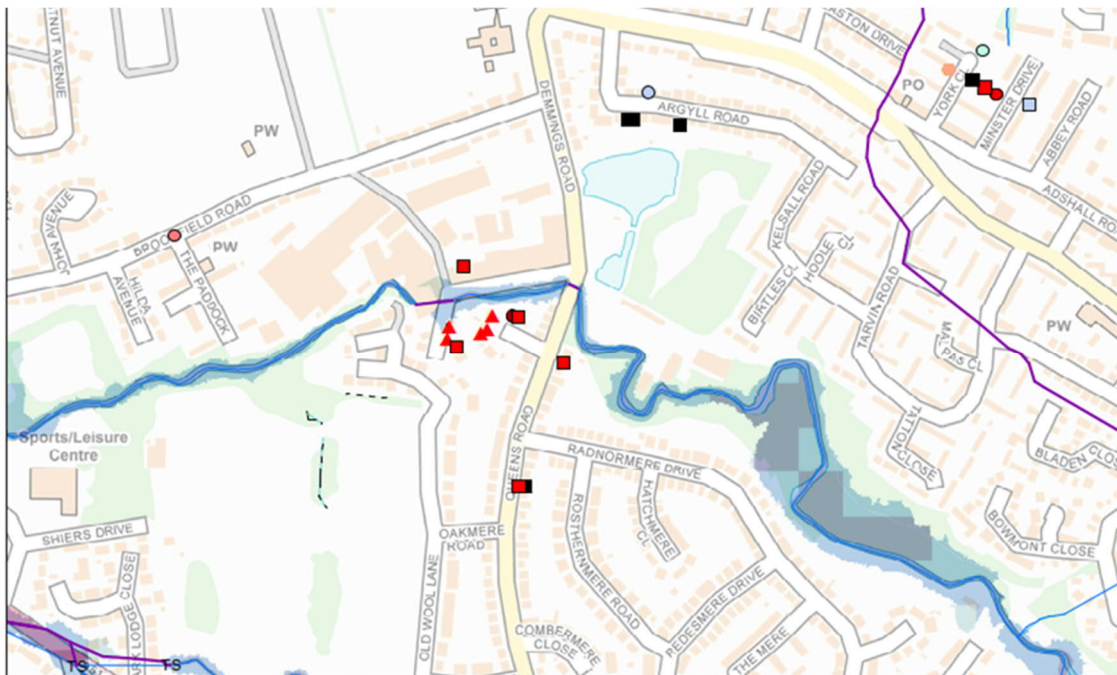
Figure F.11: EA, Queens Road; Fluvial Flood Map

dimensions. In this case there is a suspicion there is some inconsistency in the fluvial mapping. This needs to be rectified so that the local flood risk is better understood.

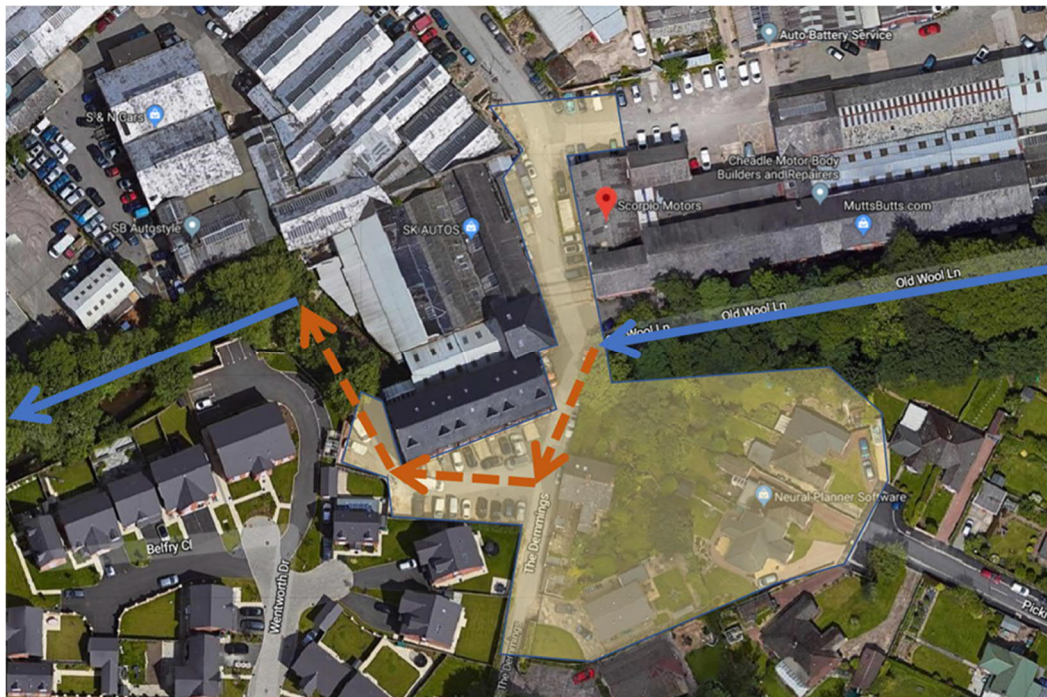
Figure F.13: Queens Road; Overhead view showing overland flow path in red.

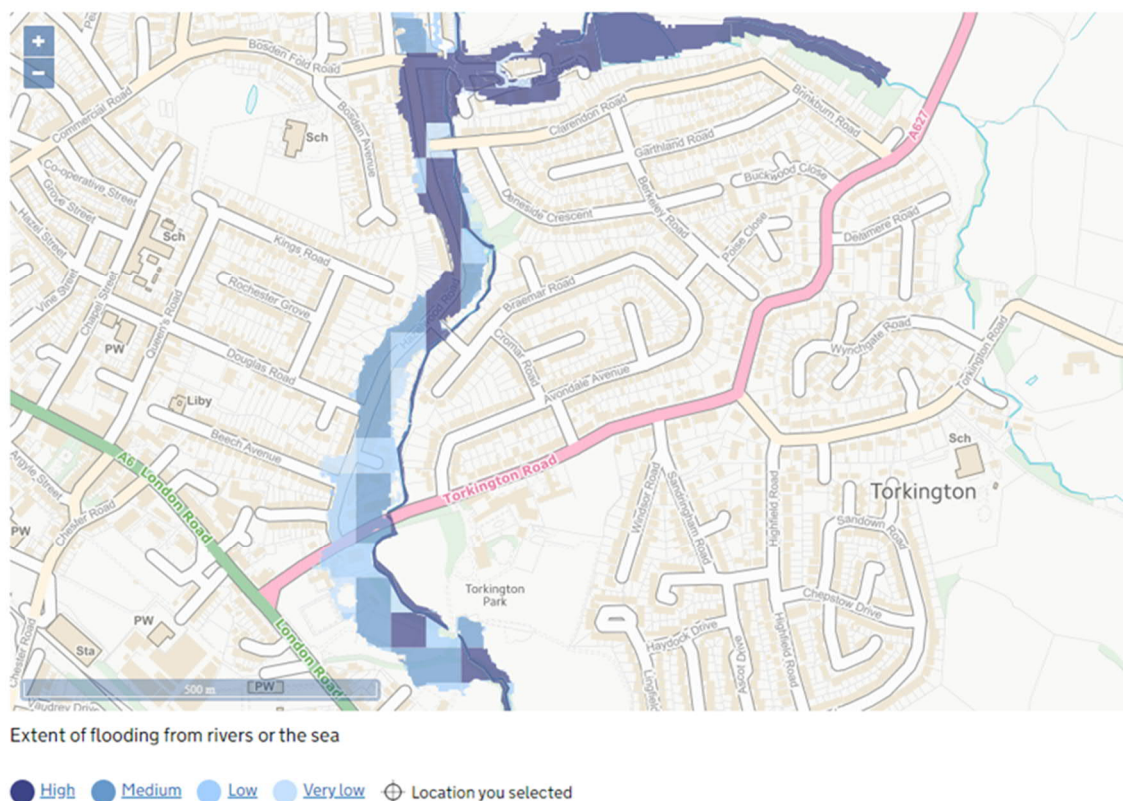
Figure J.22: Torkington Road; EA Fluvial Flood Map

This map indicates that overflowing from the culvert entrance at Torkington Road is anticipated to form an overland flow route along Hazelwood Road and return to the main river downstream as far as Bosden Fold Road and the confluence with poise Brook.

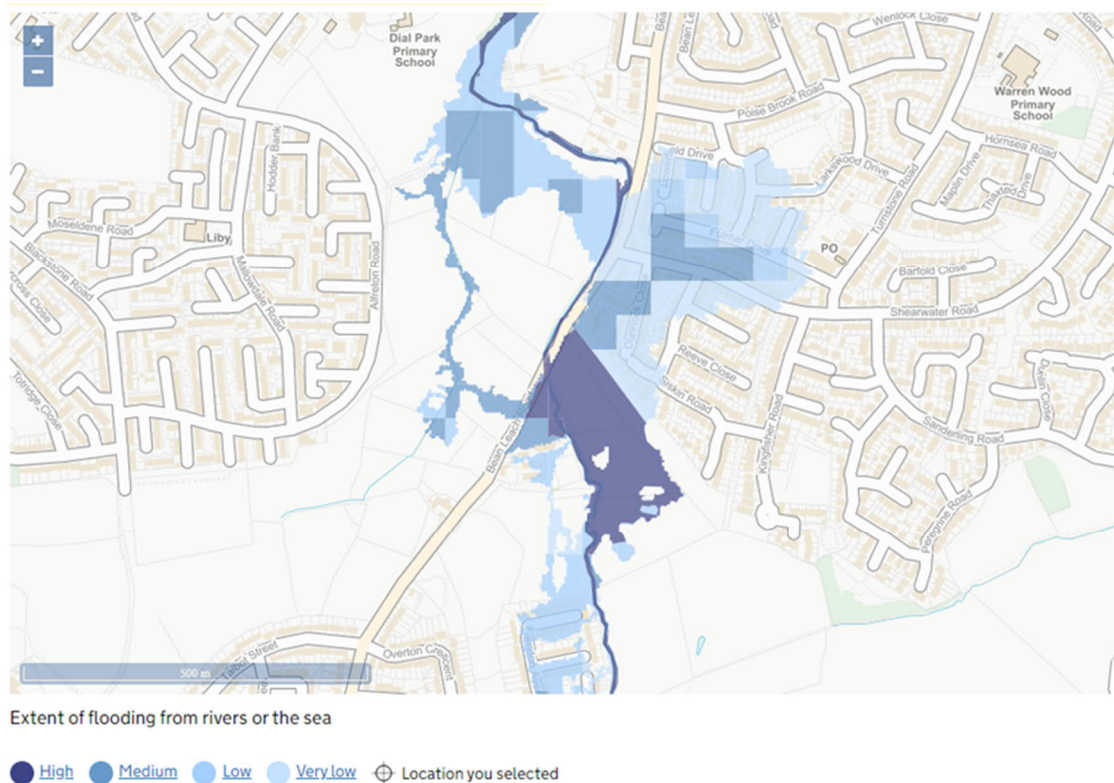
Figure K.25: Bean Leach Road; EA Fluvial Flood Map

- Greenspace upstream of Bean Leach Road and spreading NE towards the housing estate. Flood propagation directly NE into the housing is prevented by an earth embankment. This embankment is not a formal defence but does form a barrier to floodwater.
- The map does not show Bean Leach Road to flood which is contrary to the eyewitness reports.
- A large are of the estate is shown to be at Low to Medium flood risk.
- The flood extents map shows a spill route over Bean Leach Road that flows westwards to join a tributary channel that joins with Poise Brook downstream and west of Bean Leach Road
