# **Section 19 Flood Investigation Report for July 2019 Event**

**Stockport Metropolitan Borough Council**

**1 December 2020**

**Document reference:** 414640 | 001 | I

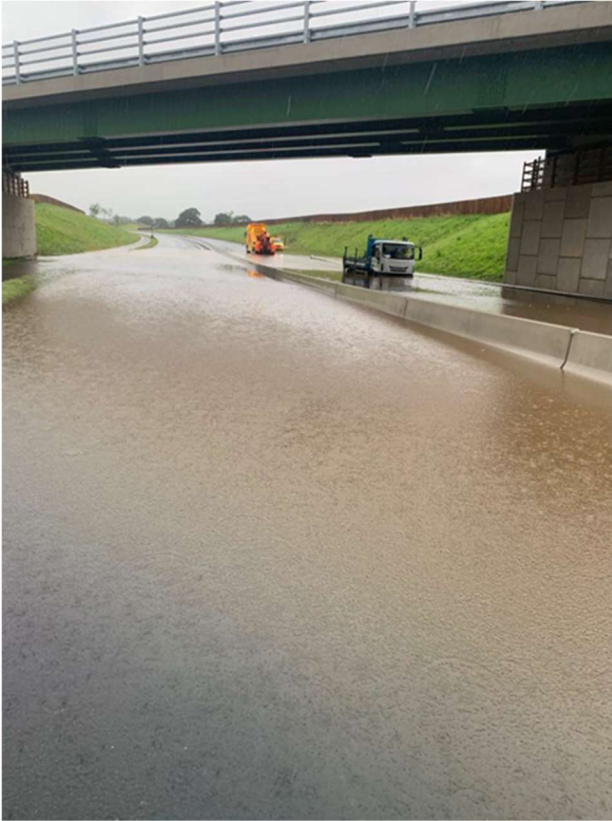
- Attended Network C pump station on Sunday 29<sup>th</sup> July 2019 at 15:00hrs,
- A555 carriageway flooded; see Figure 2.9.
- Both pumps had tripped but tested ok and were re-started and the floodwater was cleared.
- The pumps were noted to be drawing 31 to 31.4 Amps across all phases with overload trips set at 32 Amps.
- At the time the water level in the Network C pond was 300mm below the delivery pipe.
- It was understood the pond level had been higher earlier in the day.
- Revisited site on Monday 29<sup>th</sup> July 2019 to investigate cause of pump tripping but no explanation found; pumps running at 29 to 30Amps.

- By the time they arrived both Network C pumps had tripped and the high-level alarm had activated.
- A555 carriageway starting to flood at Woodford Road bridge.
- Pumps were re-started but drawing 33A (over the 32A overload setting).
- APS visited the Network C pond and found it completely full and the delivery pipe submerged.
- Pond C then started overflowing (see Figure 2.10) and flowing overland to the river (Lady Brook) which was noted as being 'very high'.
- Returning to the pump station the pumps had tripped on overload after 5 minutes.
- Re-starting a pump it then tripped on start-up (60A starter breaker).
- The pumps were re-set but not started. The engineers concluded the high pond level was increasing the pump duty' leading to overload conditions.
- A555 carriageway completely flooded at Network C pump station.

APS concluded that the high Network C pond water level was increasing the pump duty' leading to overload conditions and the pumps should not be re-started until water level drops.

**Figure 2.9: 28<sup>th</sup> July 2019 A555 carriageway flooded at Woodford bridge, Network C.**

- Check the rising main and receiving drain for obstructions/blockages.
- Review raising the overload settings if equipment is suitable,
- Review upgrading the pumps and/or electrical equipment for the higher 'flood condition' duty..

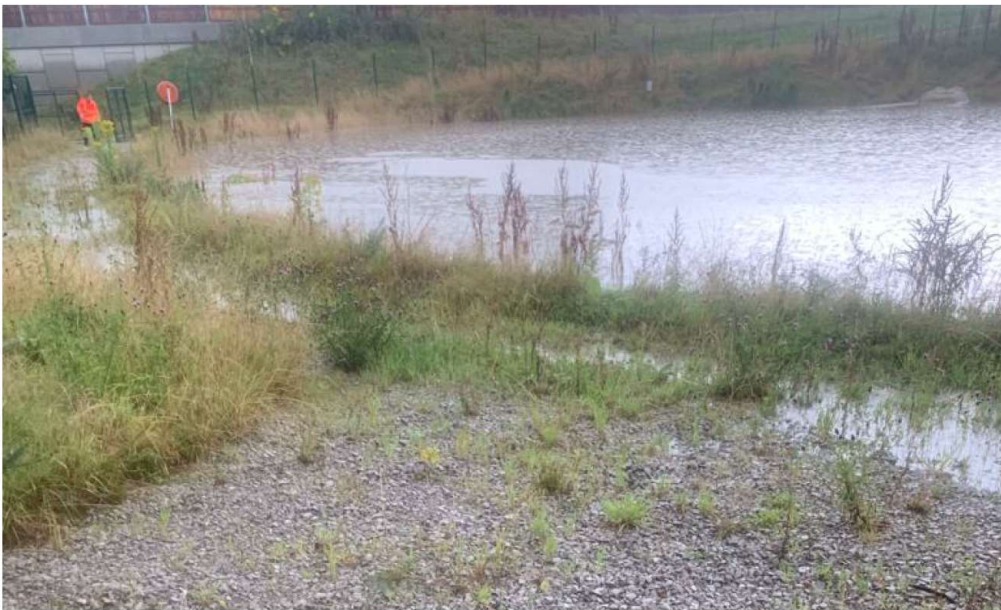
- Network C attenuation pond (discharge into Lady Brook) overflowing and damaged.
- Tuesday 30<sup>th</sup> July; A555 temporarily opened at 5pm but closed later due to more rain bringing levels in tanks back up over road level (at Hall Moss Lane).

**Figure 2.10: Network C attenuation pond overflowing 31<sup>st</sup> July 2019**

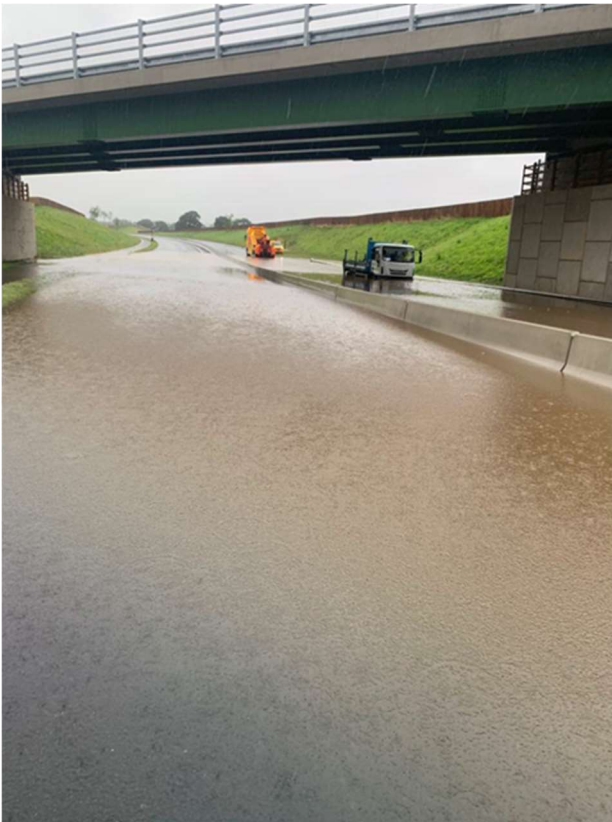
**Figure B.1: 28<sup>th</sup> July 2019 A555 carriageway flooded at Woodford bridge .**

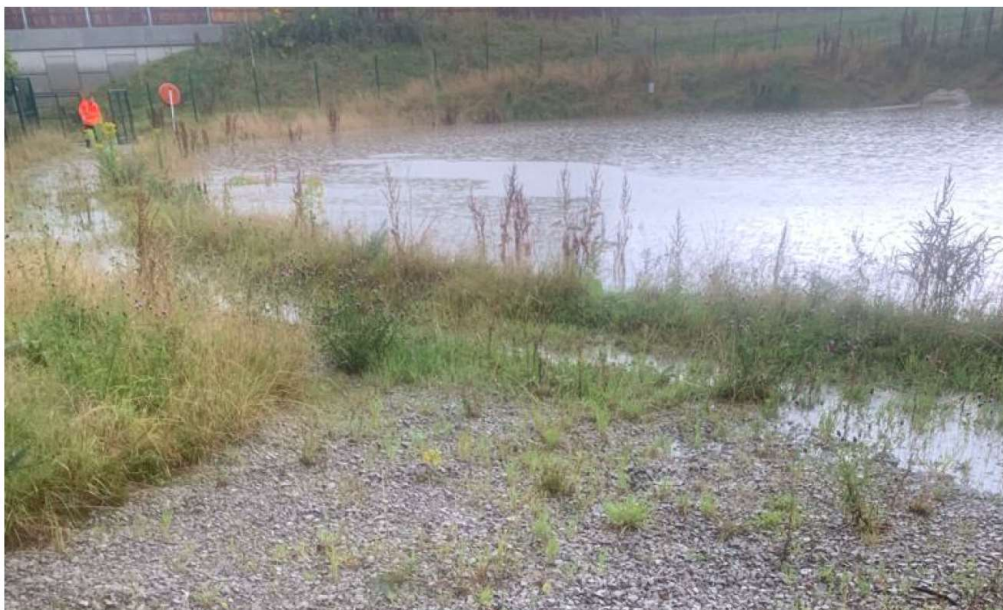
**Figure B.2: Network C attenuation pond overflowing 31<sup>st</sup> July 2019**

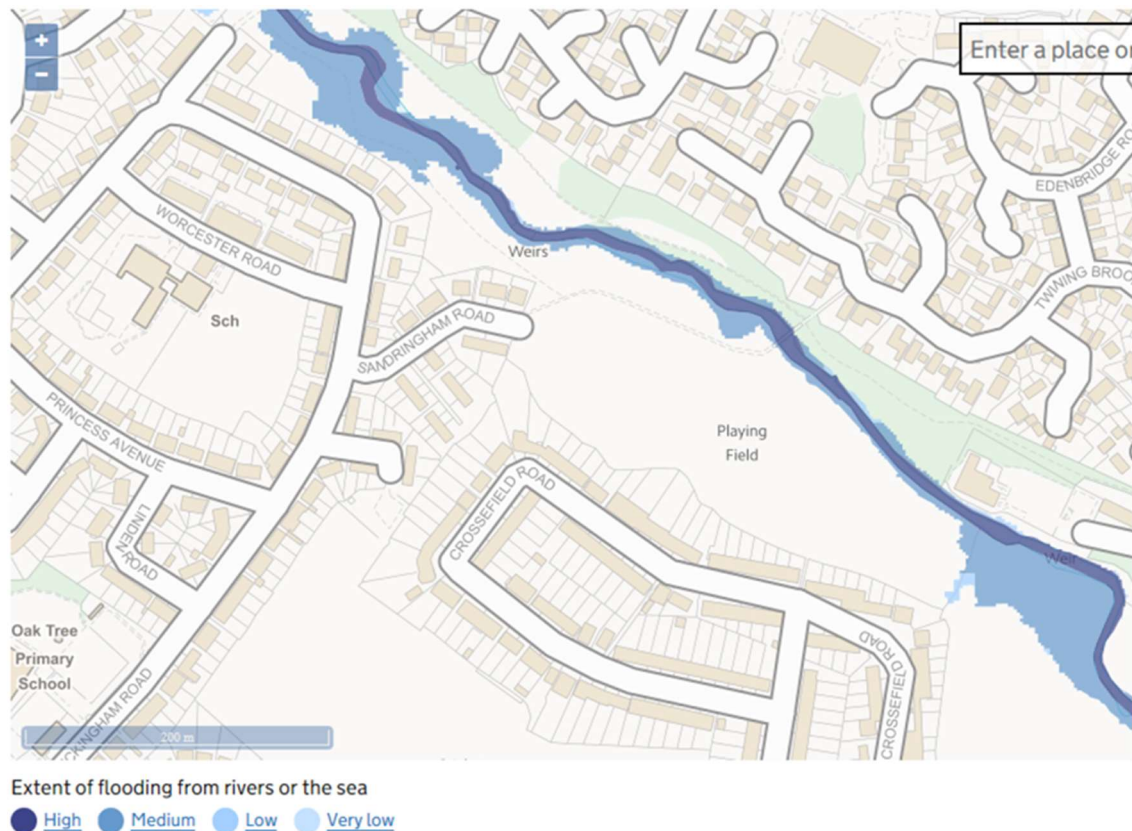
**Figure E.9: Sandringham Road; EA Fluvial Flood Map**

This map indicates that Sandringham Road lies in an area considered to be at very low flood risk (from fluvial sources) and this conflicts with the flooding mechanism observed from the July 2019 flood event. Accordingly, it is possible the flood modelling is in error or the watercourse was partially blocked by debris causing elevated flood levels, or possibly both. We have no evidence of blockage but note the presence of 'weirs' on the watercourse at the rear of the properties; which may have some bearing upon flood flow levels. Based on the fluvial flood mapping the Sandringham Road properties would not have been expected to flood in the July 2019 event and accordingly the modelling and mapping should be reviewed to establish whether the mapping needs to be amended. Amended flood levels may indicate a requirement to provide some flood mitigation measures to Sandringham Road.

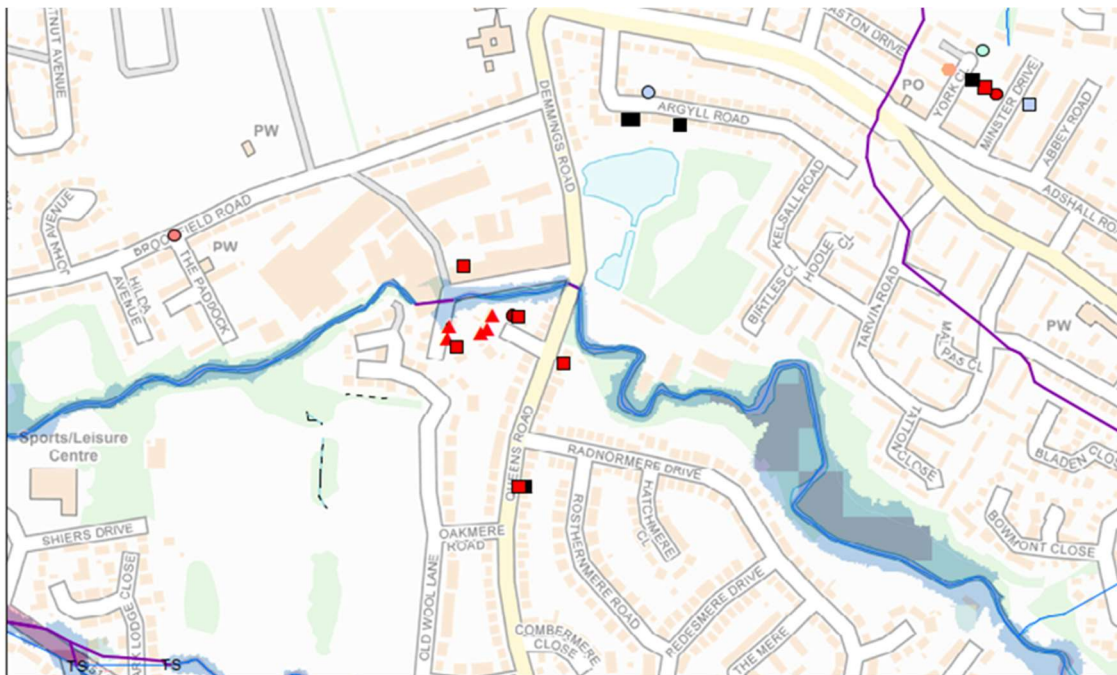
**Figure F.11: EA, Queens Road; Fluvial Flood Map**

This map indicates locations of reported flooding and shows:

dimensions. In this case there is a suspicion there is some inconsistency in the fluvial mapping. This needs to be rectified so that the local flood risk is better understood.

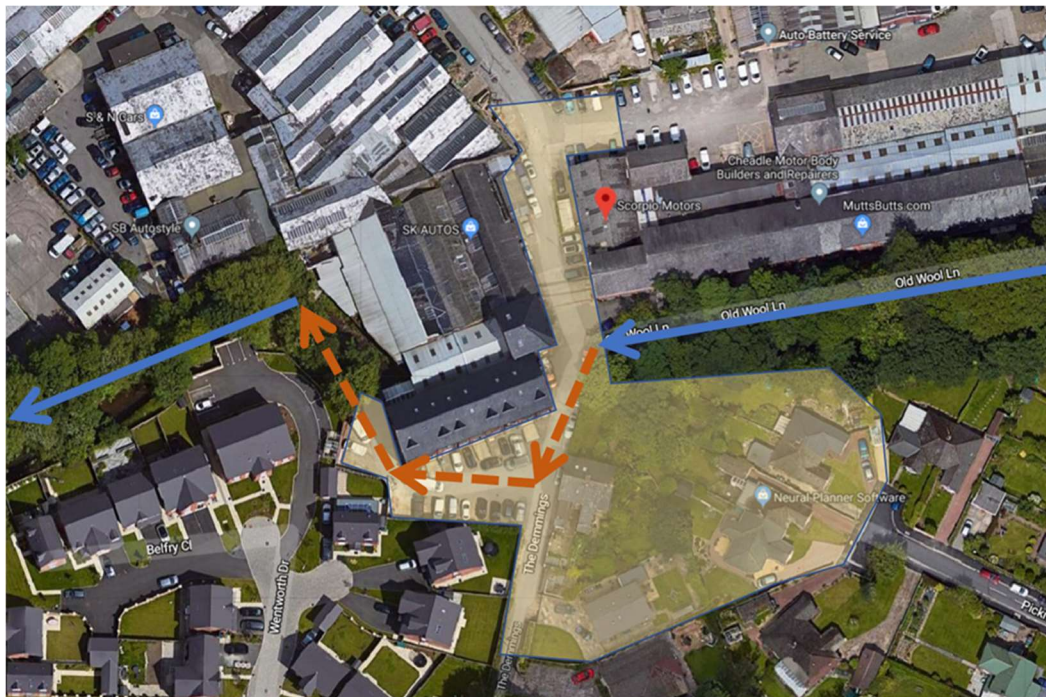
**Figure F.13: Queens Road; Overhead view showing overland flow path in red.**

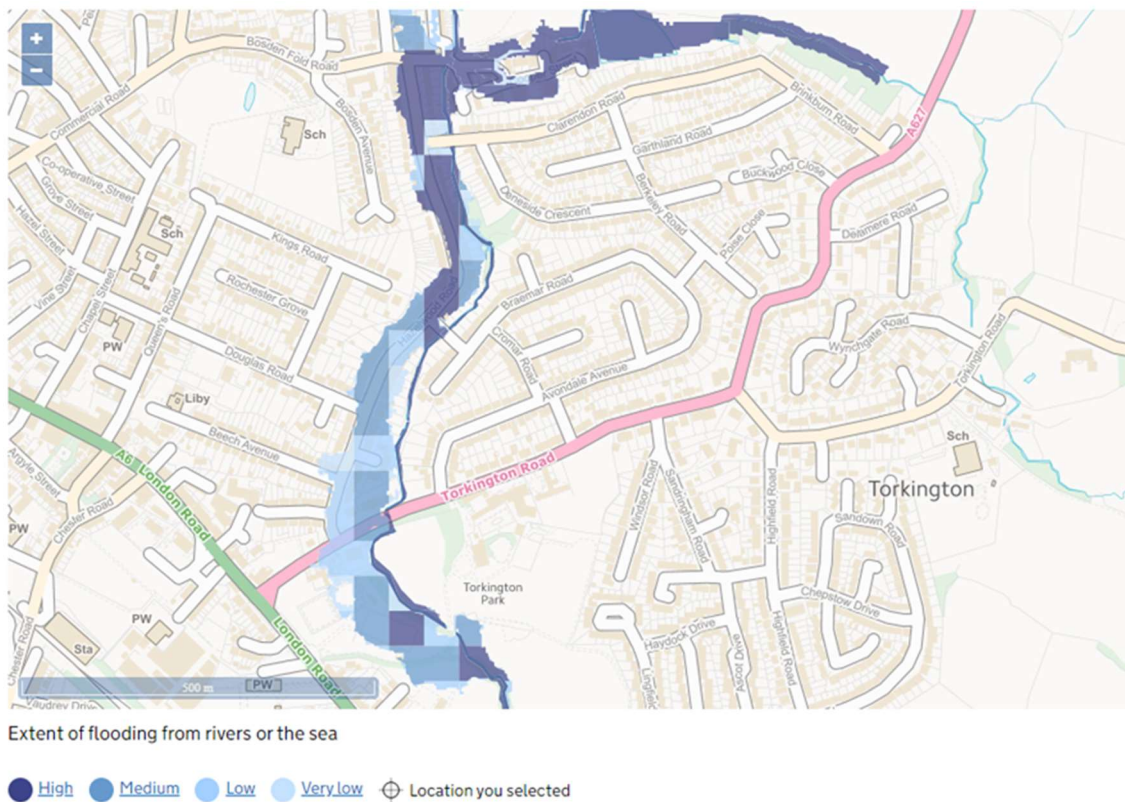
**Figure J.22: Torkington Road; EA Fluvial Flood Map**

This map indicates that overflowing from the culvert entrance at Torkington Road is anticipated to form an overland flow route along Hazelwood Road and return to the main river downstream as far as Bosden Fold Road and the confluence with poise Brook.
