Section 19 Flood Investigation Report for July 2019 Event

Stockport Metropolitan Borough Council

1 December 2020

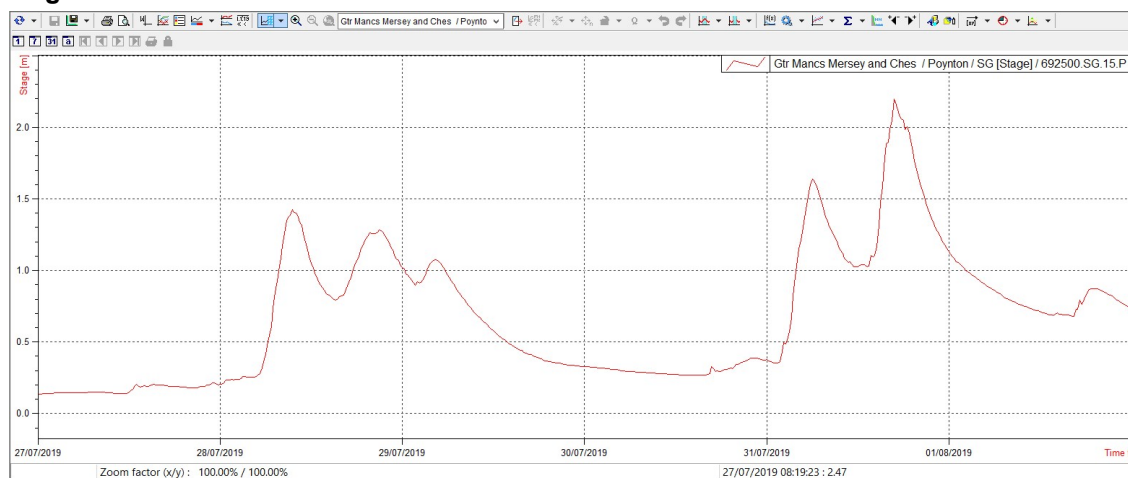
Figure 2.6: Poynton Brook at Poynton gauge level response to 28th July 2019 – 01st August 2019 rainfall

As a result of the rainfall on 31st July 2019 the water level at Poynton gauge reached 2.195m, the highest since records began in December 2008 (i.e. in around 11 years). Flood frequency analysis, based on rough flow estimates at Poynton level gauge, gives a peak flow for the July 2019 event of around 12 m³/s with an indicative return period of around 45 years.

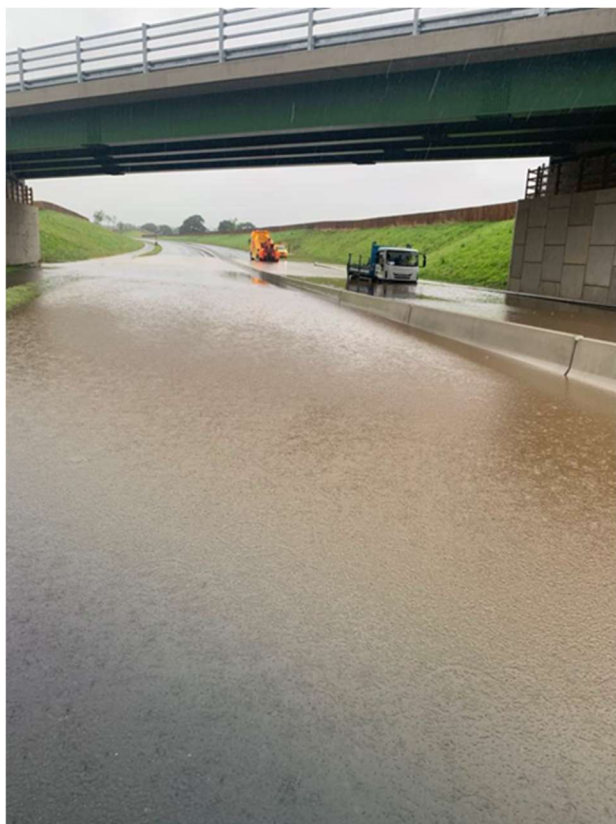
Figure B.1: 28th July 2019 A555 carriageway flooded at Woodford bridge .

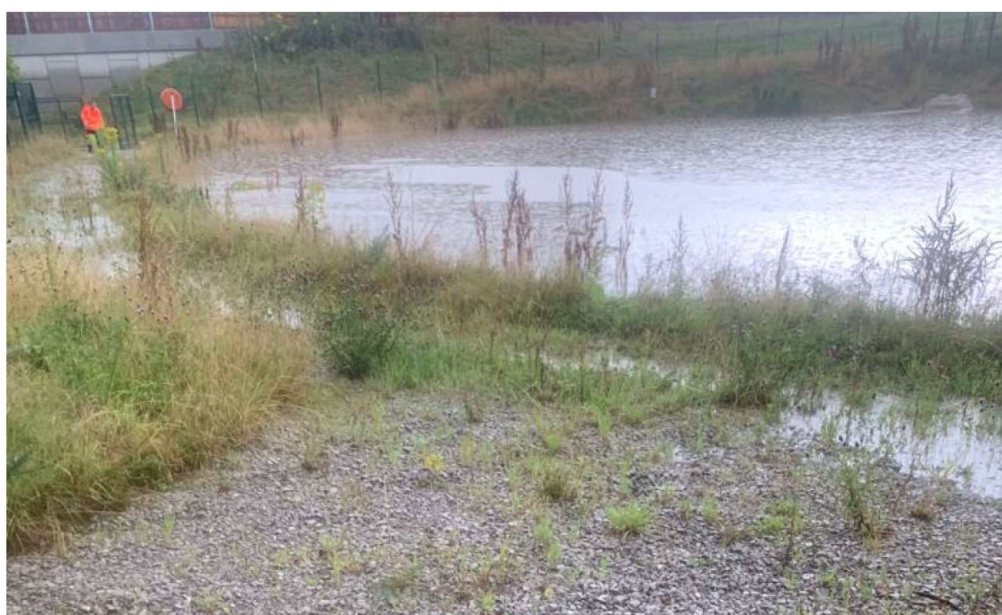
Figure B.2: Network C attenuation pond overflowing 31st July 2019

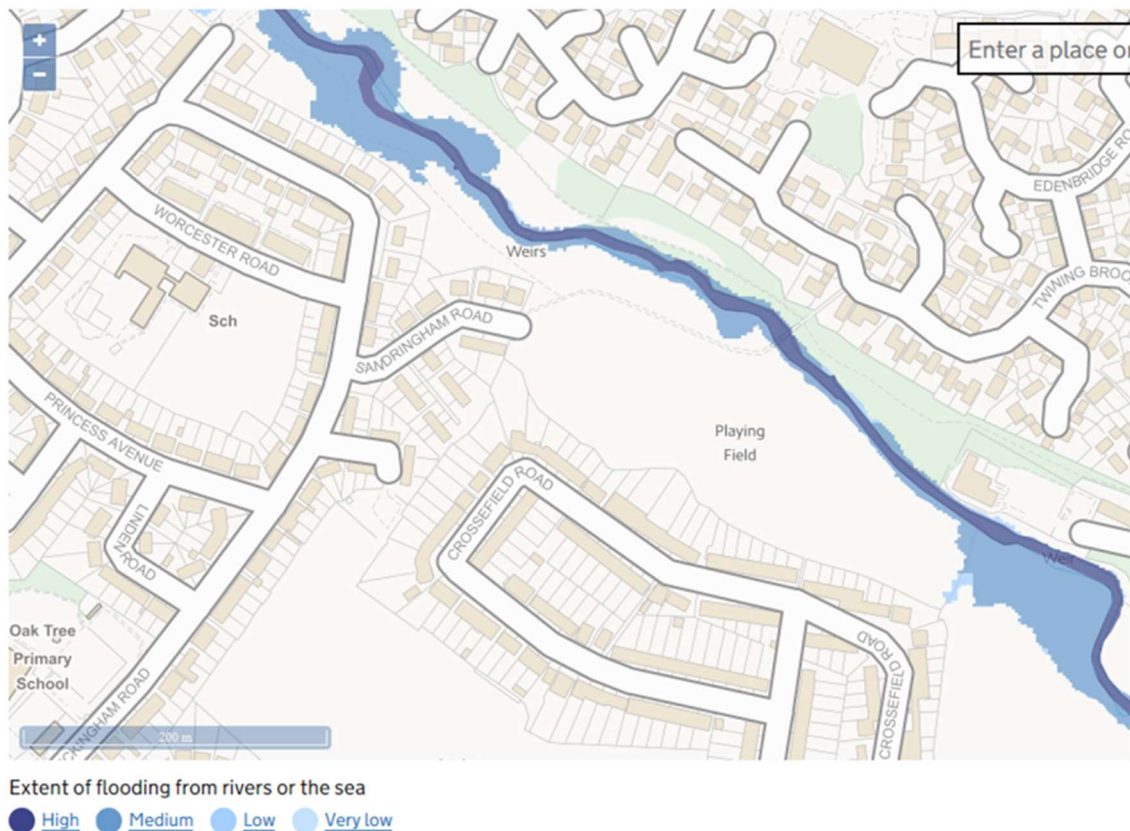
Figure E.9: Sandringham Road; EA Fluvial Flood Map

This map indicates that Sandringham Road lies in an area considered to be at very low flood risk (from fluvial sources) and this conflicts with the flooding mechanism observed from the July 2019 flood event. Accordingly, it is possible the flood modelling is in error or the watercourse was partially blocked by debris causing elevated flood levels, or possibly both. We have no evidence of blockage but note the presence of 'weirs' on the watercourse at the rear of the properties; which may have some bearing upon flood flow levels. Based on the fluvial flood mapping the Sandringham Road properties would not have been expected to flood in the July 2019 event and accordingly the modelling and mapping should be reviewed to establish whether the mapping needs to be amended. Amended flood levels may indicate a requirement to provide some flood mitigation measures to Sandringham Road.
