APPENDIX 4 – WEIR MILL SITE PHOTOS

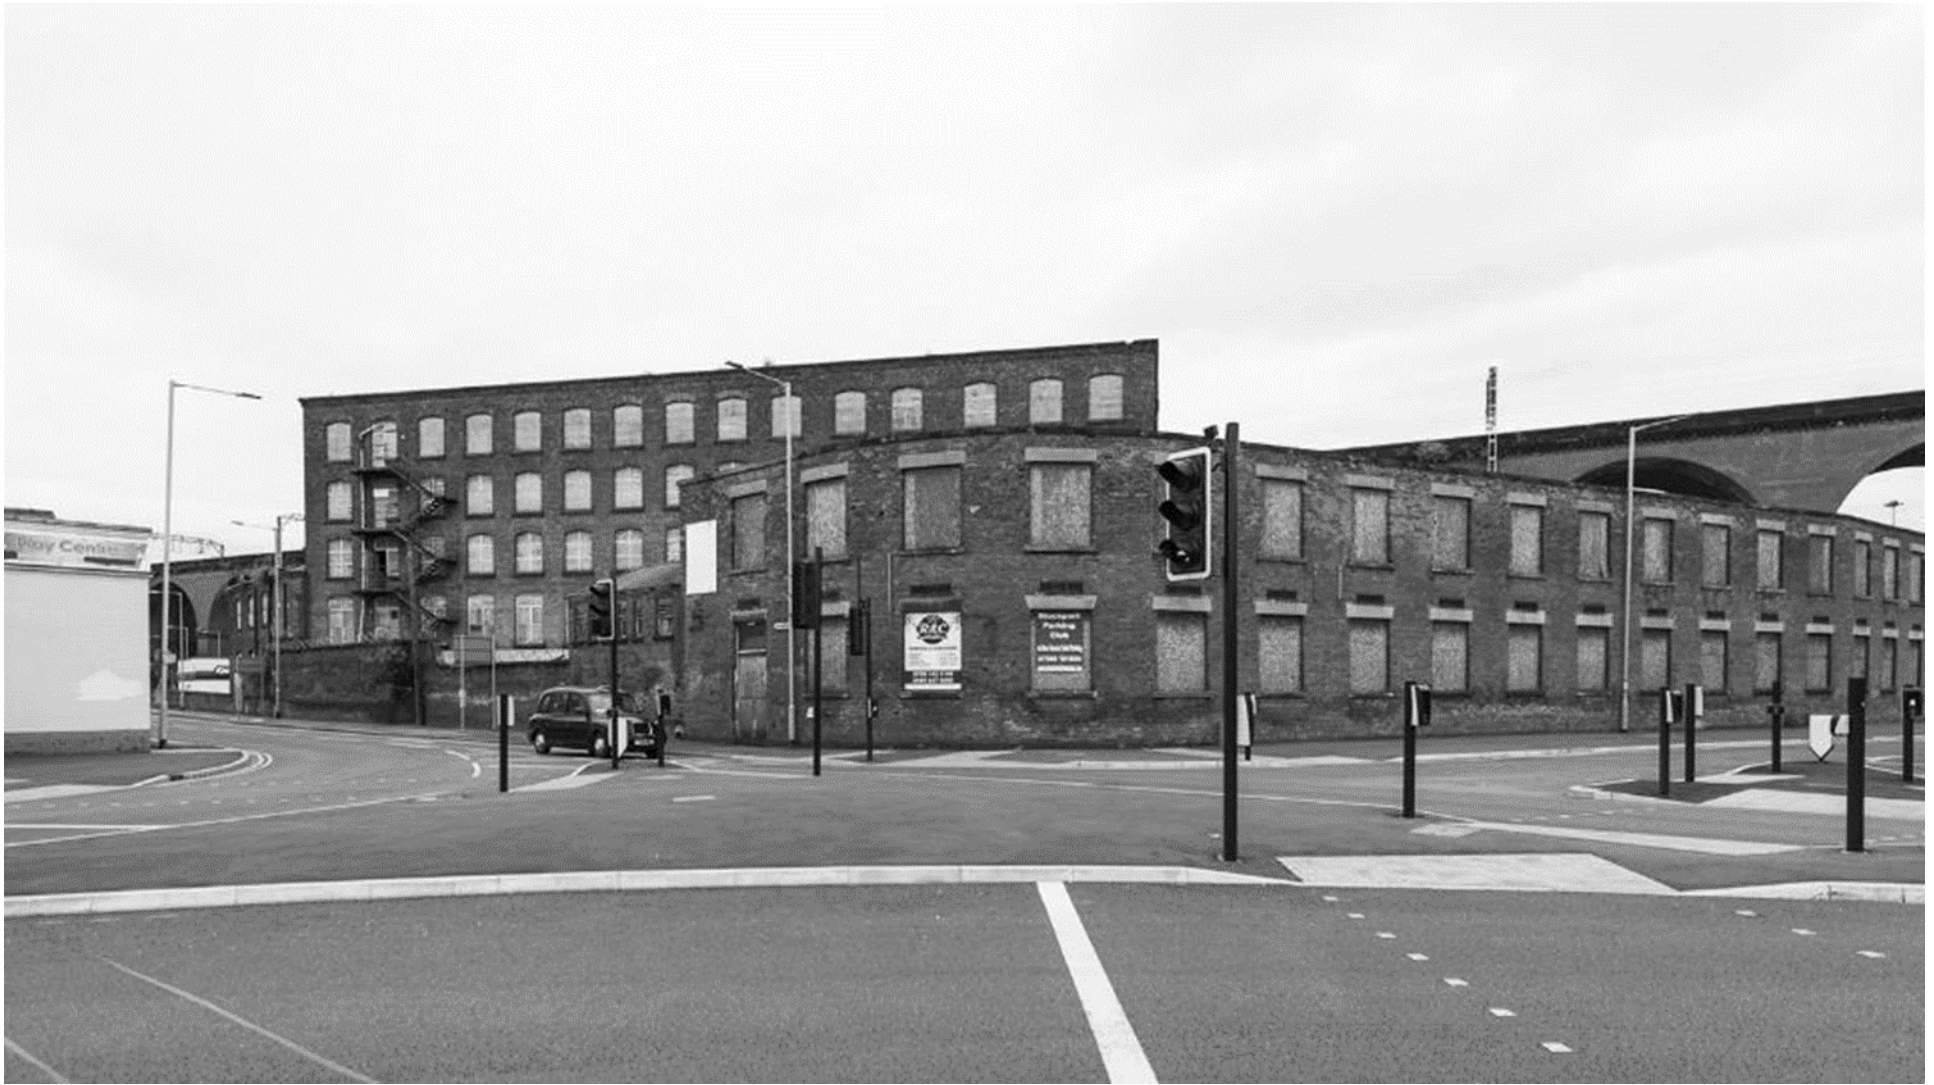
Current Condition from corner of Chestergate and King Street West.

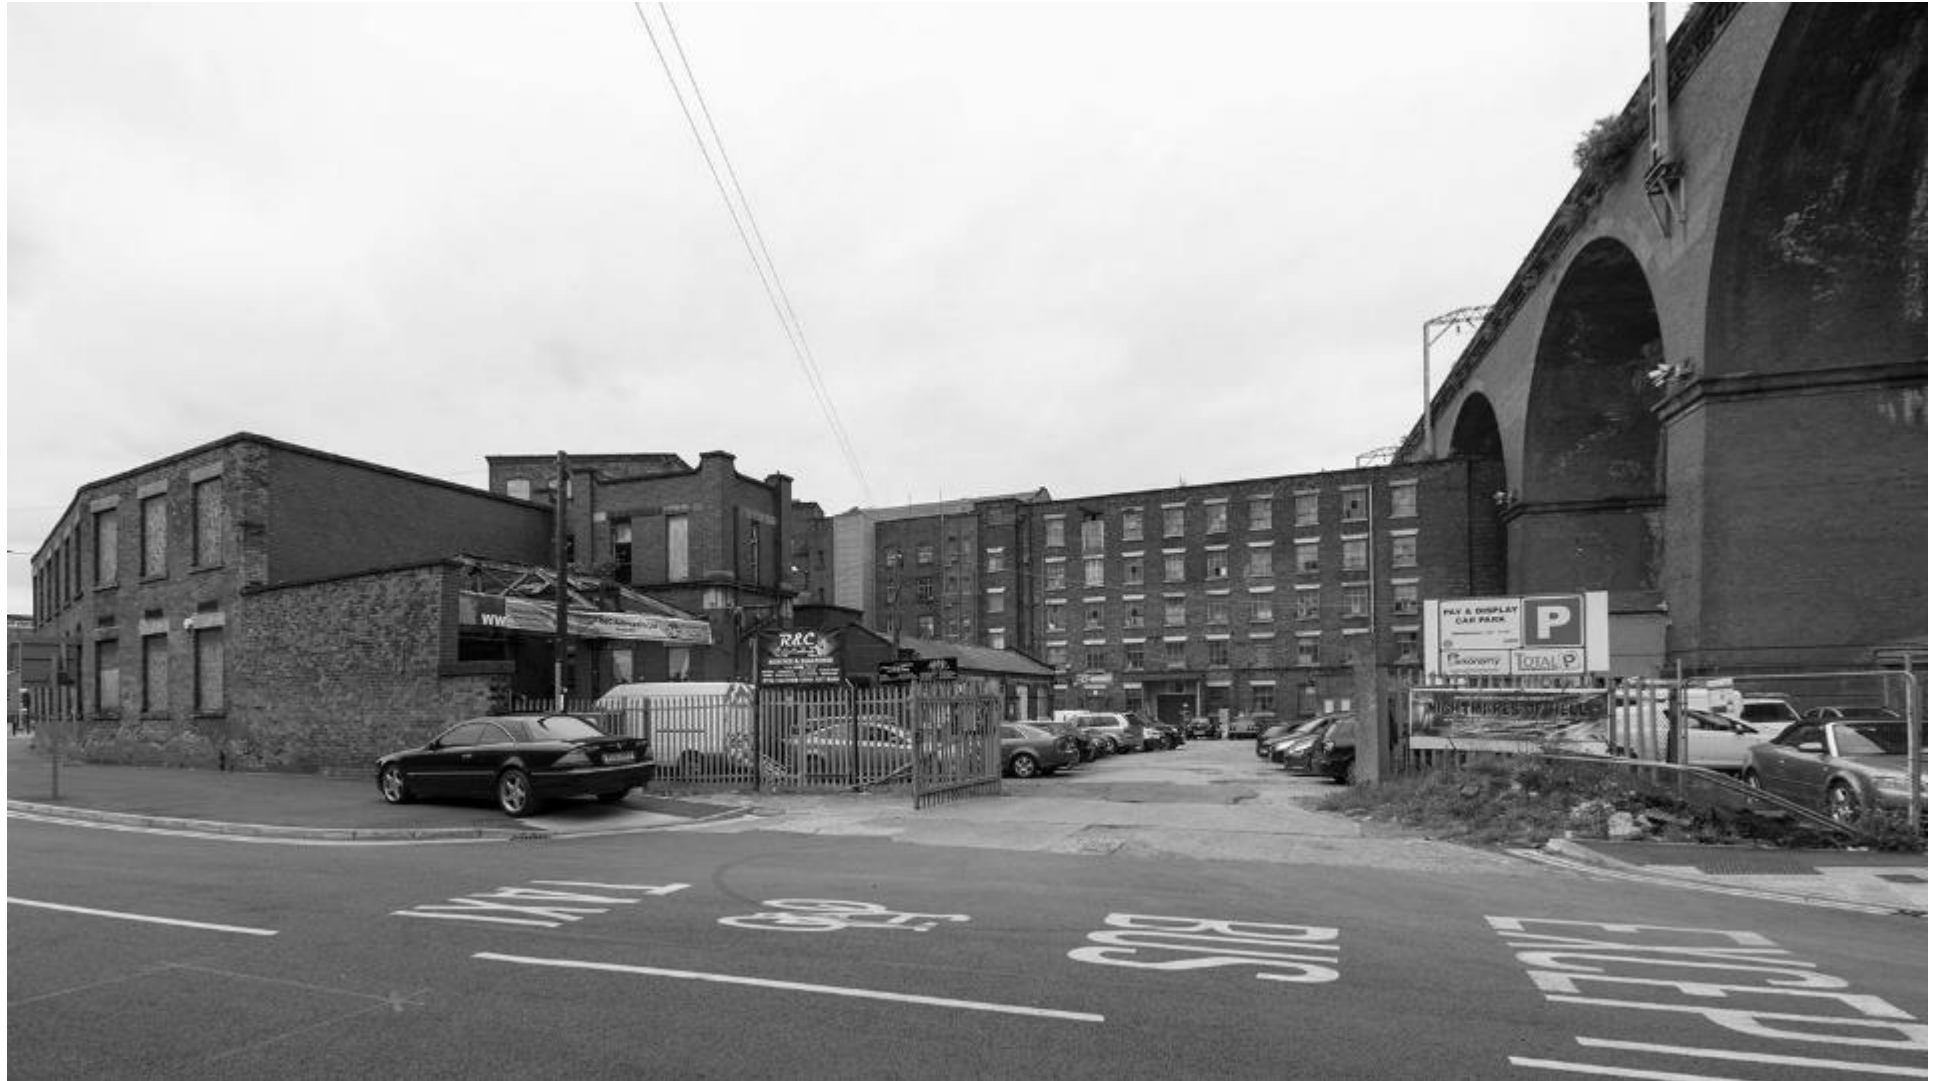
Current Condition looking into courtyard from Chestergate

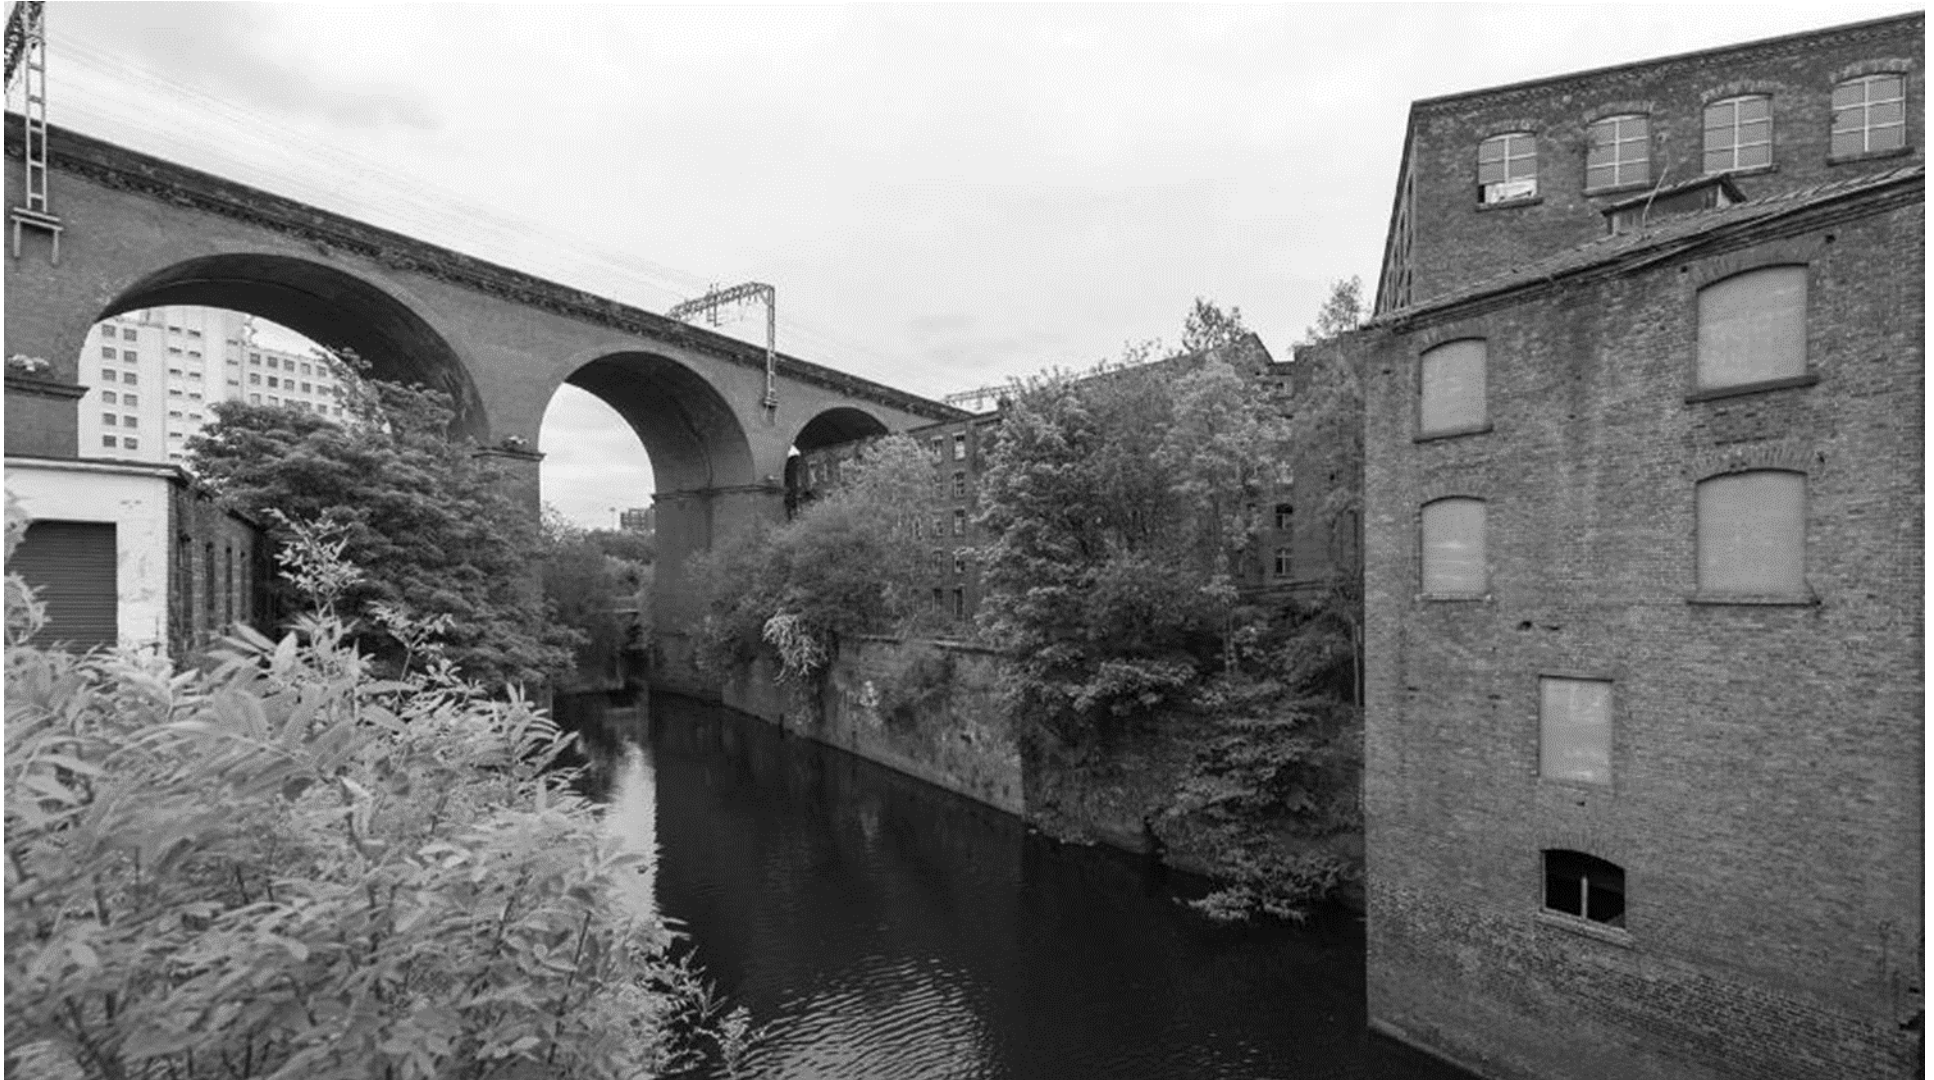
Current Condition from King Street West bridge.
