# **ECOLOGICAL CONSTRAINTS SURVEY**

**Site – Shared Cycle Path:  
Revised Heaton's Cycle Link.  
Kingsleigh Road-Harwood Road-Burnage  
Lane.**

**SURVEY UNDERTAKEN BY:  
Mr. John Rowland  
Countryside Officer**

**12<sup>th</sup> April 2021**

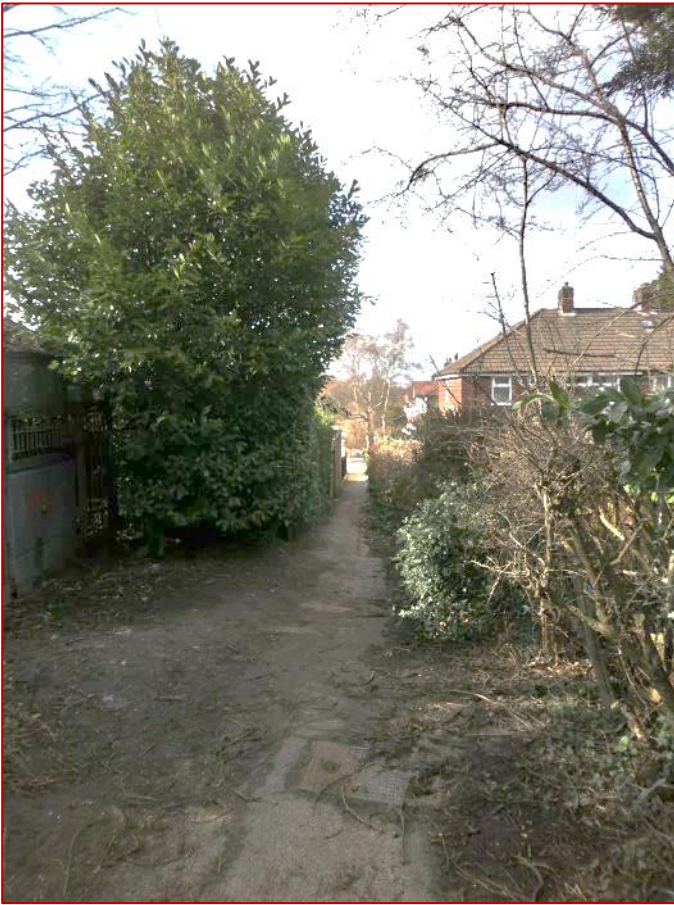
The starting point here for the survey is the narrow entrance off Kingsleigh Road. There are low value hedges to both sides of the path on the boundary with neighbouring properties (**Photo 1**) the hedge to the east side has species including choisya, leylandii, laurel as well as some wooden fencing. To the north the hedge is predominantly beech and has recently been cut back hard and reduced in height to around 1.2m. both hedges have limited value for wildlife being situated in close proximity to the path which was heavily utilised by school children at the time of one of the surveys and this footfall would be a deterrent to nesting birds. The laurel and choisya both flower which are good for supporting invertebrates and if the laurel set fruit birds too. The path enters the sports field/amenity grassland, via a sloping dirt path which continues to the intersection of paths at Trentham Avenue. At the start of this path there is an extremely overgrown privet hedge (**Photo 2**) extending for around 40m, which growing out over the path and although privet is generally considered to be of a low value to wildlife this hedge is deep enough to support nesting bird species including blackbird and thrush, and the flowers will offer an early nectar source for invertebrates. No field signs of badger were identified (footprints,

**Photo 1: Entrance off Kingsleigh Road**

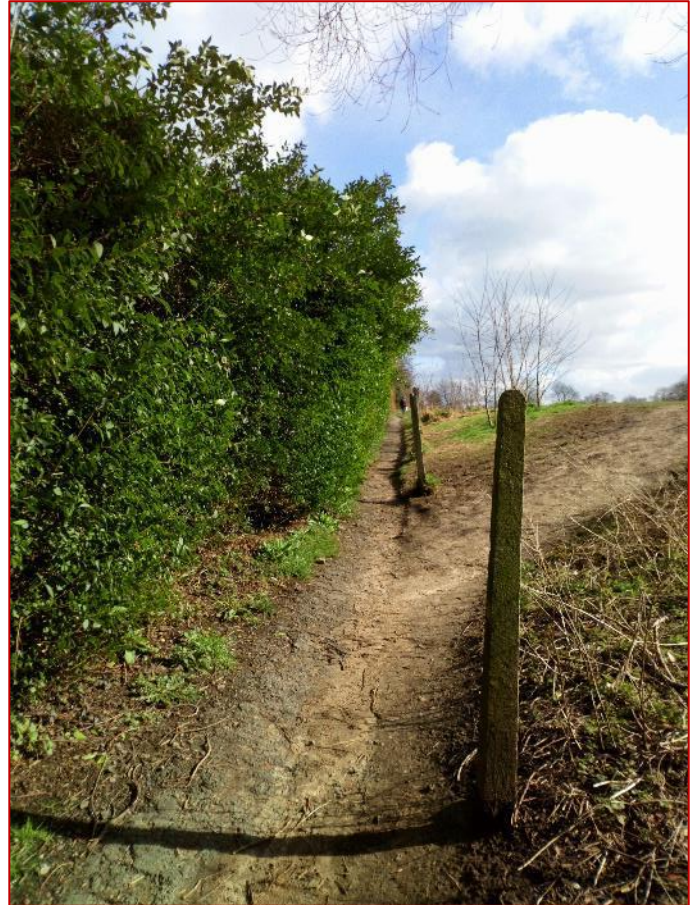
**Photo 2: Obstructed Path**

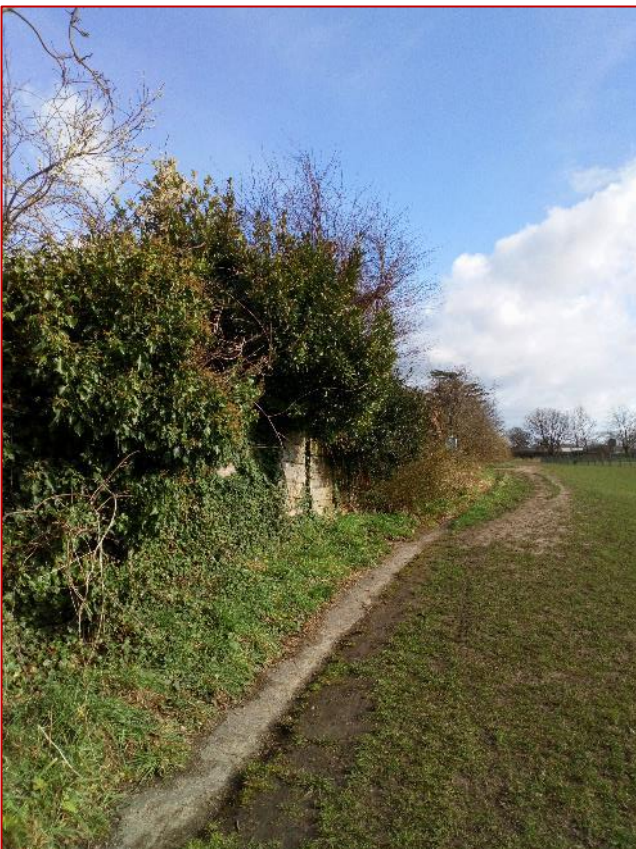
**Photo 4: Muddy Path. High Value Grass Verge**

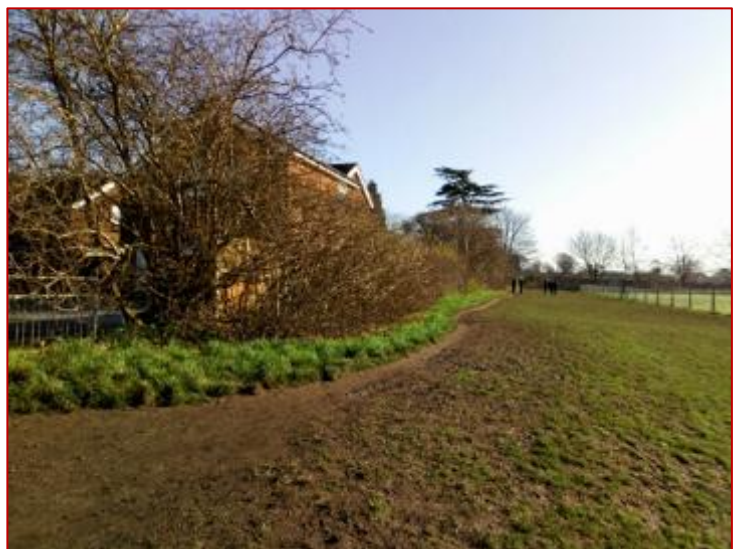
The proposed cycle path would continue past the access point off Cherry Holt Avenue running along the rear of the properties on Dovercourt Avenue along a strip of muddy amenity grassland (**Photo 4**). There is an unmanaged intermittent hedge row separating the gardens from the field which contains a good mix of species including lilac, hawthorn and flowering cherry, with a large cedar in the garden and a good ground layer of common ivy, rough grass with bramble and nettle, which is creating a localised connectivity to the surrounding area. This area has no potential roost features but offers potential to nesting bird species with the small flowering trees and shrubs supporting invertebrates. No field signs of badger were identified (footprints, latrines and snuffle holes) along the line of the route within the localised area at the time of the survey.

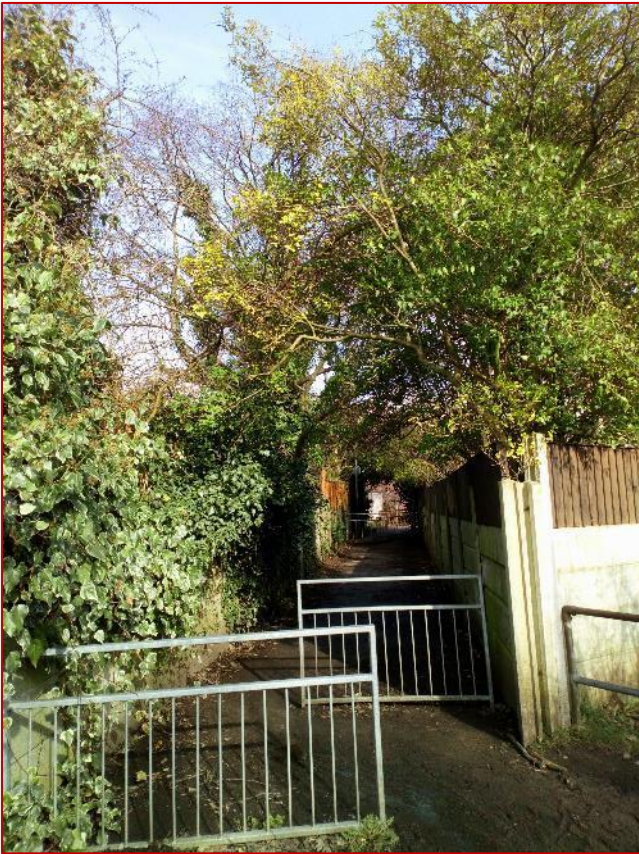
- 5.2.1 At the junction with the link path to Trentham Avenue (**Photo 5**) which has a sealed surface and panel fencing to both sides with overarching vegetation in places which become thicker towards the end of the passageway (**Photo 6**). There is limited wildlife value along this path, with some nesting opportunity within the thicker vegetation and the large Ivy-covered lime tree which has a low bat roost potential. No field signs of badger were identified (footprints, latrines and snuffle holes) along the line of the route within the localised area at the time of the survey.

**Photo 5: Path to Trentham Avenue**

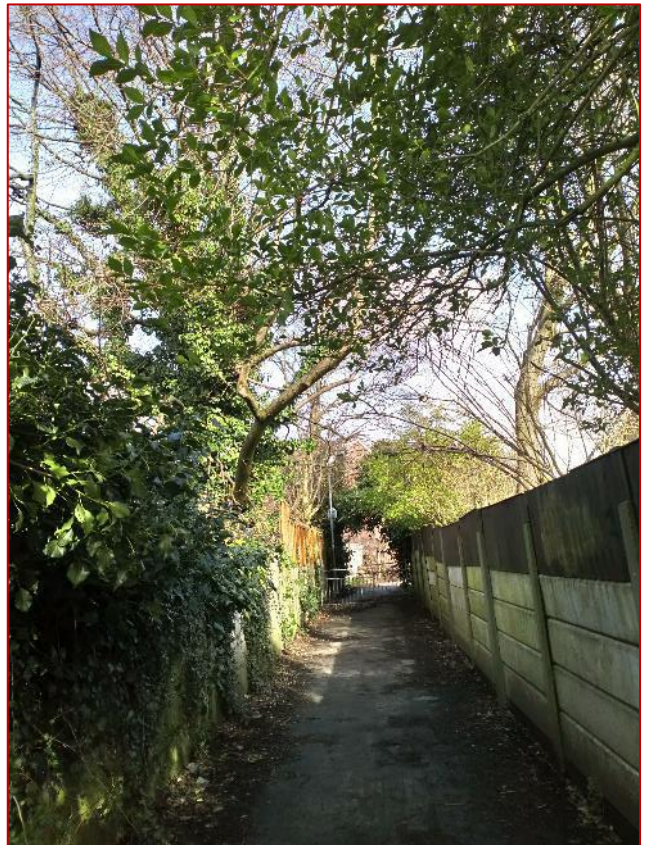
**Photo 6: Overhanging Vegetation**

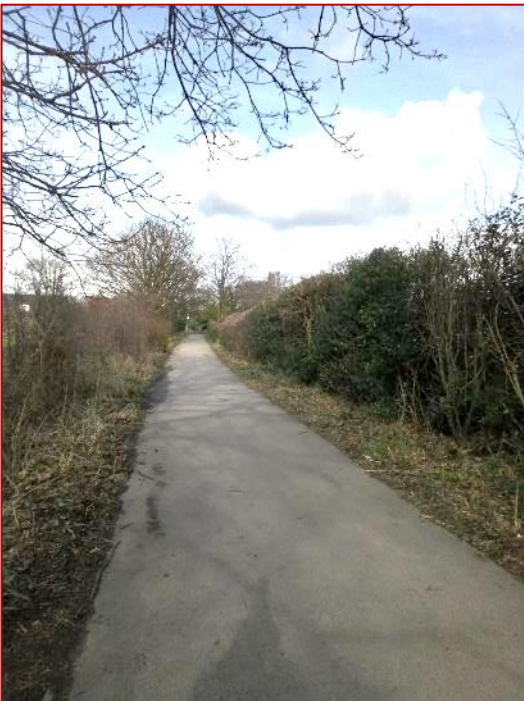
- 5.2.2 The route then turns south joining a 2m wide sealed surface footpath which runs between an allotments and Preinstall School sports field (**Photo 7**) and is lined with hedging to both sides with a formal 'maintained' hedge on the allotment side and a less formal hedge to the field side with some rudimentary hedge laying having taken place in certain areas. The maintained hedge along the boundary with the allotments is around 1.5m high and has more potential to support nesting birds than the thinner hedge on the field side, however this hedge although sparsely growing does contain holly, wild rose and dogwood as well as the major component which is hawthorn. The hedge becomes more of a line of trees as it turns along the boundary with Bluestone Gardens (**Photo 8**), which is as a result of lack of maintenance but this adds to the diversity of the hedge line with species including semi mature oaks and sycamore. Ground flora along this interconnecting hedge row includes daffodils, snowdrops, wood avens and nettles with a scrubby area left to grow wild which has created a 'bund' of bramble encompassing a line of hawthorn whips. This area will be a good place for small mammals offering shelter and forage areas away from predators. No field signs of badger were identified (footprints, latrines and snuffle

**Photo 7: 2m Wide Path with Hedges**

- 5.3 The path has some LED lighting, and this should be reviewed to ensure that the light is directional and on a timed system to limit any potential impact on commuting or foraging bat species.

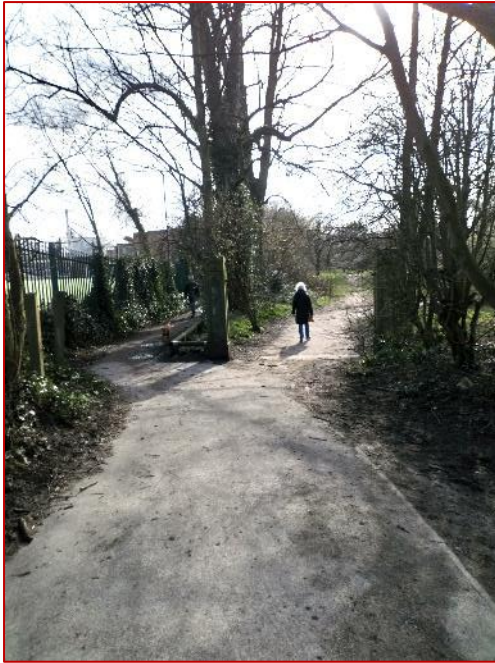
- 5.4.1 At the fork in the path (**Photo 9**) the proposed route takes the right fork around Bluestone Gardens, a small 'formal' area with tree lined paths, group plantings with mature and semi mature trees and old shrub beds with close cut amenity grassland. The route follows the line of an existing semi-circular route around the west side of the park passing a link path to Bluestone Drive before joining the main path through the northern boundary with Heaton Mersey Common to Burnage Lane.

**Photo 9: Fork to Bluestone Grds**

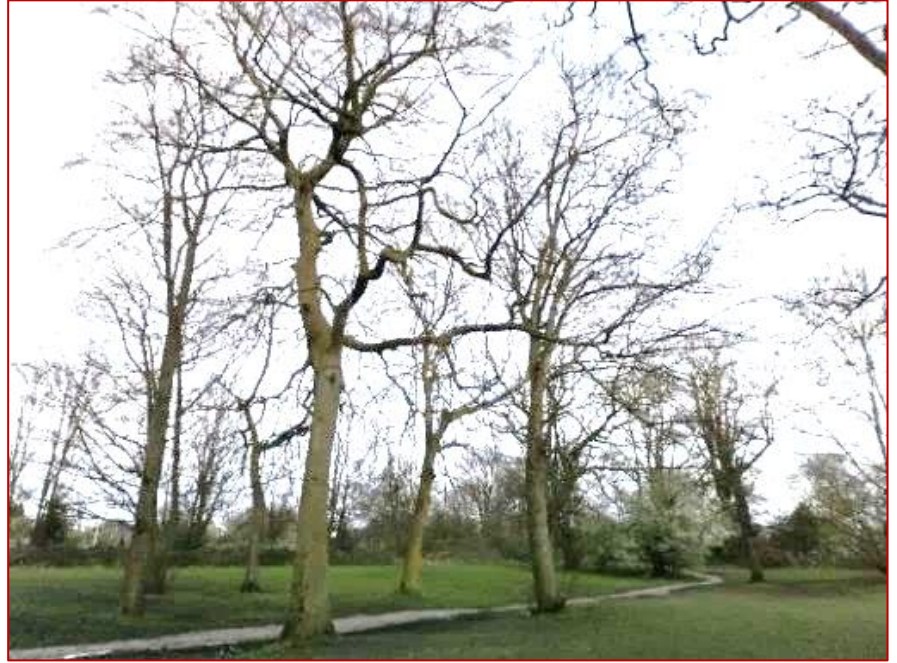
The first section of the park is lined with mature sycamore, lime, beech & ash (**Photo 10**) with stands of trees including wild cherry, sycamore beech with group planting of blackthorn and island beds containing regenerating beech and ash. The trees were surveyed and few PRF were noted some superficial fissures were noted in a medium sized ash and a hole in a beech tree which was being utilised by a squirrel! The trees in this area are considered to be of low potential to support a bat roost. Birds nests were noted in a couple of the trees.

**Photo 10: Tree Lined Footpath**

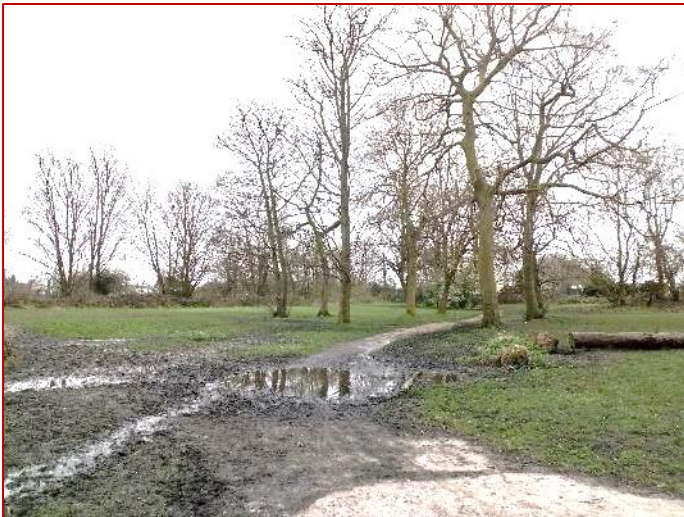
- 5.5 At the junction with the link path to Bluestone Drive the path is ponding (**Photo 11**) resulting the surrounding area being extremely waterlogged and the possible cause of a dead sycamore located in this area and preventing people from following the footpath. The junction of the paths (**Photo 12**) there is an area of scrub to the left of the path which is good habitat for supporting small mammals and invertebrates and potential nest sites and as much as possible should be retained. Along the boundary with the neighbouring property there is a mature beech and sycamore with two silver birch trees close by which should be retained. However, these trees exhibited a low potential to support a bat roost but the trees and the conifers in the garden next to the fence line do have potential to support nesting birds.

**Photo 11: Ponding & Waterlogged Area**

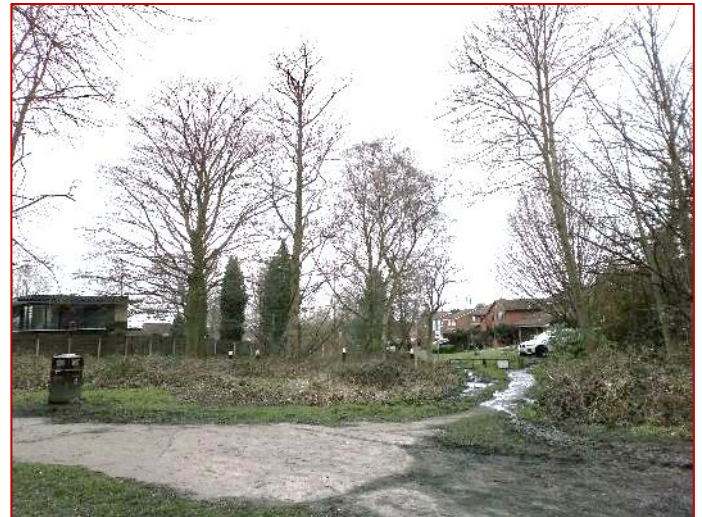
On the righthand side there is a smaller area of scrub with some regen trees including lime, ash and sycamore with a good cover of bramble creating links to the nearby hedgerow. There is water issuing out of the ground just in front of the garage of the house and this is running all the way down the path to Bluestone Drive. The track itself is lined on both sides by a variety of young and semi-mature trees and shrubs but the area is considered to be of low conservation value with the trees having negligible potential to support a bat roost. There is potential to support 'non-hole' nest building bird species to use the trees and hedges. (**Photo 13**). No field signs of badger were identified (footprints, latrines and snuffle holes) along the line of the route within the localised area at the time

**Photo 12: Areas of Scrub around path**

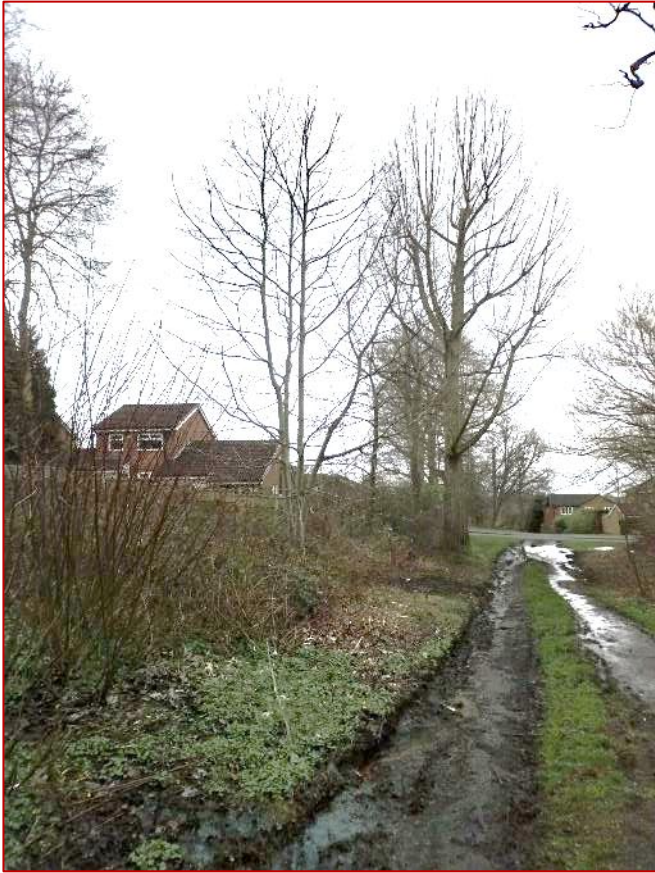
- 5.6.1 The path runs south at the rear of the properties on Hepple Close with trees lining the path on both sides (**Photo 14**). The trees lining the path although mature had very few PRF and are classed as low potential to support a bat roost but could support non hole nesting bird species. Adjacent to the path on the park side there is a large island bed running all the way along to meet up with the connecting path from Priestnall Road containing a mixture of regenerating semi-mature and mature trees with a shrub layer of bramble and nettle with some dogwood present. A ground layer with bluebells, dock, buttercup, great willow herb, wood avens, yellow welsh poppy, herb robert and cow parsley etc is a good nectar source for bees and beetles etc. the majority of the larger trees have a low potential to support a bat roost with the exception of a large majestic beech tree with a large feature suitable to contain a large bats roost but is currently being occupied by a colony of bees. **Next to this is a large mature sycamore with multiple PRF and must be considered as having high potential to support a bat roost and bat surveys must be undertaken if any tree work is considered necessary on this tree Grid Ref SJ86625-91247.**

**Photo 14: Rear of Hepple Close**

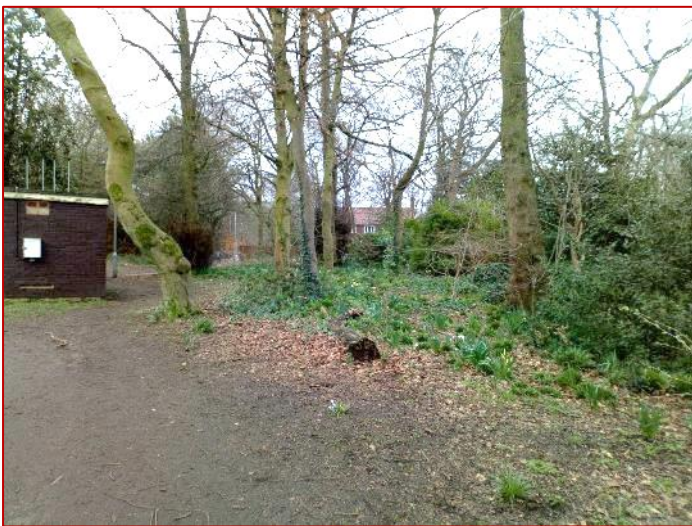
This path joins the path to Burnage Lane by the small sub-station, via an unmade, unsurfaced path (**Photo 15**).

**Photo 15: Junction with Burnage Ln Path**

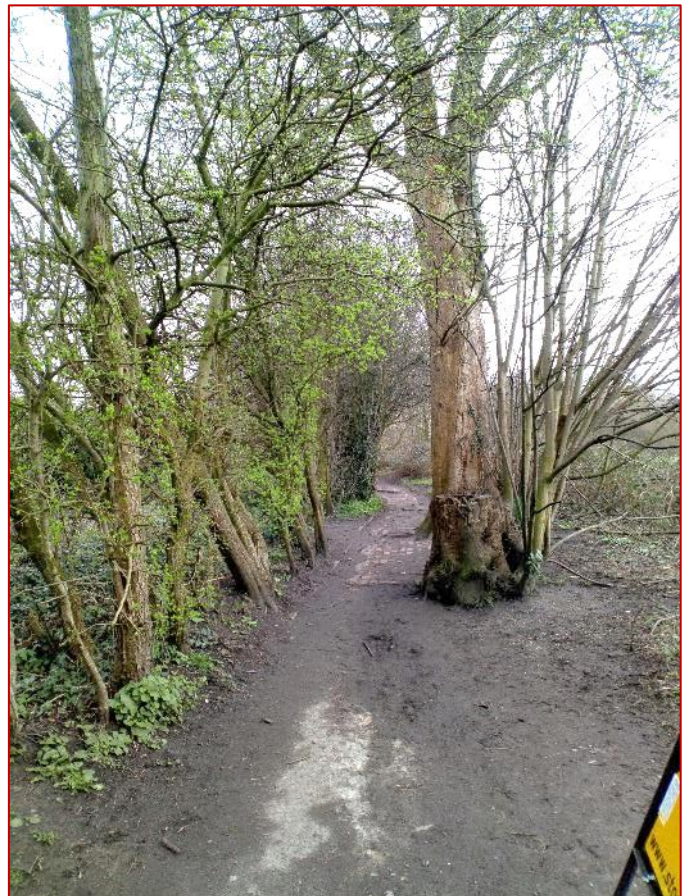
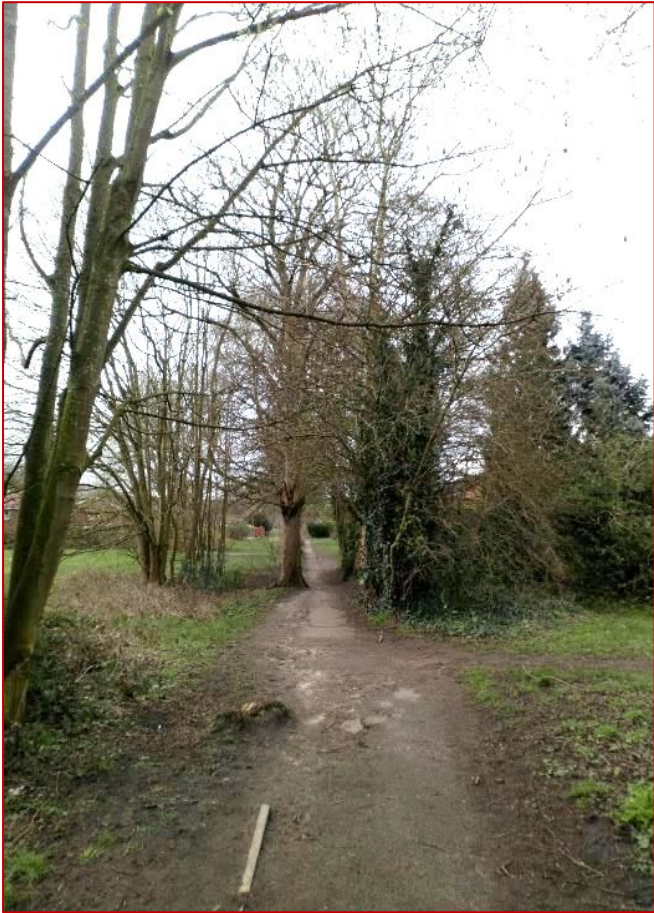
- 5.9.1 The in places is extremely narrow and has trees and or hedges to either side (**Photo 16 & 17**) and where possible these areas should be avoided and the path diverted to prevent the loss of trees and or hedges, and any trees that need to be removed must be replaced at a value of two to one. Where there is an option to divert the path (**Photo 18**) this should be utilised and will have the least overall impact on the site as these areas are mostly down to escaped garden shrubs and or overgrown vegetation from the gardens next to the route. There is potential to support 'non-hole' nest building bird species to use the trees and hedges. No field signs of badger were identified (footprints, latrines and snuffle holes) along the line of the route within the localised area at the time of the survey.

**Photo 16: Path Narrows between Hedge/Trees**

**Photo 17: Narrow Path between hedge & trees**

There is a section of hedgerow that could be improved by allowing more light to reach it and this could be achieved by removing a sycamore and some low value multi stemmed ash which are shading out the old hedge (**Photo 16**). These hedges could also be extended by additional planting of native species.

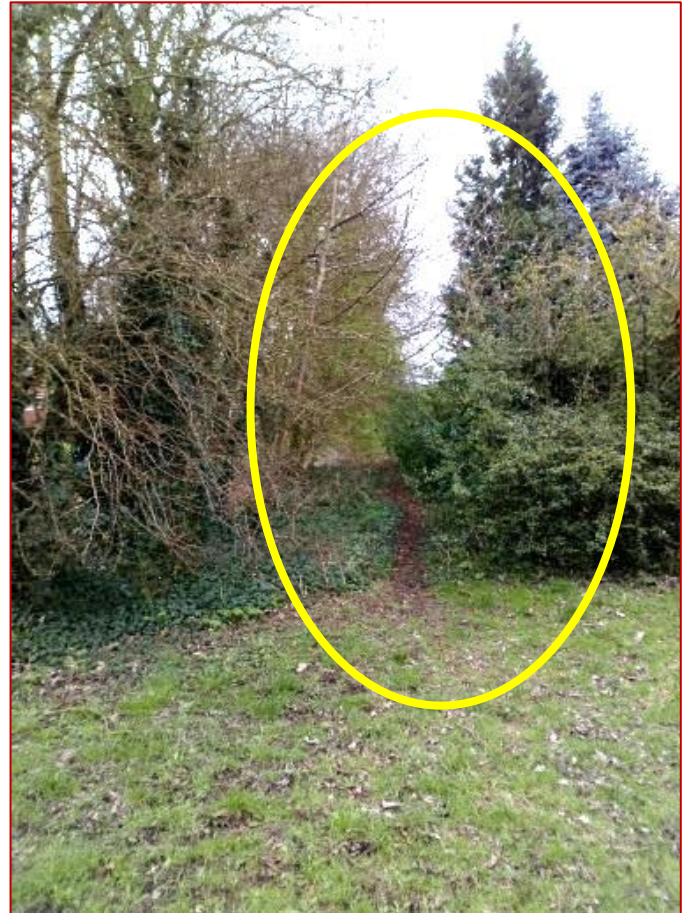
- 5.9.2 The path runs past the wildflower meadow (which is cut and cleared in late August/early September) and is extremely narrow in places with an option to bypass without removing any of the old hedge rows (**Photo 19**), other links to the surround housing estates are available, which are sealed surface paths and close cut low wildlife value amenity grass and shrub beds. After the southern link to Ingram Drive the path runs in a straight line with the majority being amenity grassland and of a low wildlife value (**Photos 20 & 21**). The largest expanses of grass are at the Burnage Lane end of the routes (**Photos 22 & 23**) this amenity grassland is of low wildlife value which could be improved by amending the cutting regimes and creating wildflower areas and adding shrub beds with species that have successional flowering and being outside of the LNR these shrubs could include cultivated species to obtain a this successional flowering to support bees and other invertebrates. One section of this grassland is particularly wet with some localised ponding and this could be expanded to create a small wildlife pond and marsh area (**Photo 24**). There is scope here to for additional tree planting and this could be ornamentals including flowering cherry and fruit trees providing nectar and pollen sources for bees and invertebrates.

**Photo 19: Alternative Route**

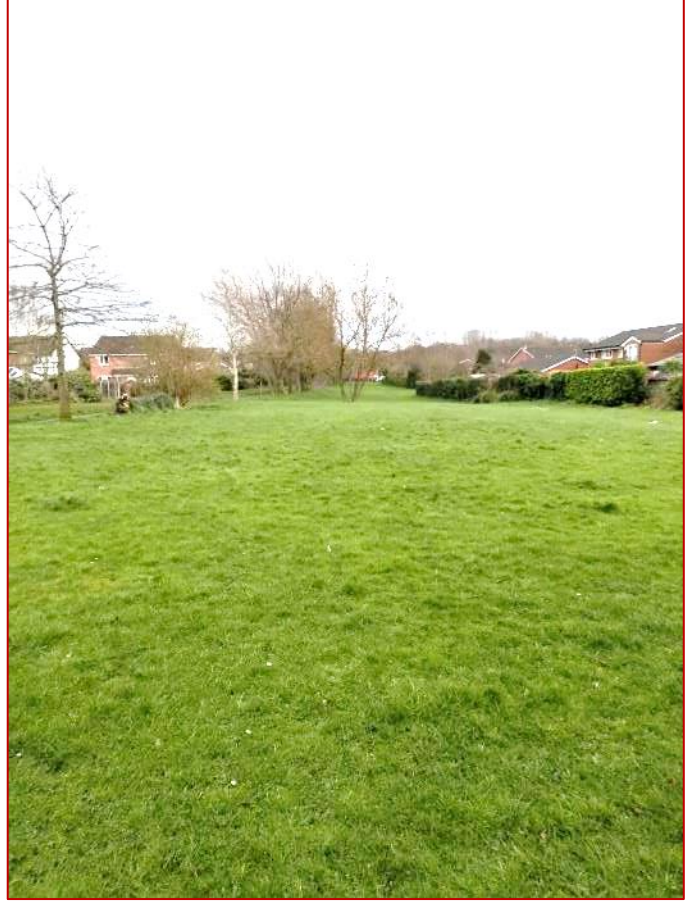
- 5.9.4 This part of the proposed route heads south along the perimeter of a flat 'recreational' area of the common, to the west of the Woodheys Apartment Complex with broadleaved parkland trees and linear broadleaved woodland. The open areas between the trees is down to amenity grassland being close-cut and maintained on a regular basis (**Photo 25**). As a result of the maintenance regime the grassed areas are of a low wildlife value. The trees surveyed have few PRF and are of a low potential to support a bat roost but there is potential for the trees and shrubbier areas to supports nesting birds. This area provides potential foraging and commuting opportunities for bats.

**Photo 23: Amenity Grassland**

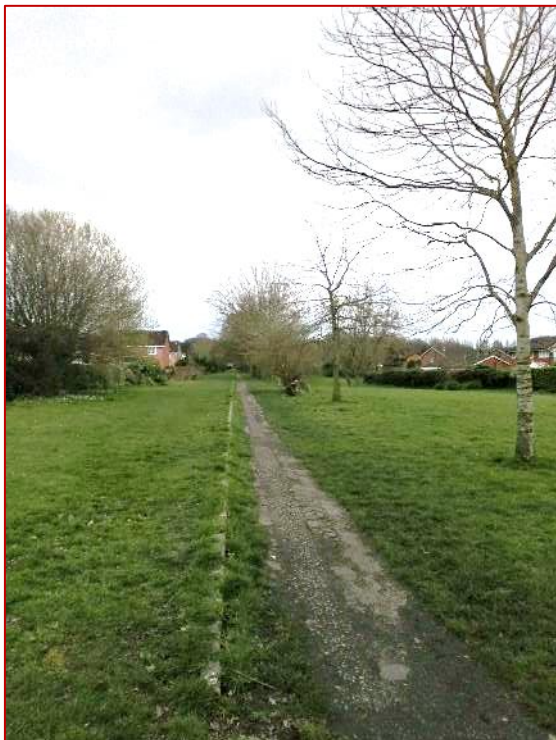
**Photo 24: Wet Area. Wildlife Pond or Marsh Flowers**

- There is an extremely wet area of grass alongside the path to Burnage Lane which could be excavated to create a wildlife pond or planted up as a wet meadow.

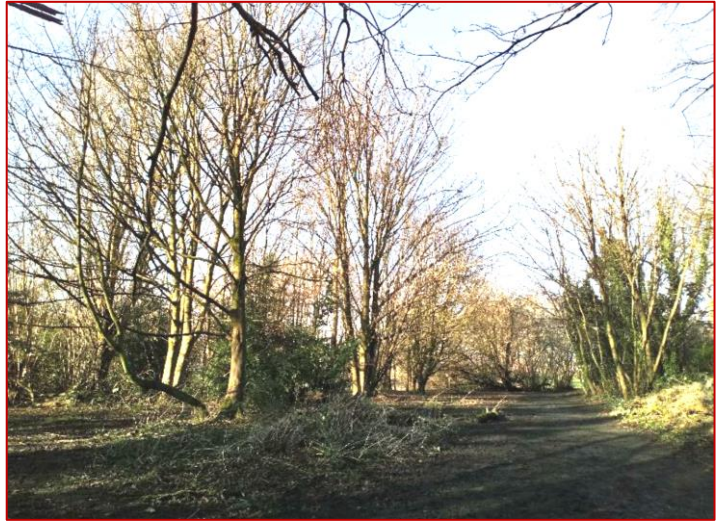
- 5.9.5 The route continues along the rear the residential properties on Mersey Road into a section of woodland following the line of an old existing rolled stone path. This wooded area is comprised of mature and semi mature broadleaved trees, with an understory containing and abundance of regenerating trees species (mainly sycamore) with scrubby areas of blackthorn, elder, bramble and nettle with some holly present and in places a thick carpet of ivy (**Photos 26 & 27**). The trees within the survey area had only a few PRF and are classed as a low potential to support a bat roost, but potential opportunity does

**Photo 27: Woodland Path & Trees**

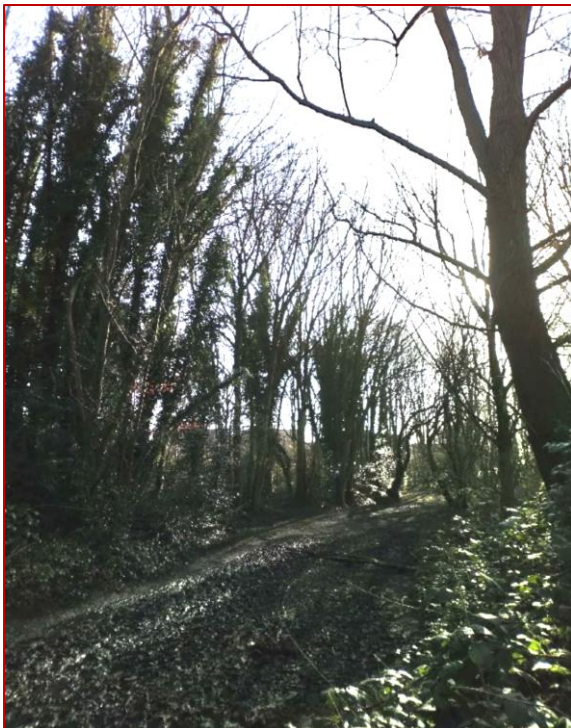
The ground layer is dominated by ivy (extending up into the tree canopy) and bramble with other woodland flora being sparse due to the dense shade and invasive nature of the ivy and bramble. The wooded area to the west of the path is dominated by regenerating trees and blackthorn with a thick cover of bramble (**Photo 28**) and this area represents high value area for nesting birds but with very few mature trees there is negligible bat roost potential. This area, however, does represent a high value foraging site for bats. The localised woodland fringes along the route do contain some woodland species including lesser celandine, wood avens, dog's mercury, nettle, bluebells and the rarer white bluebell, snow drops, cow parsley, hogweed and carpets of ground elder.

**Photo 28: Scrub and Regenerating Tree Species**

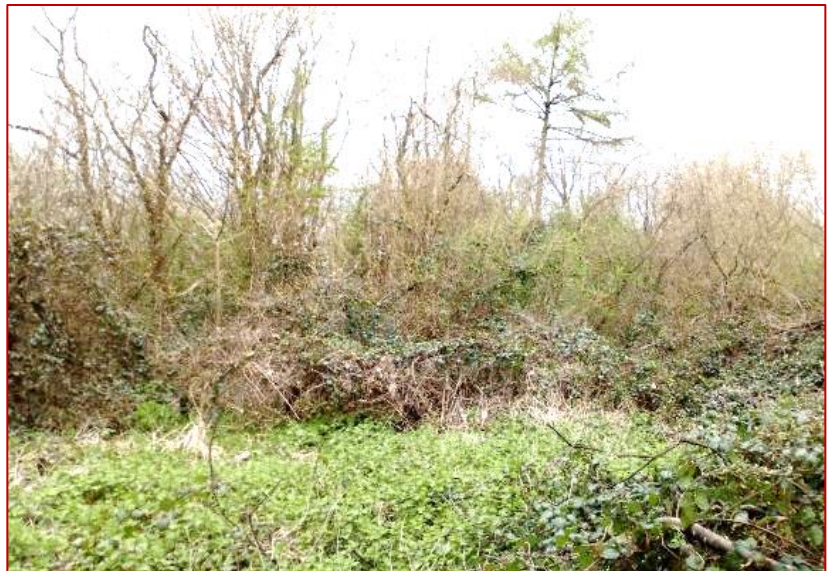
- 5.9.6 The footpath then leaves the woodland continuing along a narrow muddy path in between the boundary of St John's C of E Primary School and the panel fencing of a neighbouring property (**Photos 29 & 30**) on the corner of Hawthorn Street. Along the school boundary there are some young silver birch, hawthorn and ash with a large wild cherry at the end of the line. There are no PRF in these trees and in the main they are of a low conservation value with the exception of the cherry which produces flowers for pollinators and berries later in the year. The grass on the school side is maintained and of limited value for wildlife. Some potential roost features were visible on the local housing, but these could not be surveyed using binoculars for privacy reasons!

**Photo 29: Muddy Section of Path By School**

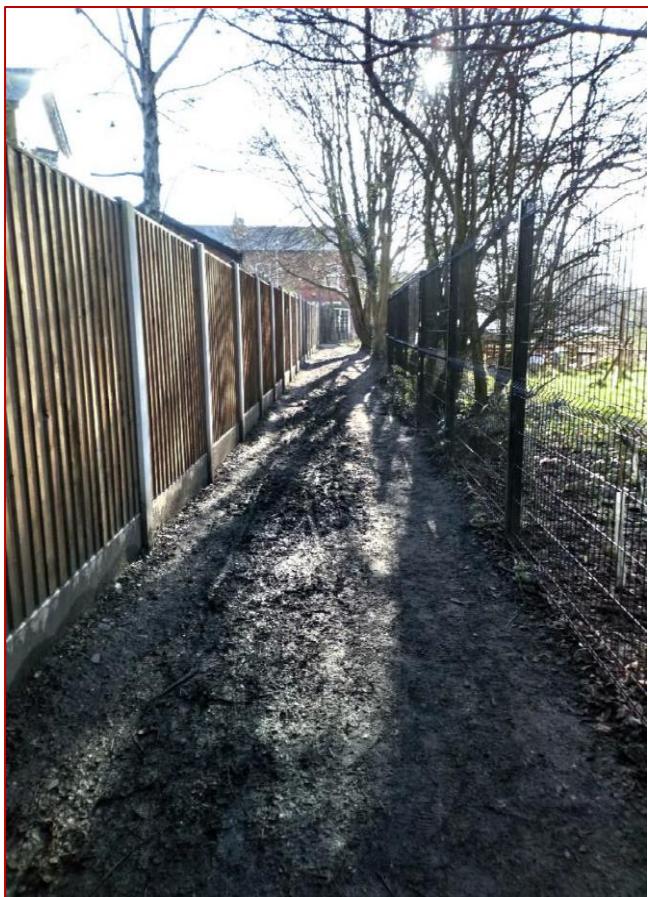
Where the path runs alongside the boundary of St John's C of E primary School, the first section is muddy over the top of a narrow, rolled stone path. The school grounds are all being maintained as amenity grassland with close cut grass of little wildlife value. There are some young trees growing in the fence line, but these too have limited wildlife value, but where any tree is to be removed, they should be replaced at a ratio of two to one.

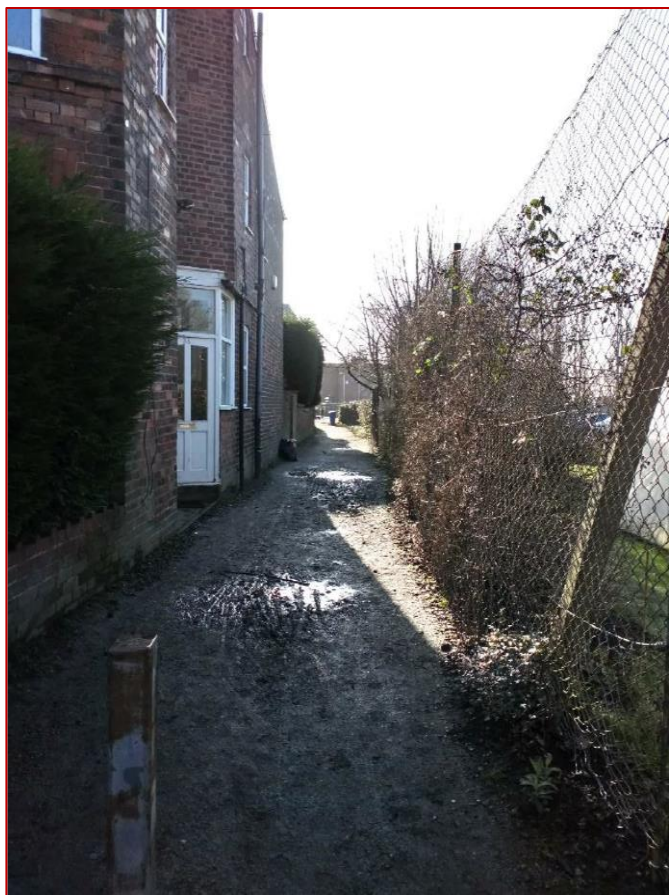
**Photo 31: End of Path**
