**Section 19 Flood Investigation  
Report for July 2019 Event**

Stockport Metropolitan Borough Council

9 September 2020

**Document reference:** 414640 | 001 | E

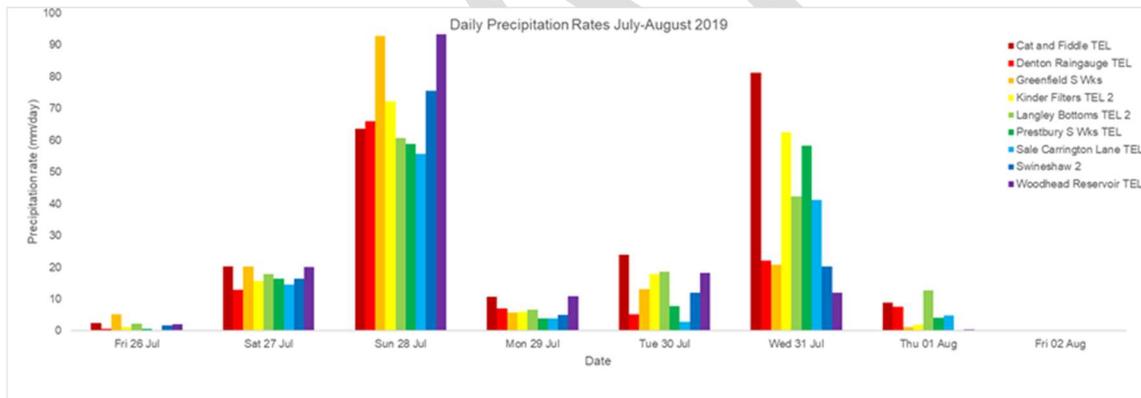
**Figure 2.4: Daily rainfall totals for gauge sites local to Stockport**

Figure 2.4 shows that, with the exception of Cat and Fiddle, all 1-day rainfalls were greater on the 28<sup>th</sup> than on 31<sup>st</sup> July, although some locations e.g. Prestbury received similar rainfall. Figure 2.6 shows the hourly distribution of the Prestbury rainfalls indicating that the 28<sup>th</sup> was characterised by steady but heavy rain whereas on the 31<sup>st</sup> there were pulses of intense rainfall.

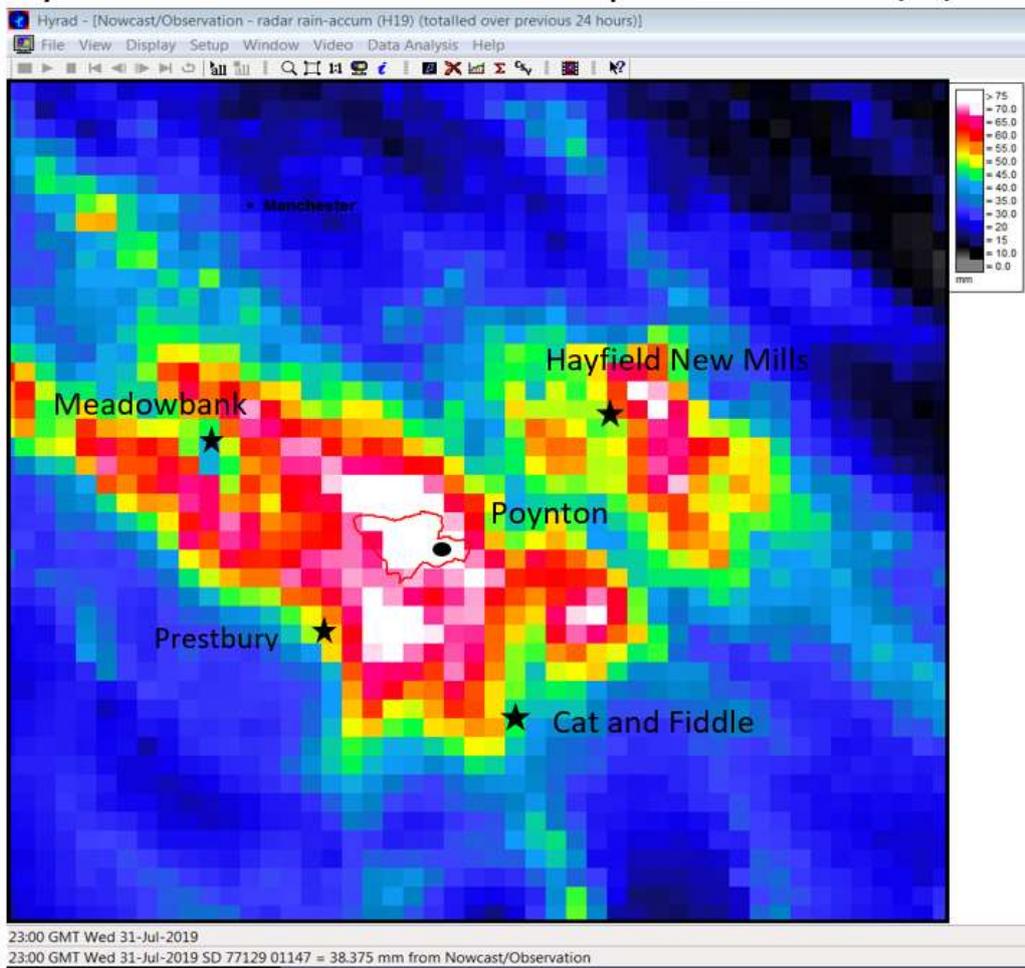
**Figure 2.5: Poynton rainfall radar accumulation 24 hours prior to 23:00 GMT 31/07/2019.**

The location of the key rain gauge sites is shown on Figure 2.5; this also shows for 31<sup>st</sup> July 2019 the distribution of 24 hour rainfall across the borough based upon rainfall radar measurements. This indicates that the highest total rainfall, in excess of 75mm (white area), was centred around Poynton which lies just upstream of the critical watercourse of Lady Brook/ Micker Brook.

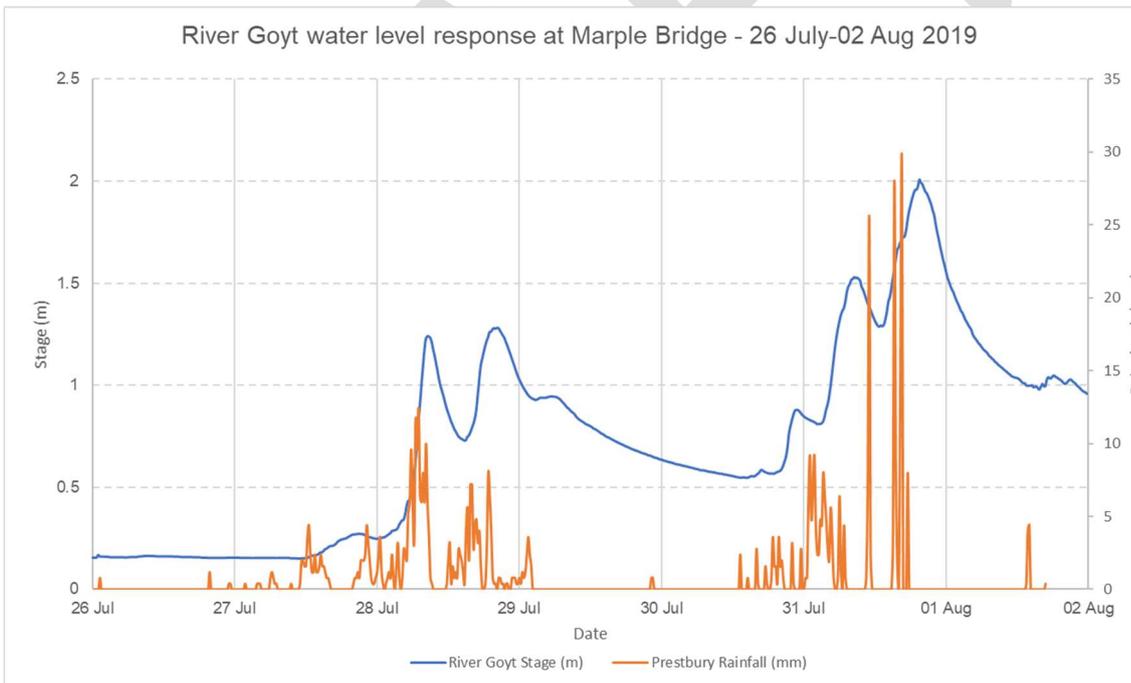
**Figure 2.7: Runoff response; River Goyt Flood levels with Prestbury Rainfall data**

For the River Goyt flood levels, Figure 2.7, hourly rainfall is also shown to indicate the response in gauged flow depth. We have used the rainfall data from Prestbury to illustrate the behaviour but the actual catchment response is relative to the distribution of rainfalls across the whole catchment; in this case from the Cat and Fiddle in the south and east right down to the gauge site at Marple Bridge. The figure serves to show how the flood levels rise rapidly to spikes of rainfall and then decline more slowly. Also relevant in all of Figures 2.6, 2.7 and 2.8 is that the flow level between 28<sup>th</sup> and 31<sup>st</sup> almost returns to the starting condition; indicating for these watercourses, which have a rapid rainfall to runoff response, that the events of 28<sup>th</sup> and 31<sup>st</sup> are almost independent. It is relevant however that the 31<sup>st</sup> rainfall would have fallen on saturated ground and most likely a higher percentage would have immediately runoff to watercourses.
