Section 19 Flood Investigation Report for July 2019 Event

Stockport Metropolitan Borough Council

25 September 2020

Document reference: 414640 | 001 | G

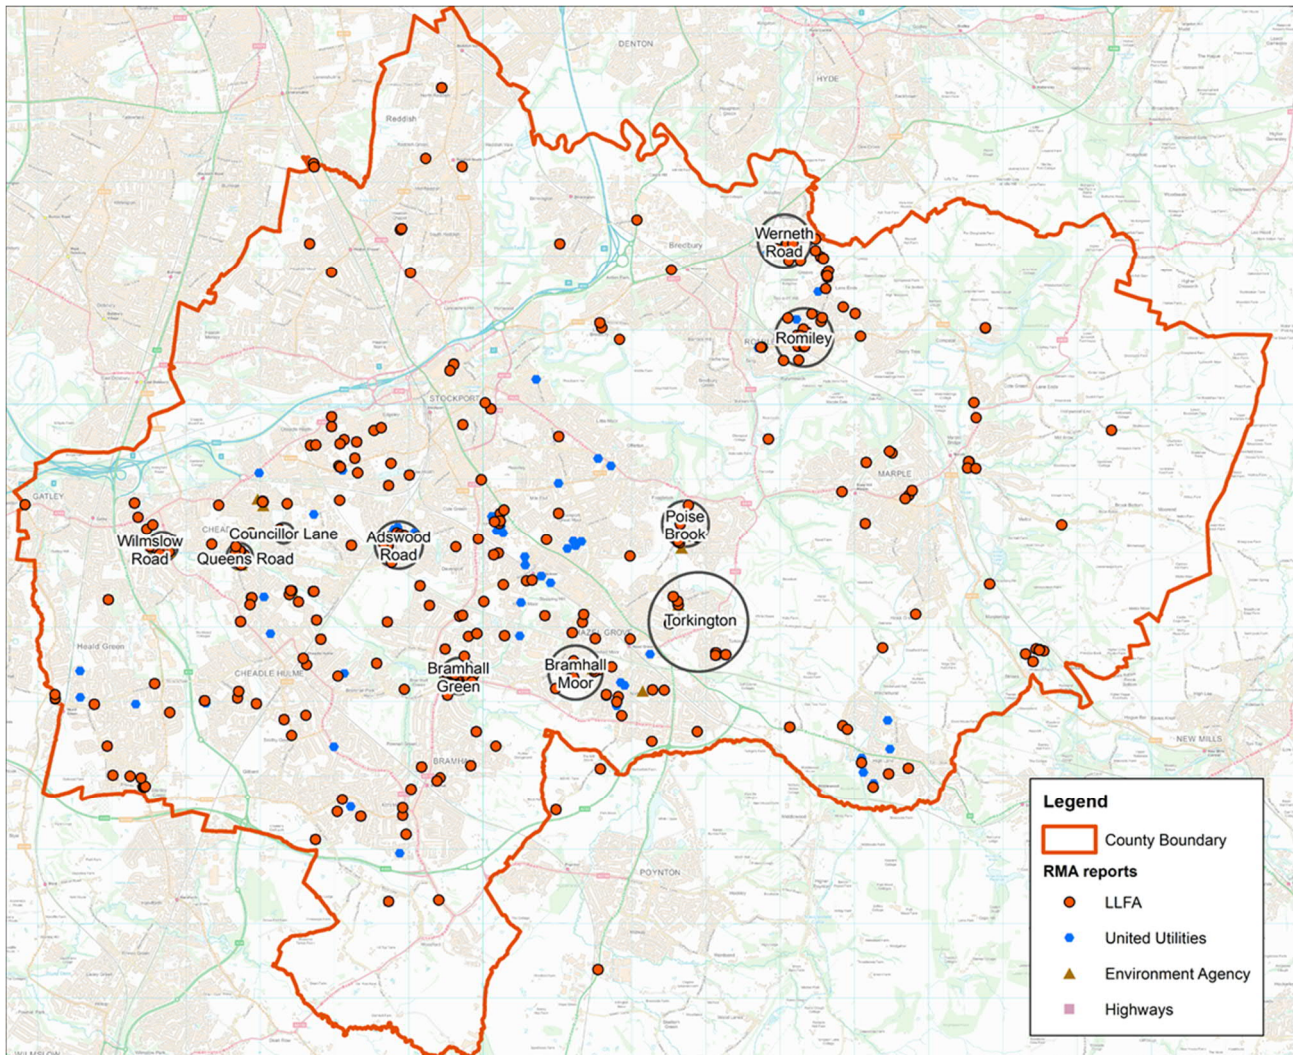
Figure 2.1: All July 2019 reported flooding plotted by postcode; showing flooding 'hotspots'.

Figure 2.1 Indicates the locations of all 776 reported incidences of property flooding; the figure plots reported flooding by postcode and as such a spot on the figure is plotted at the central postcode location and does not locate individual properties affected. Accordingly, there are multiple spots overlaid in some locations giving the impression of fewer than 776 occurrences. The figure serves to indicate:

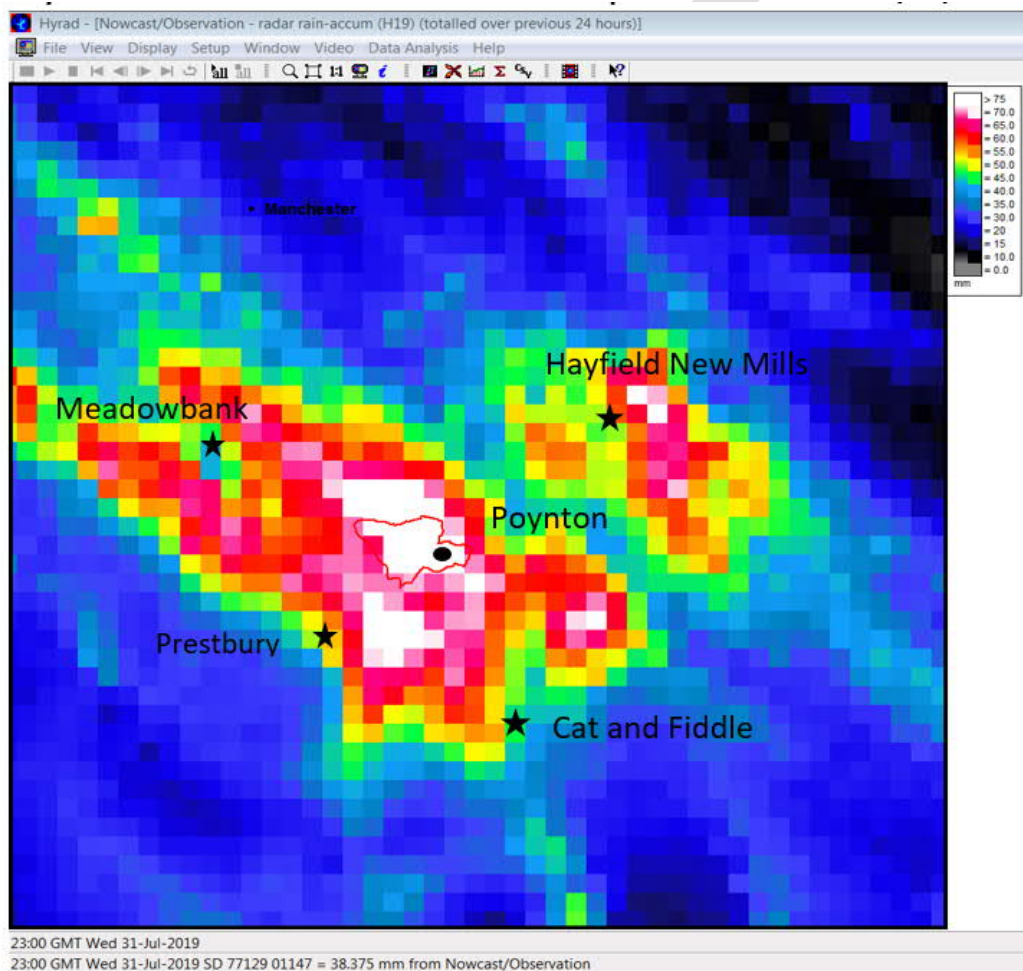
Figure 2.5: Poynton rainfall radar accumulation 24 hours prior to 23:00 GMT 31/07/2019.

The location of the key rain gauge sites is shown on Figure 2.5; this also shows for 31st July 2019 the distribution of 24 hour rainfall across the borough based upon rainfall radar measurements. This indicates that the highest total rainfall, in excess of 75mm (white area), was centred around Poynton which lies just upstream of the critical watercourse of Lady Brook/ Micker Brook.

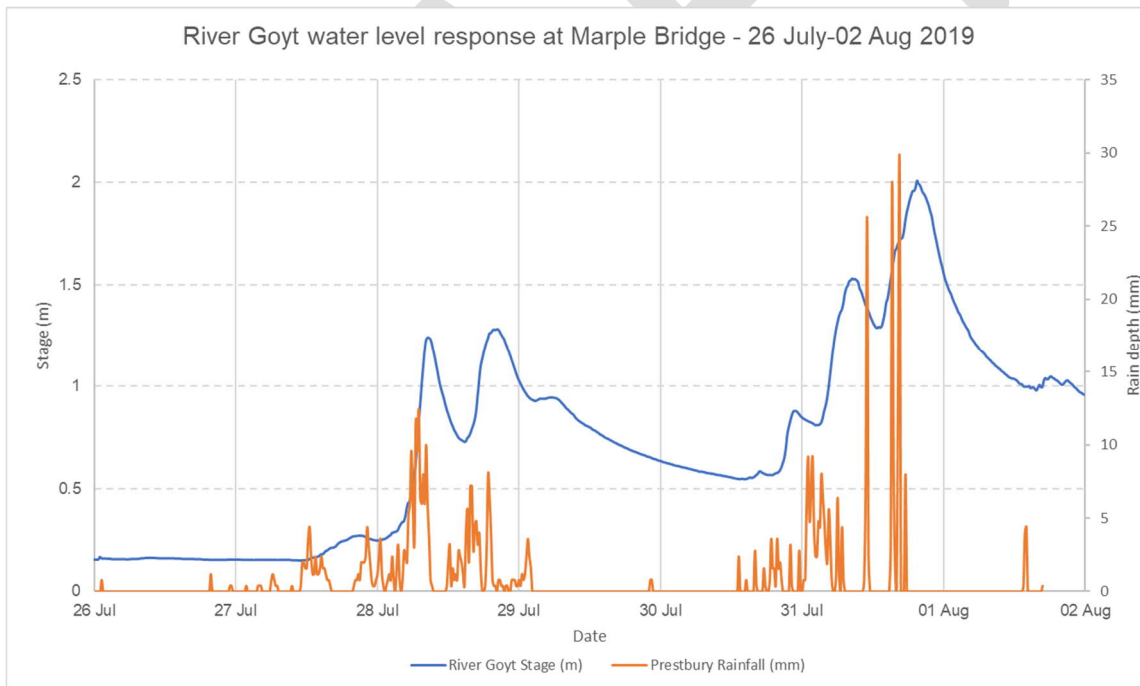
Figure 2.7: Runoff response; River Goyt Flood levels with Prestbury Rainfall data

For the River Goyt flood levels, Figure 2.7, hourly rainfall is also shown to indicate the response in gauged flow depth. We have used the rainfall data from Prestbury to illustrate the behaviour but the actual catchment response is relative to the distribution of rainfalls across the whole catchment; in this case from the Cat and Fiddle in the south and east right down to the gauge site at Marple Bridge. The figure serves to show how the flood levels rise rapidly to spikes of rainfall and then decline more slowly. Also relevant in all of Figures 2.6, 2.7 and 2.8 is that the flow level between 28th and 31st almost returns to the starting condition; indicating for these watercourses, which have a rapid rainfall to runoff response, that the events of 28th and 31st are almost independent. It is relevant however that the 31st rainfall would have fallen on saturated ground and most likely a higher percentage would have immediately runoff to watercourses.

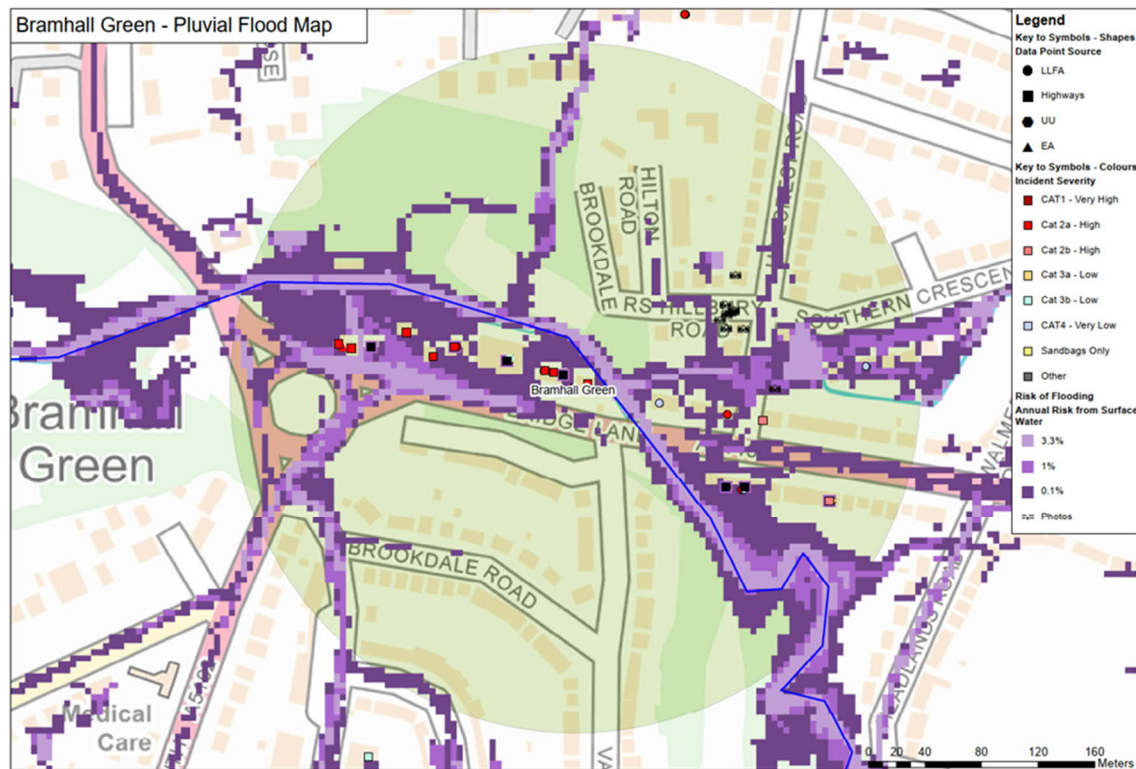
Figure C.6: EA, Bramhall Green, Pluvial Flood Map

- Flood risk to properties between Womanscroft Bridge and the roundabout is very similar to the fluvial case (note some property footprints show as no risk but are surrounded by flooding; this is a feature of the method of mapping that requires floodwater to flow around the buildings).
- Localised flooding on Bramhall Lane South.

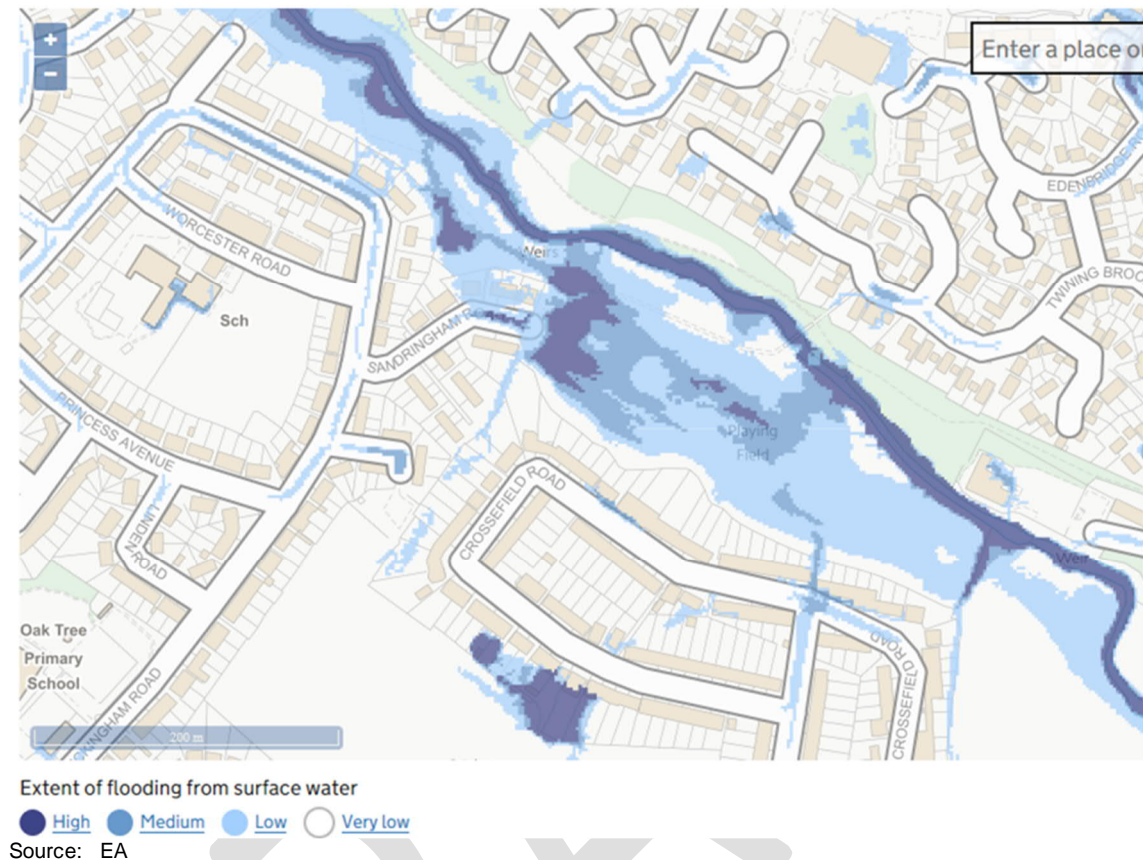
Figure E.10: EA, Sandringham Road; Pluvial Flood Map

Given the methodology of modelling, the underlying assumptions and the topographic data source used for the production of the 'pluvial' or surface water flood maps it is surprising that this map replicates the July 2019 flood flow in Micker Brook. The hydraulics of the main river channel will dominate flood water levels and these should be much better represented in the fluvial modelling.

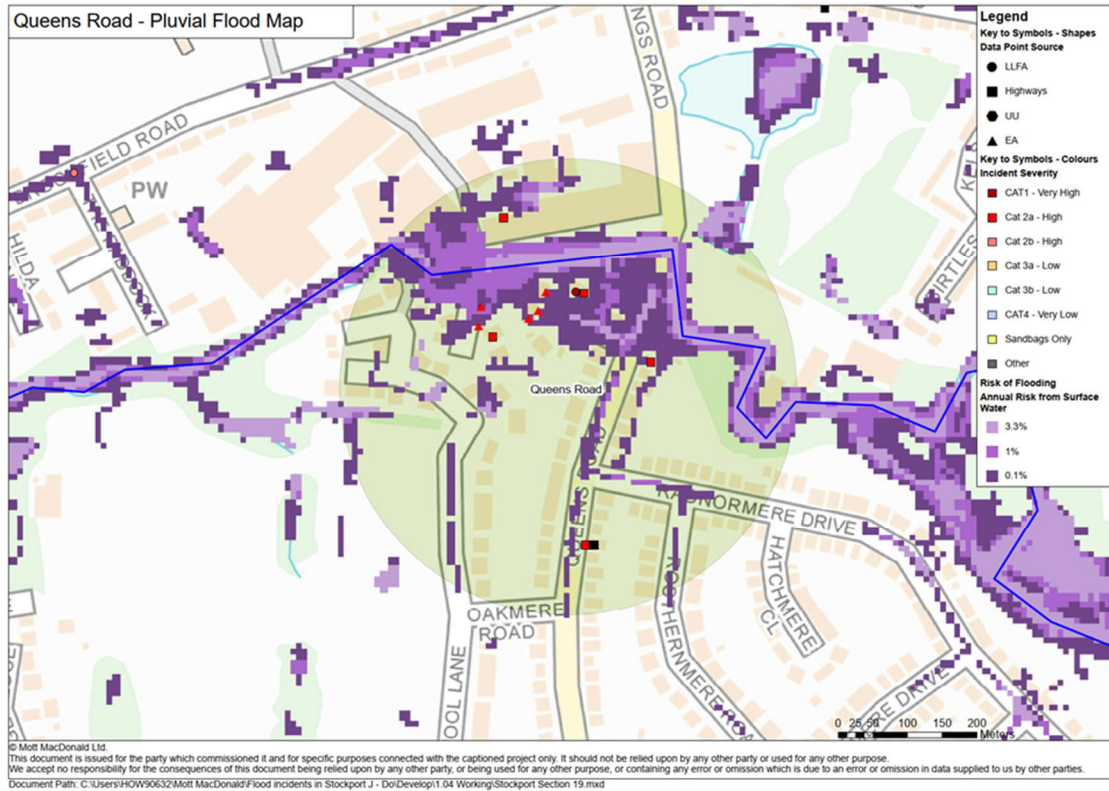
Figure F.12: EA, Queens Road; Pluvial Flood Map

dimensions. In this case there is a suspicion there is some inconsistency in the fluvial mapping. This needs to be rectified so that the local flood risk is better understood.

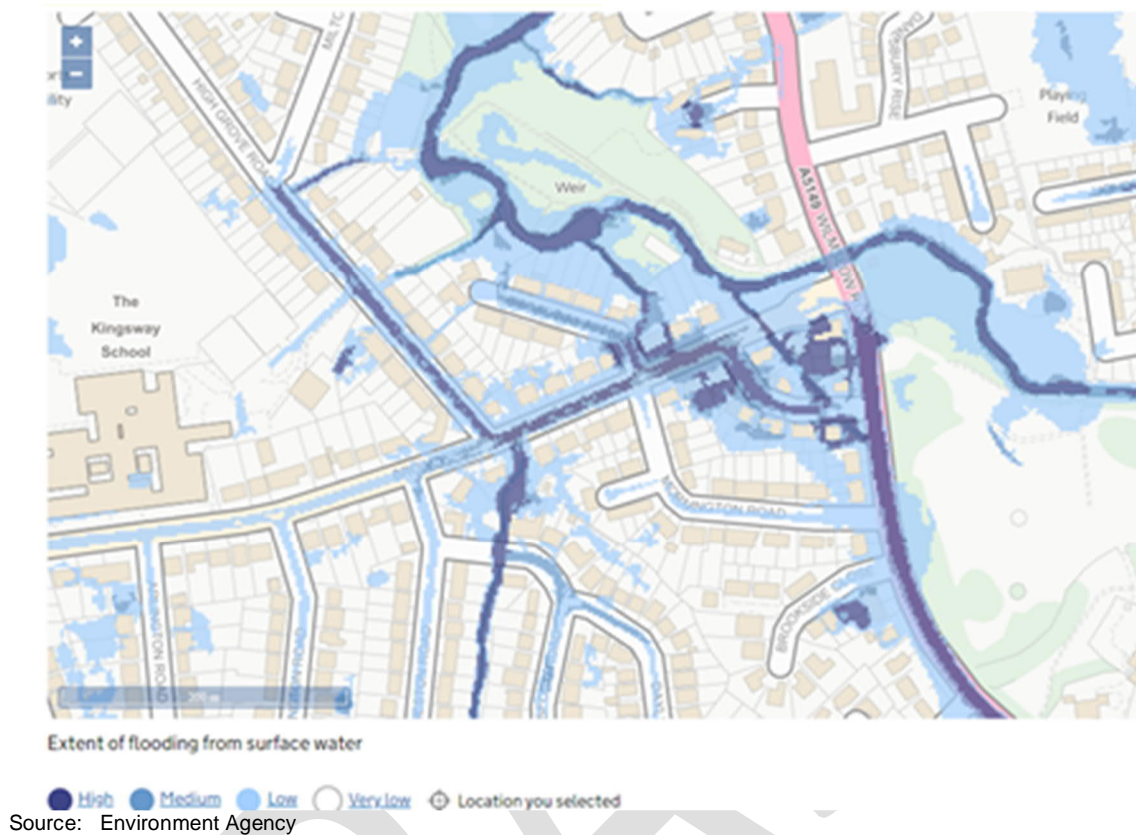
Figure G.16: EA Wilmslow Road; Pluvial Flood Map

Similarly, the EA produces flood mapping from 'Pluvial' sources; this is shown in Figure F.16. The pluvial flood map shows flooded extents that are generally consistent with the fluvial flood map; except that the pluvial flood mapping shows flooding or flow paths along some of the roads; notably Broadway and High Grove Road. This mapped flooding is likely a consequence of the modelling methodology because the culverted tributary will not have been modelled and hence all runoff from it has been modelled as progressing to Micker Brook via overland flow routes, along the roads.

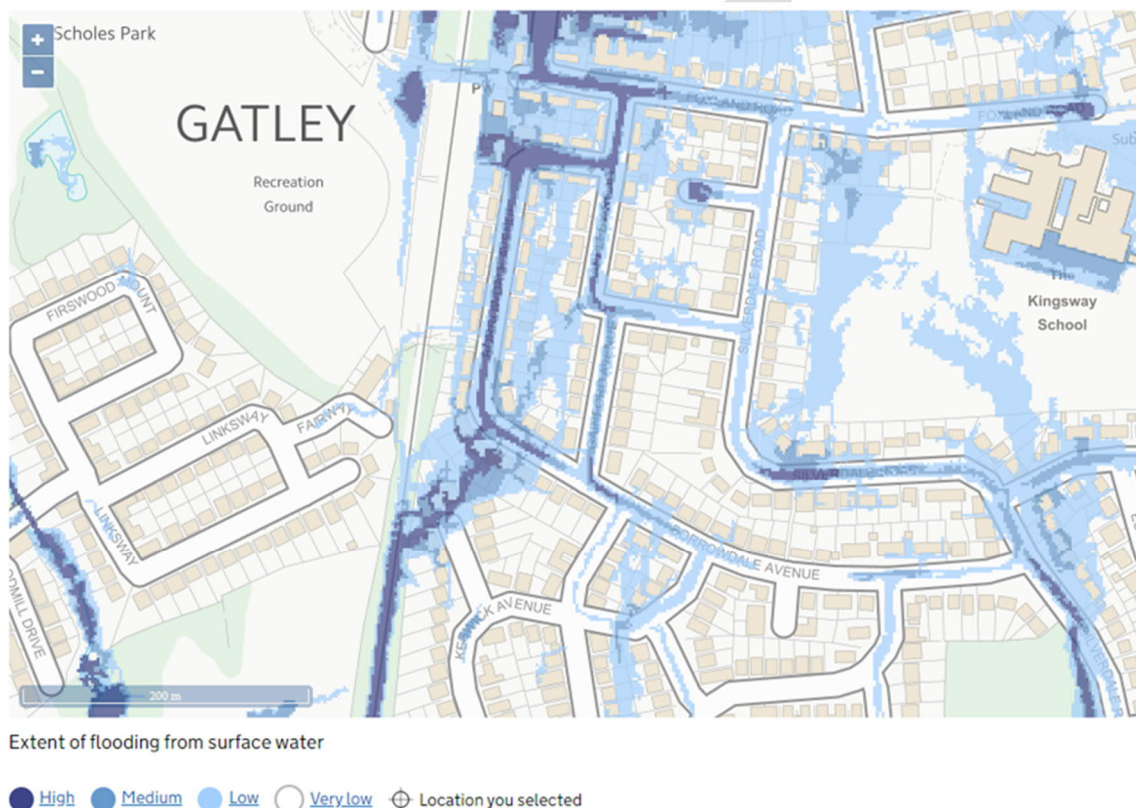
Figure H.18: Borrowdale Avenue; EA Pluvial Flood Map

The EA produces flood mapping from 'Pluvial' sources; this is shown in Figure H.18. The pluvial flood map shows widespread SW flooding due to the absence of clearly defined watercourses and the blockage of drainage routes by the railway. A flow path is shown for SW runoff northwards from the railway to Borrowdale Avenue and ponding at the bend in the road at its north end. Further flooding is shown to the north but this does not appear to have manifested in the July 2019 event. Ponding of overland flows at the bend in Borrowdale Avenue is likely to overwhelm the UU combined sewers draining the area.

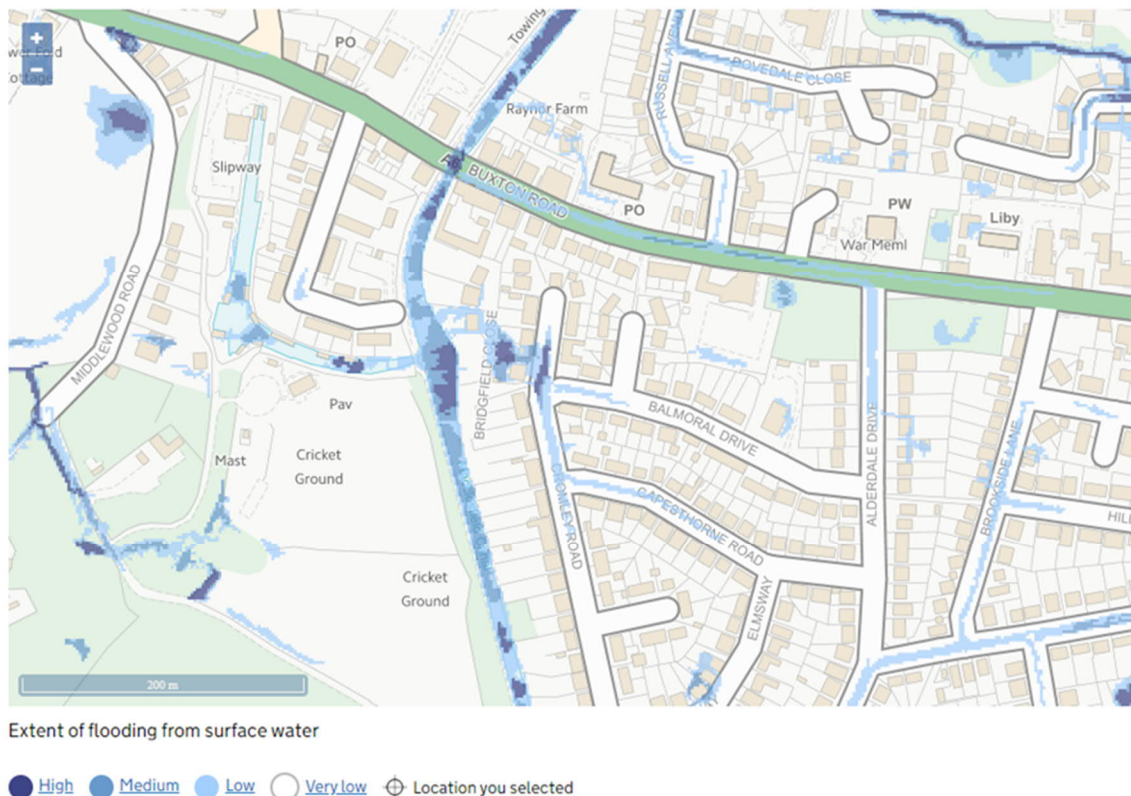
Figure I.20: High Lane; EA Pluvial Flood Map

The EA produces flood mapping from 'Pluvial' sources; this is shown in Figure I.20. The pluvial flood map shows flooding of Cromley Road at the junction with Balmoral Drive and an overland flowpath to Bridgefield Close and onwards to the canal. Some of the runoff volume will be drained by UU (and Highway?) drainage systems but the map serves to indicate the area at risk.

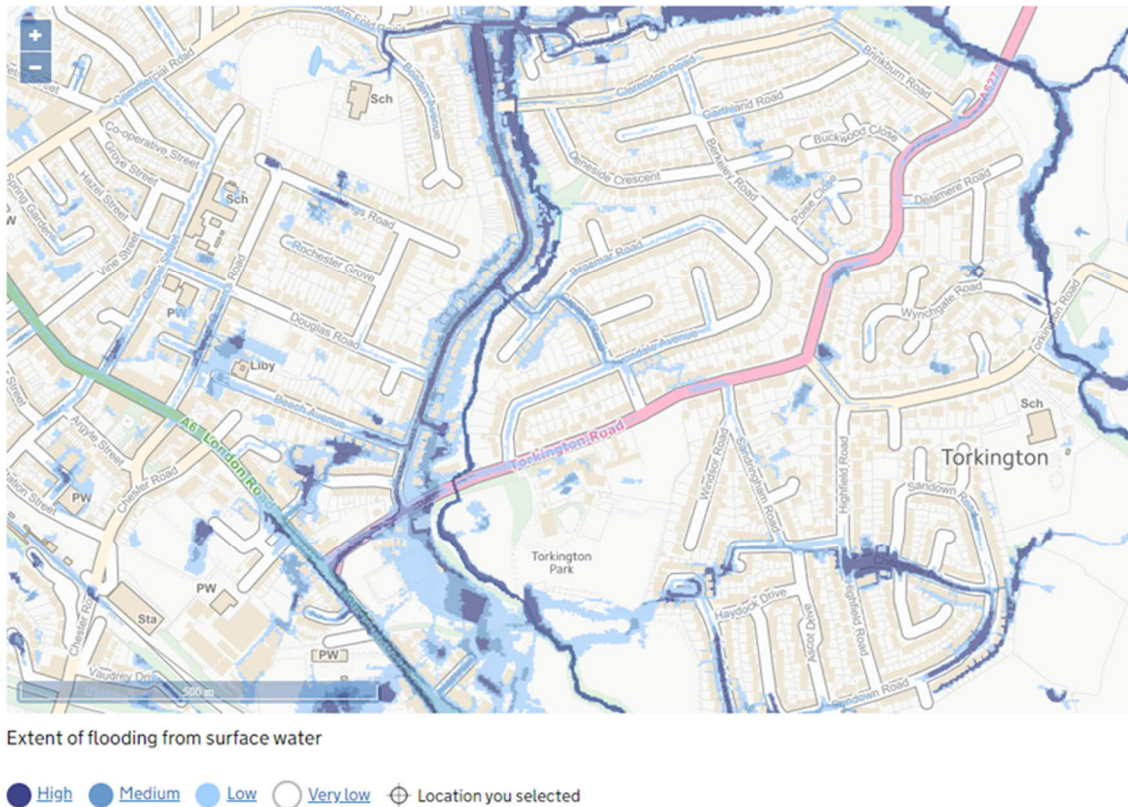
Figure J.23: Torkington Road; EA Pluvial Flood Map

Similarly, the EA produces flood mapping from 'Pluvial' sources; this is shown in Figure J.23. The pluvial flood map shows flooded extents that are generally consistent with the fluvial flood map.

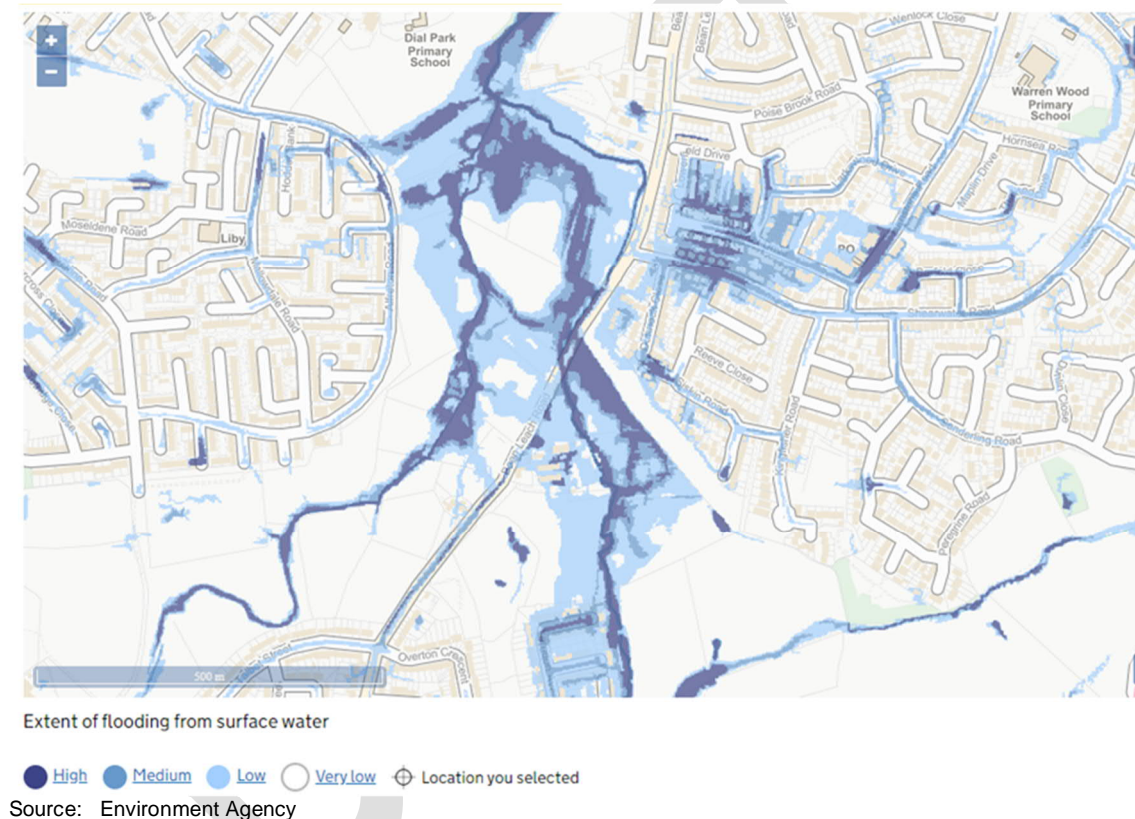
Figure K.26: Bean Leach Road; EA Pluvial Flood Map

Accordingly, the fluvial and pluvial mapping are also inconsistent with one another. As stated for other locations, the pluvial flood map should normally provide the more reliable forecast of flow routes and flooding but in this case it does not. There is a suspicion that assumptions in the modelling of the estate flood embankment may be confusing the picture.

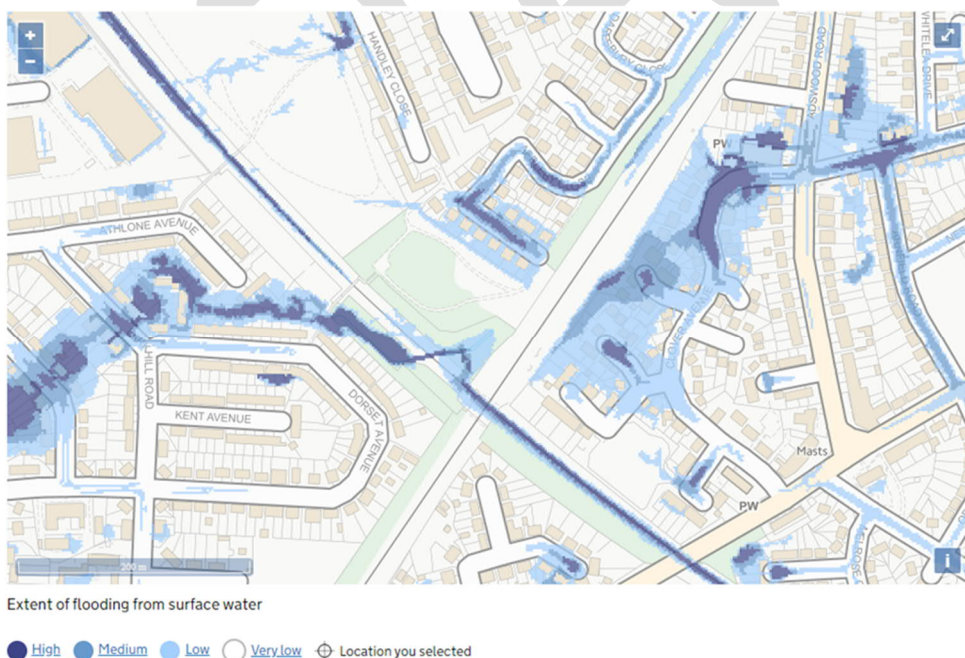
Figure L.29: Adswood Road; EA Pluvial Flood Map

Accordingly, the pluvial mapping is only an indication of the flooded extent if the railway culvert were to become completely blocked. Nevertheless, the areas of highest flood risk are indicative of the areas flooded in July 2019 and earlier events.

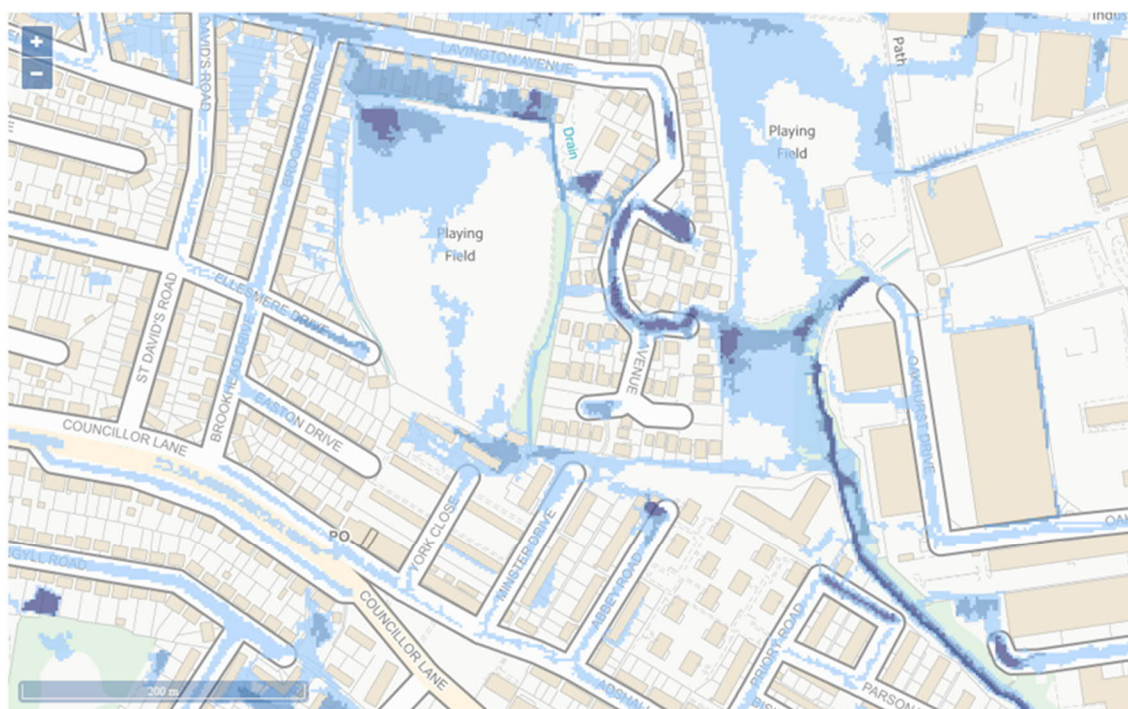
Figure M.31: Councillor Lane; EA Pluvial Flood Map

The EA produces flood mapping from 'Pluvial' sources; this is shown in Figure M.31. The pluvial flood map shows property at the north end of York Avenue to be at low to medium flood risk from local SW runoff.
