# **Section 19 Flood Investigation Report for July 2019 Event**

**Stockport Metropolitan Borough Council**

**1 December 2020**

**Document reference:** 414640 | 001 | I

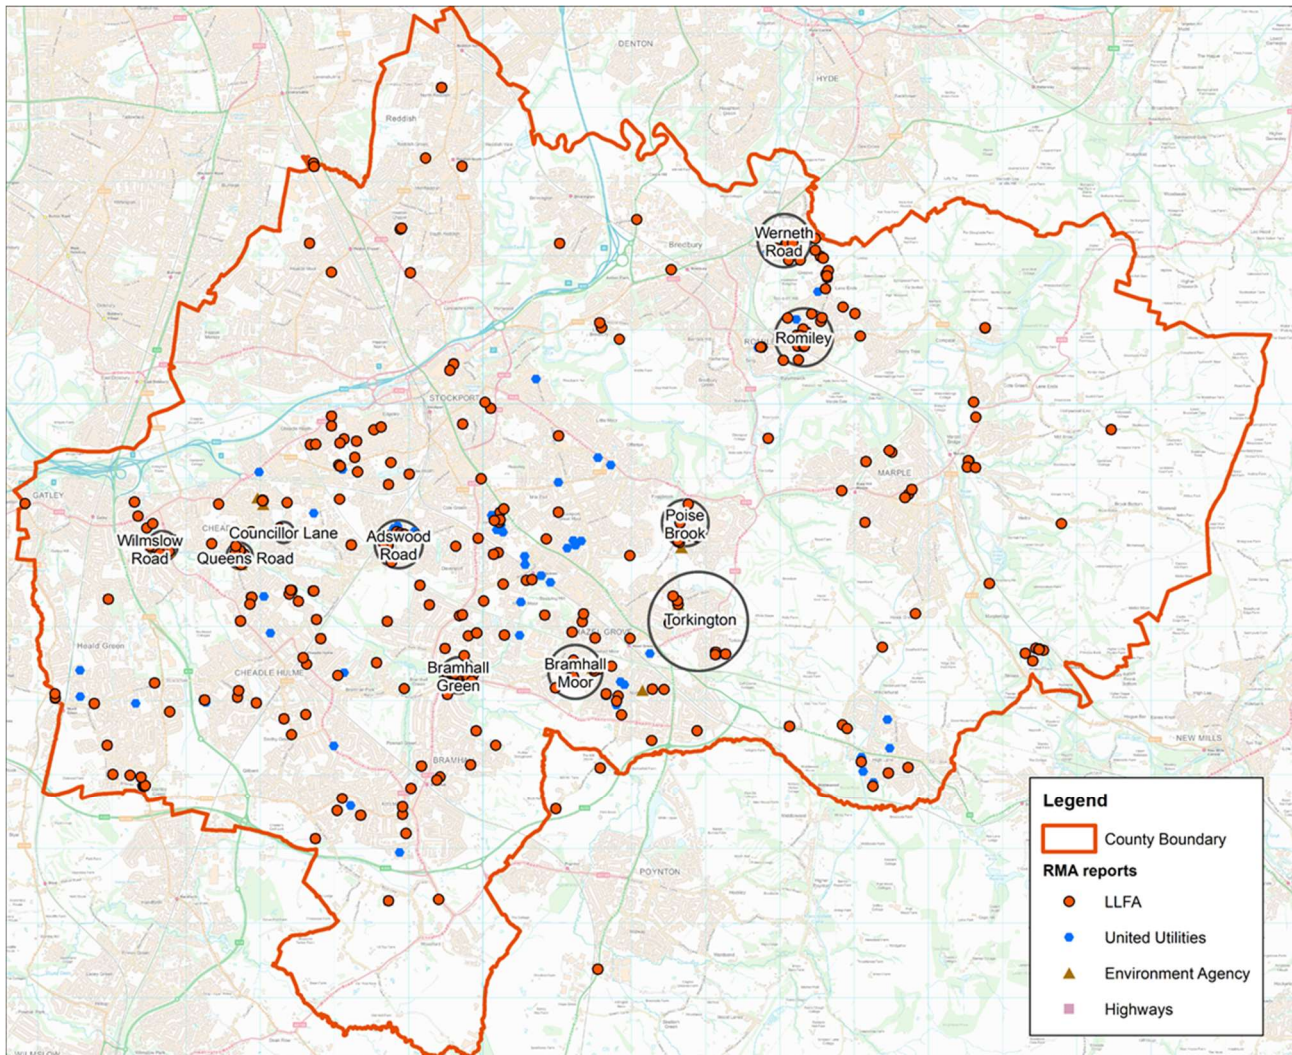
**Figure 2.1: All July 2019 reported flooding plotted by postcode; showing flooding 'hotspots'.**

Figure 2.1 Indicates the locations of all 776 reported incidences of property flooding; the figure plots reported flooding by postcode and as such a spot on the figure is plotted at the central postcode location and does not locate individual properties affected. Accordingly, there are multiple spots overlaid in some locations giving the impression of fewer than 776 occurrences. The figure serves to indicate:

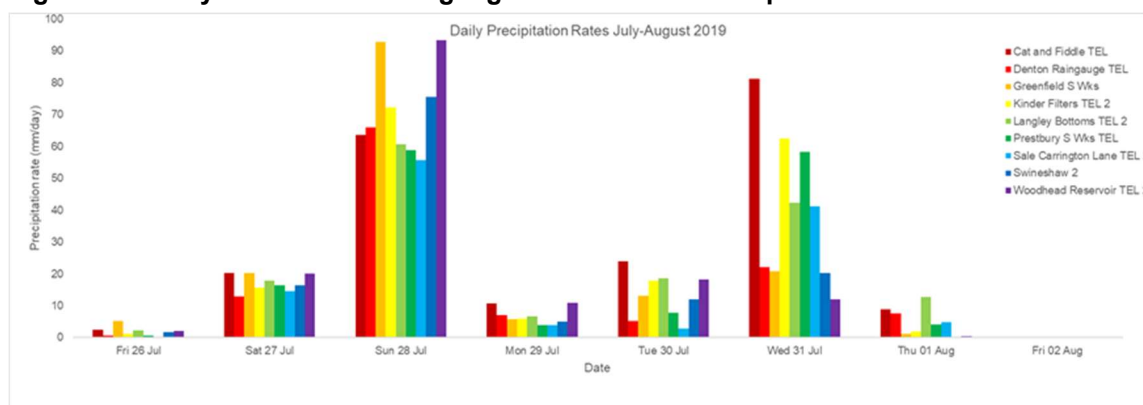
**Figure 2.4: Daily rainfall totals for gauge sites local to Stockport**

Figure 2.4 shows that, with the exception of Cat and Fiddle, all 1-day rainfalls were greater on the 28<sup>th</sup> than on 31<sup>st</sup> July, although some locations e.g. Prestbury received similar rainfall. Figure 2.6 shows the hourly distribution of the Prestbury rainfalls indicating that the 28<sup>th</sup> was characterised by steady but heavy rain whereas on the 31<sup>st</sup> there were pulses of intense rainfall.

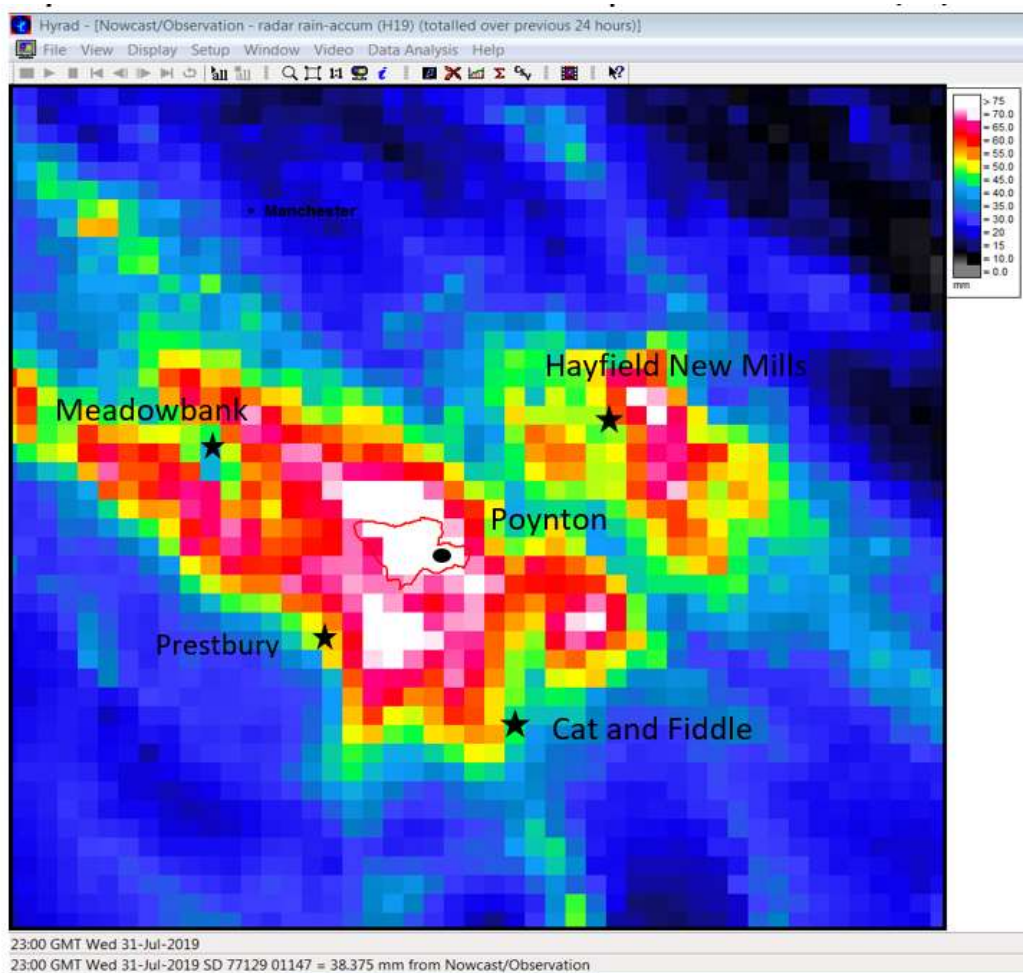
**Figure 2.5: Poynton rainfall radar accumulation 24 hours prior to 23:00 GMT 31/07/2019.**

The location of the key rain gauge sites is shown on Figure 2.5; this also shows for 31<sup>st</sup> July 2019 the distribution of 24 hour rainfall across the borough based upon rainfall radar measurements. This indicates that the highest total rainfall, in excess of 75mm (white area), was centred around Poynton which lies just upstream of the critical watercourse of Lady Brook/ Micker Brook.

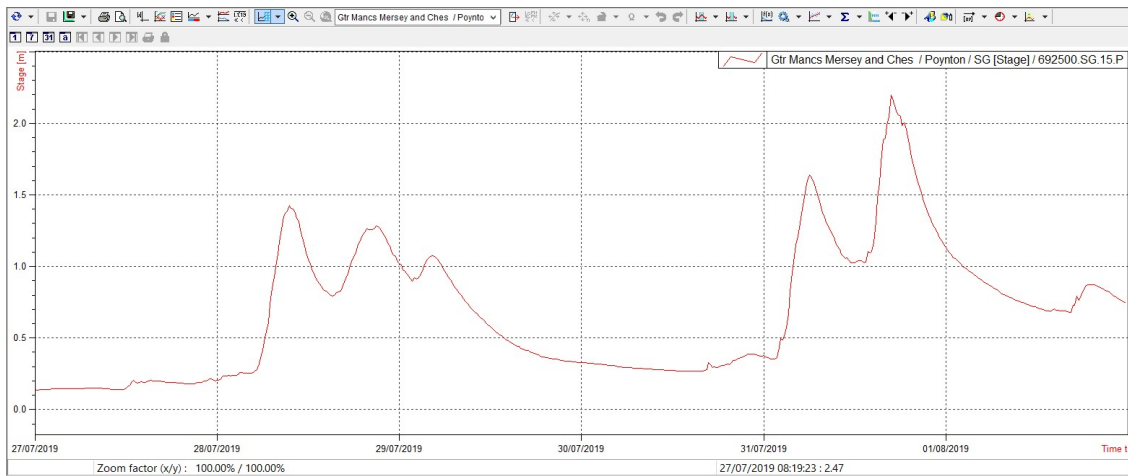
**Figure 2.6: Poynton Brook at Poynton gauge level response to 28<sup>th</sup> July 2019 – 01<sup>st</sup> August 2019 rainfall**

As a result of the rainfall on 31<sup>st</sup> July 2019 the water level at Poynton gauge reached 2.195m, the highest since records began in December 2008 (i.e. in around 11 years). Flood frequency analysis, based on rough flow estimates at Poynton level gauge, gives a peak flow for the July 2019 event of around 12 m<sup>3</sup>/s with an indicative return period of around 45 years.

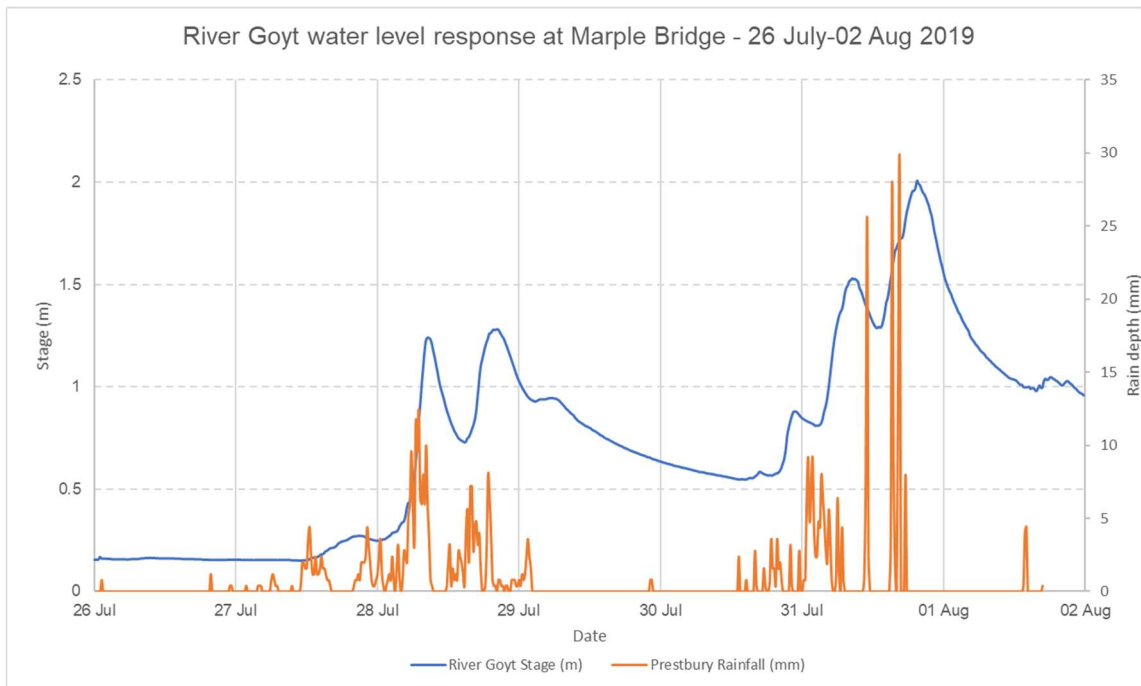
**Figure 2.7: Runoff response; River Goyt Flood levels with Prestbury Rainfall data**

For the River Goyt flood levels, Figure 2.7, hourly rainfall is also shown to indicate the response in gauged flow depth. We have used the rainfall data from Prestbury to illustrate the behaviour but the actual catchment response is relative to the distribution of rainfalls across the whole catchment; in this case from the Cat and Fiddle in the south and east right down to the gauge site at Marple Bridge. The figure serves to show how the flood levels rise rapidly to spikes of rainfall and then decline more slowly. Also relevant in all of Figures 2.6, 2.7 and 2.8 is that the flow level between 28<sup>th</sup> and 31<sup>st</sup> almost returns to the starting condition; indicating for these watercourses, which have a rapid rainfall to runoff response, that the events of 28<sup>th</sup> and 31<sup>st</sup> are almost independent. It is relevant however that the 31<sup>st</sup> rainfall would have fallen on saturated ground and most likely a higher percentage would have immediately runoff to watercourses.

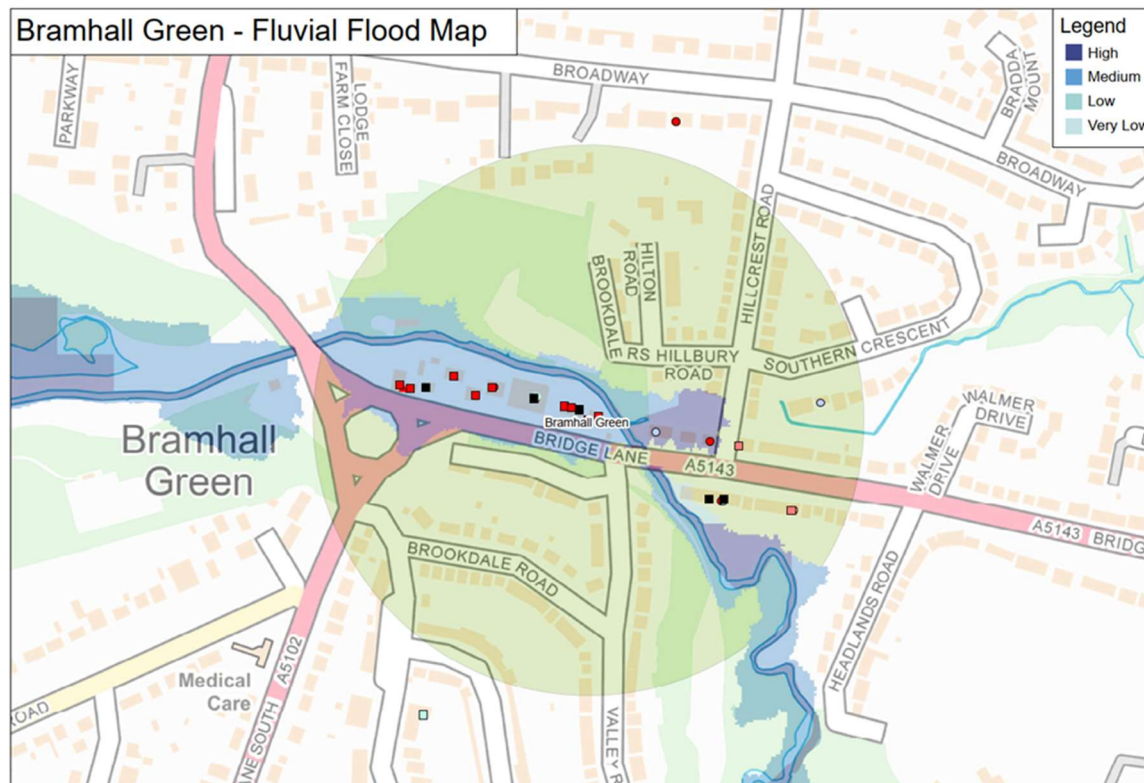
**Figure C.5: EA, Bramhall Green, Fluvial Flood Map**

This map indicates locations of reported flooding and shows:

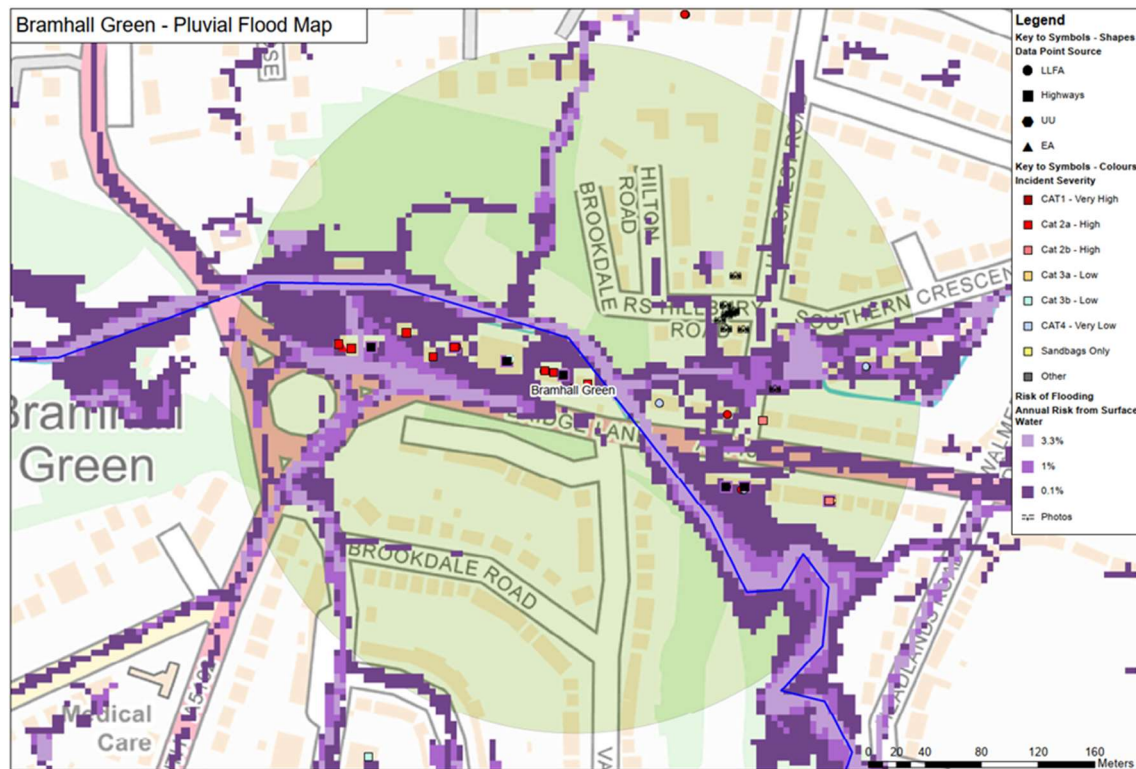
**Figure C.6: EA, Bramhall Green, Pluvial Flood Map**

- Flood risk to properties between Womanscroft Bridge and the roundabout is very similar to the fluvial case (note some property footprints show as no risk but are surrounded by flooding; this is a feature of the method of mapping that requires floodwater to flow around the buildings).
- Localised flooding on Bramhall Lane South.

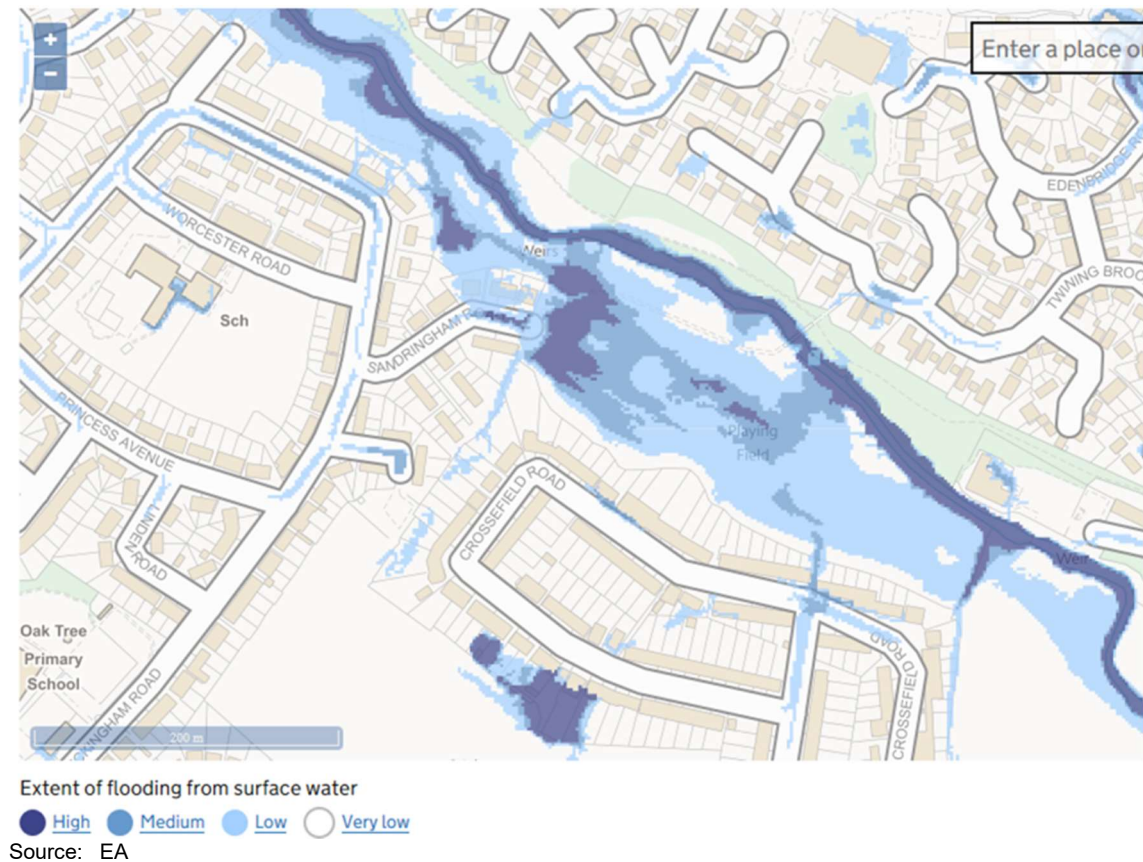
**Figure E.10: EA, Sandringham Road; Pluvial Flood Map**

Given the methodology of modelling, the underlying assumptions and the topographic data source used for the production of the 'pluvial' or surface water flood maps it is surprising that this map replicates the July 2019 flood flow in Micker Brook. The hydraulics of the main river channel will dominate flood water levels and these should be much better represented in the fluvial modelling.

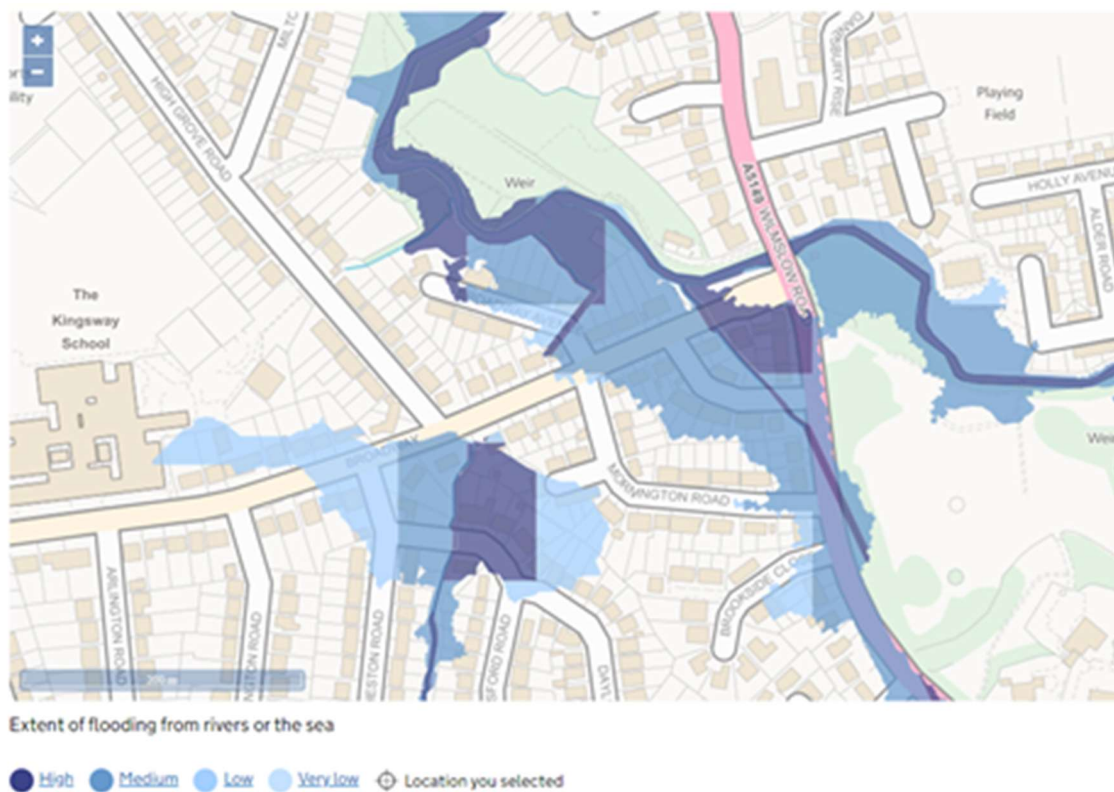
**Figure G.15: EA Wilmslow Road; Fluvial Flood Map**

This map indicates that depending upon the severity of the event the following locations may experience flooding:

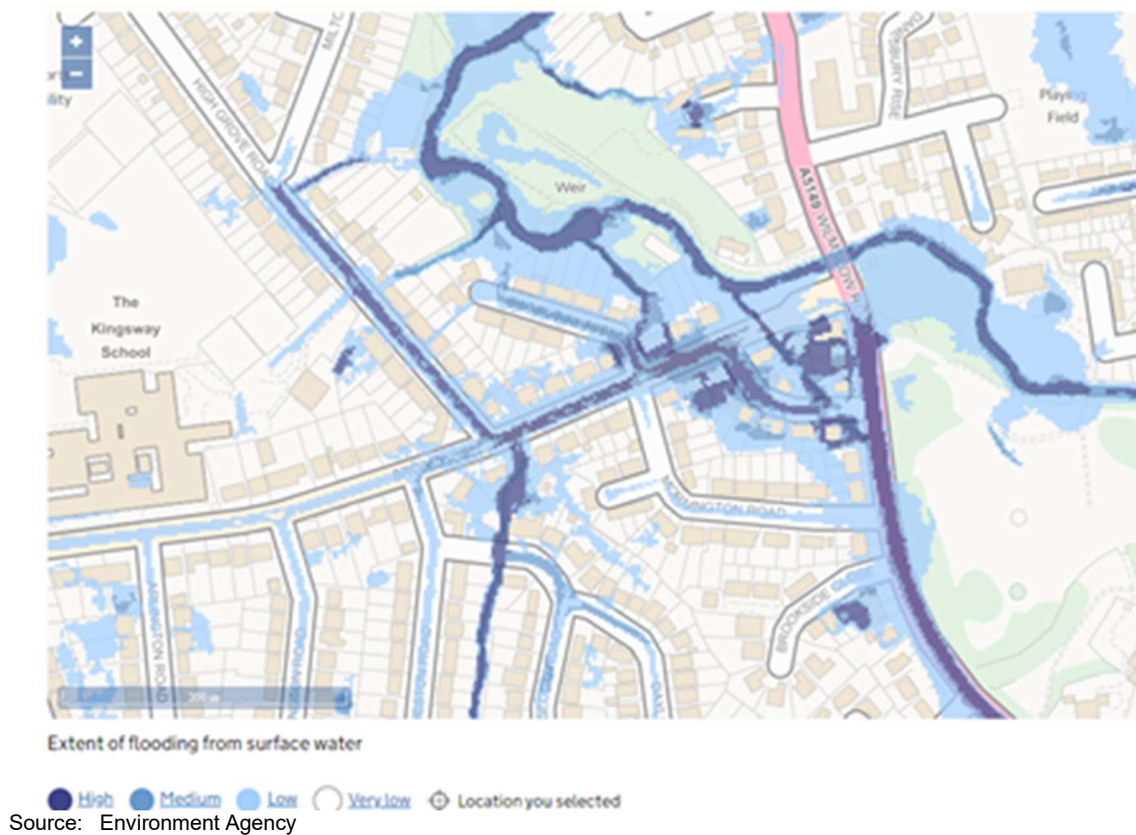
**Figure G.16: EA Wilmslow Road; Pluvial Flood Map**

Similarly, the EA produces flood mapping from 'Pluvial' sources; this is shown in Figure F.16. The pluvial flood map shows flooded extents that are generally consistent with the fluvial flood map; except that the pluvial flood mapping shows flooding or flow paths along some of the roads; notably Broadway and High Grove Road. This mapped flooding is likely a consequence of the modelling methodology because the culverted tributary will not have been modelled and hence all runoff from it has been modelled as progressing to Micker Brook via overland flow routes, along the roads.

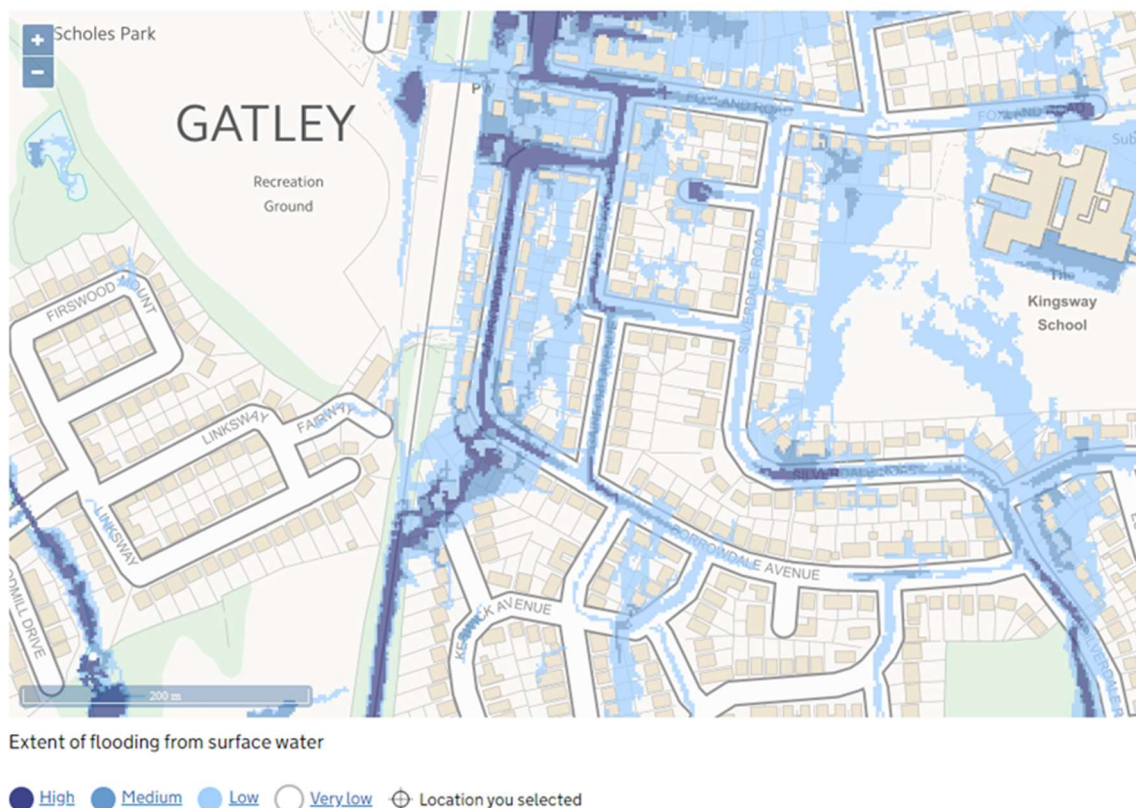
**Figure H.18: Borrowdale Avenue; EA Pluvial Flood Map**

The EA produces flood mapping from 'Pluvial' sources; this is shown in Figure H.18. The pluvial flood map shows widespread SW flooding due to the absence of clearly defined watercourses and the blockage of drainage routes by the railway. A flow path is shown for SW runoff northwards from the railway to Borrowdale Avenue and ponding at the bend in the road at its north end. Further flooding is shown to the north but this does not appear to have manifested in the July 2019 event. Ponding of overland flows at the bend in Borrowdale Avenue is likely to overwhelm the UU combined sewers draining the area.

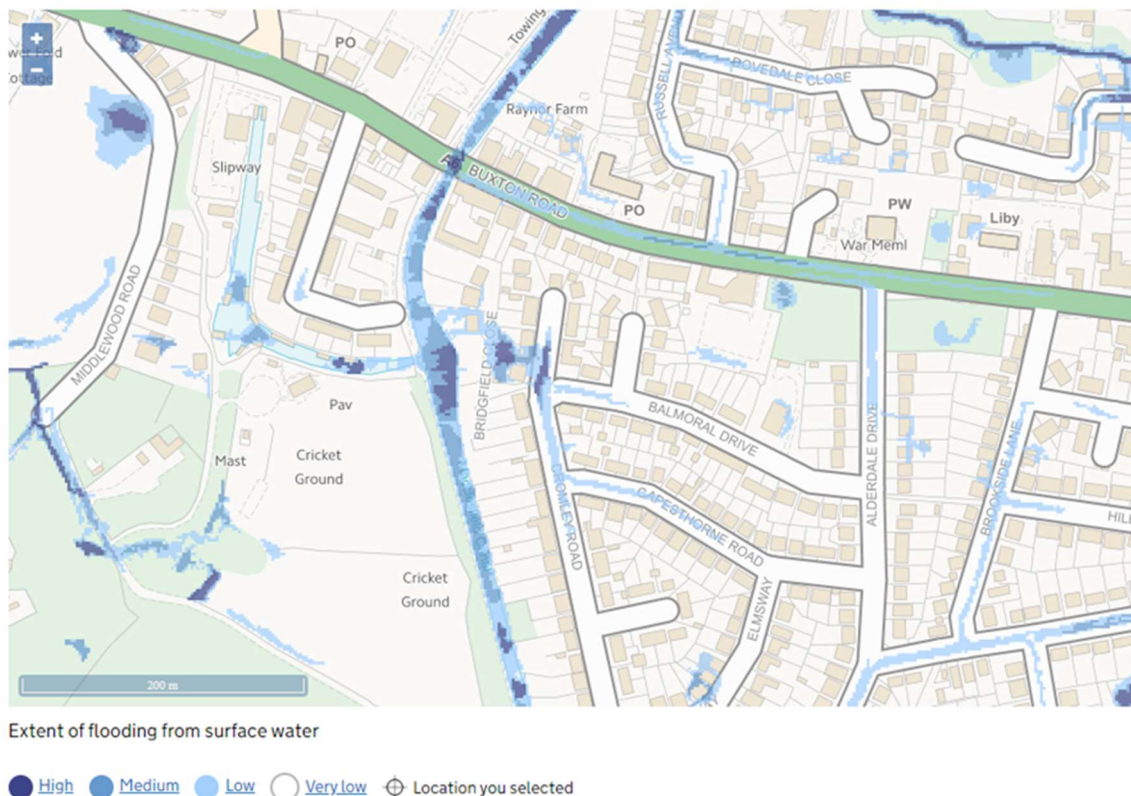
**Figure I.20: High Lane; EA Pluvial Flood Map**

The EA produces flood mapping from 'Pluvial' sources; this is shown in Figure I.20. The pluvial flood map shows flooding of Cromley Road at the junction with Balmoral Drive and an overland flowpath to Bridgefield Close and onwards to the canal. Some of the runoff volume will be drained by UU (and Highway?) drainage systems but the map serves to indicate the area at risk.

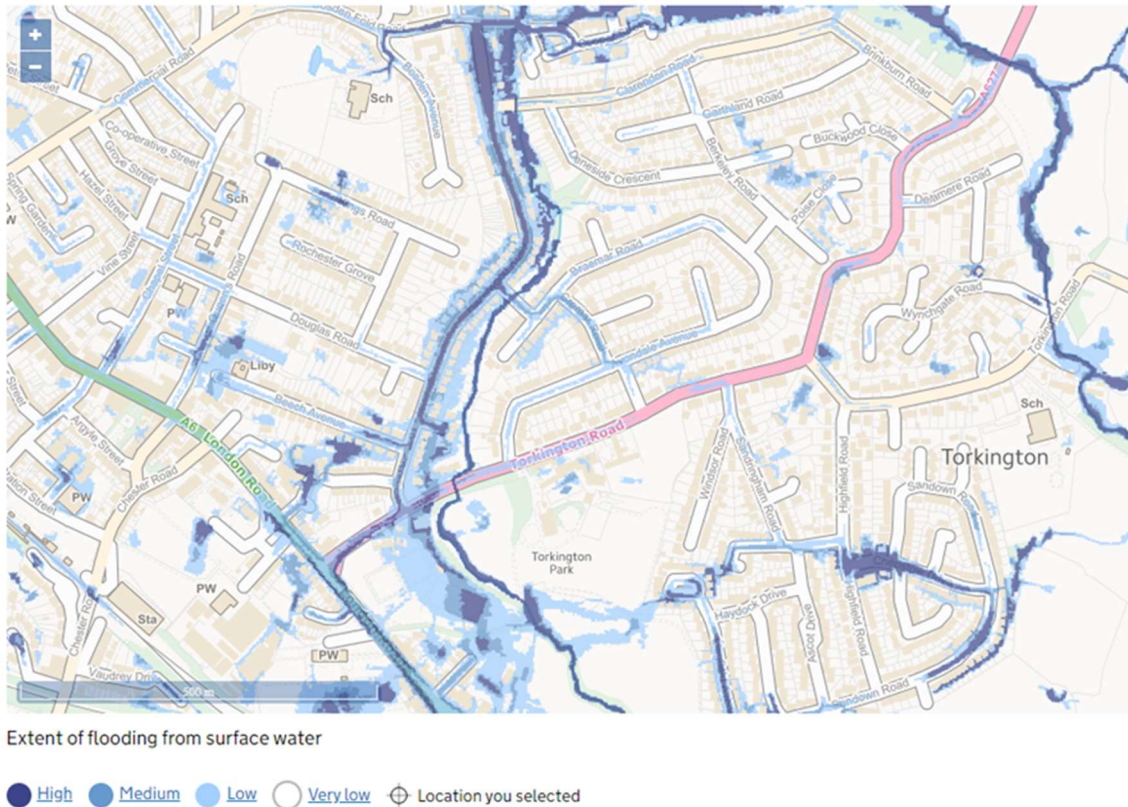
**Figure J.23: Torkington Road; EA Pluvial Flood Map**

Similarly, the EA produces flood mapping from 'Pluvial' sources; this is shown in Figure J.23. The pluvial flood map shows flooded extents that are generally consistent with the fluvial flood map.

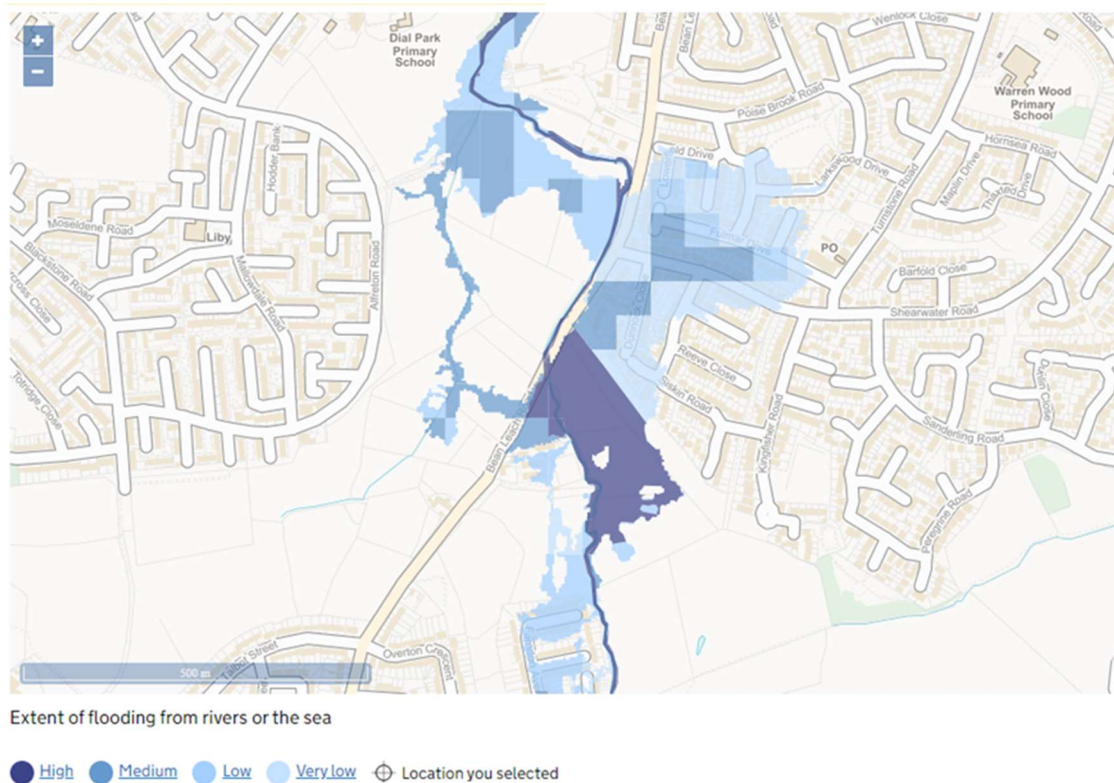
**Figure K.25: Bean Leach Road; EA Fluvial Flood Map**

This map indicates that depending upon the severity of the event the following locations may experience flooding:

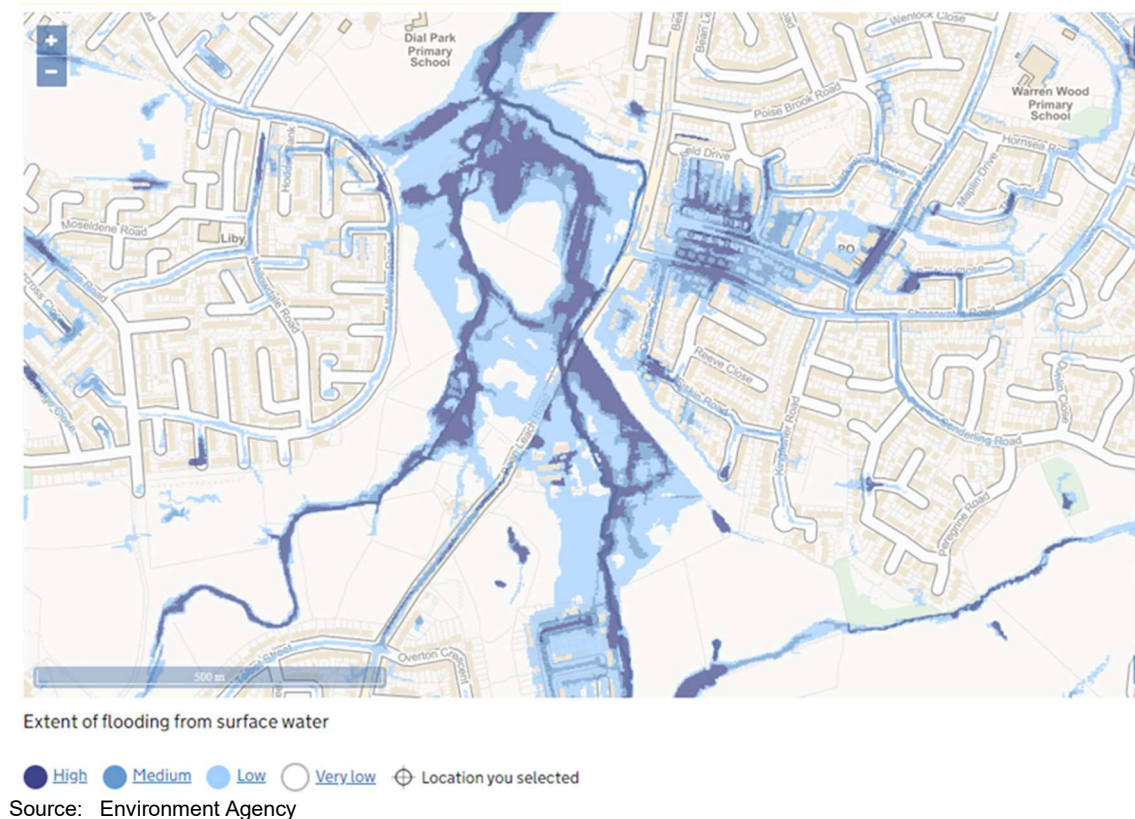
**Figure K.26: Bean Leach Road; EA Pluvial Flood Map**

Accordingly, the fluvial and pluvial mapping are also inconsistent with one another. As stated for other locations, the pluvial flood map should normally provide the more reliable forecast of flow routes and flooding but in this case it does not. There is a suspicion that assumptions in the modelling of the estate flood embankment may be confusing the picture.

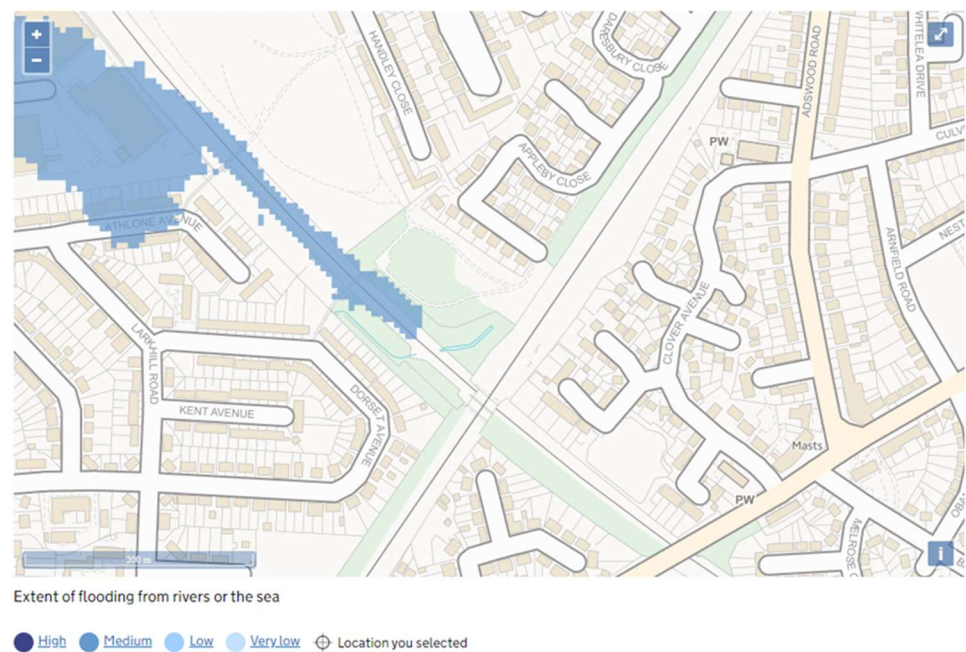
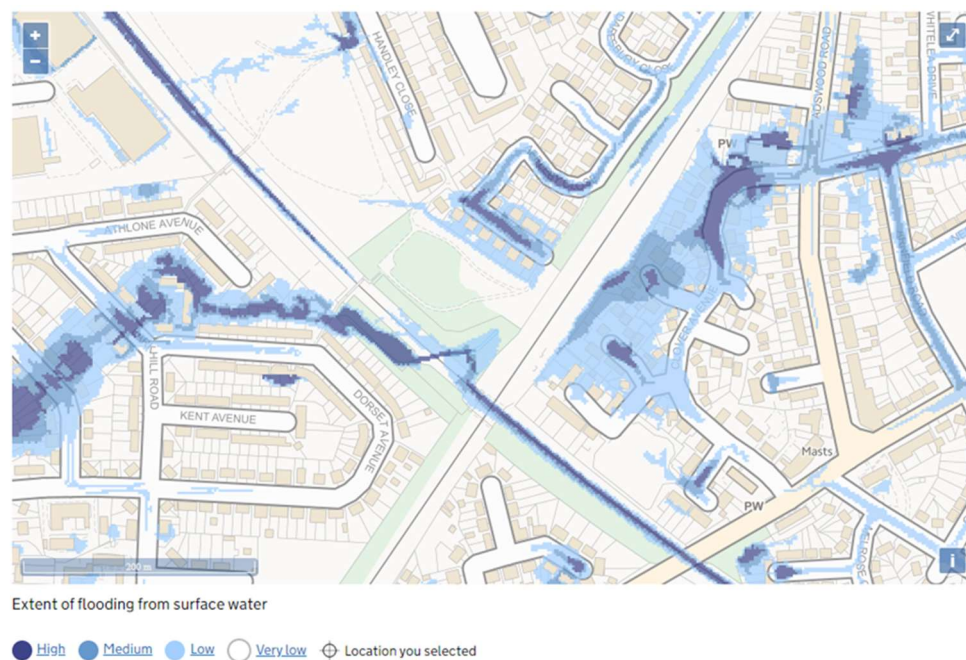
Accordingly, the pluvial mapping is only an indication of the flooded extent if the railway culvert were to become completely blocked. Nevertheless, the areas of highest flood risk are indicative of the areas flooded in July 2019 and earlier events.

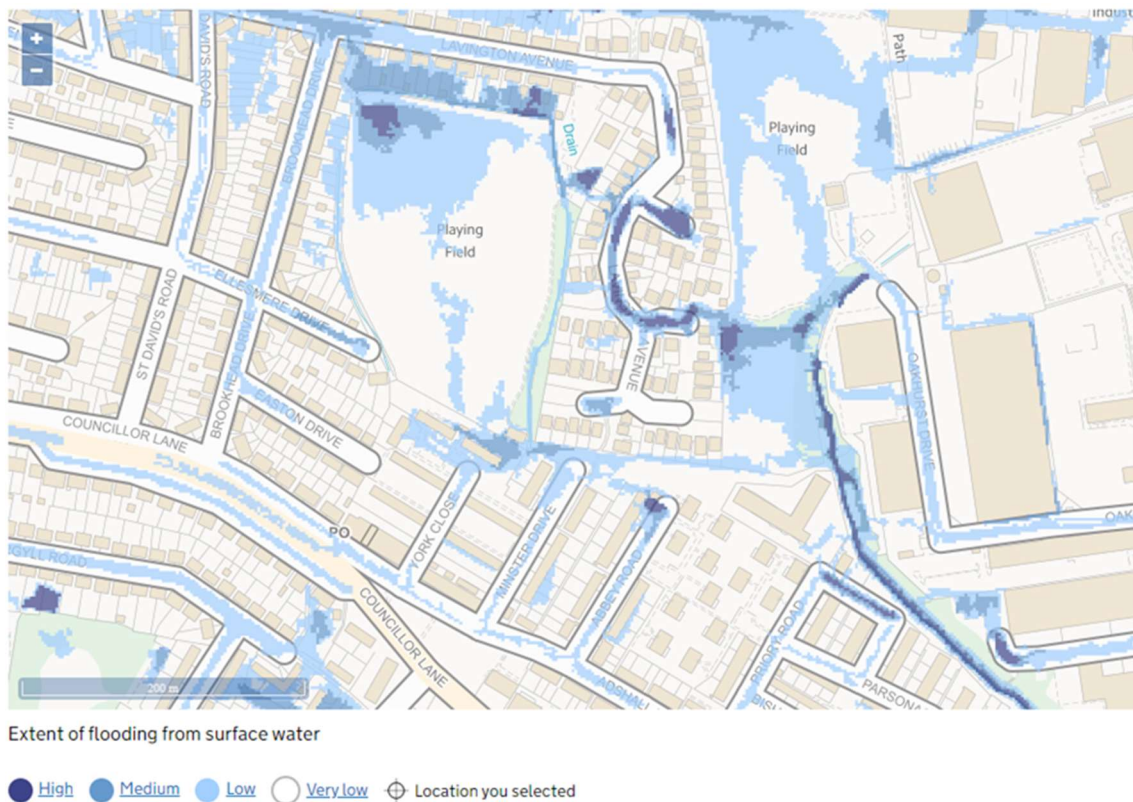
**Figure M.31: Councillor Lane; EA Pluvial Flood Map**

The EA produces flood mapping from 'Pluvial' sources; this is shown in Figure M.31. The pluvial flood map shows property at the north end of York Avenue to be at low to medium flood risk from local SW runoff.

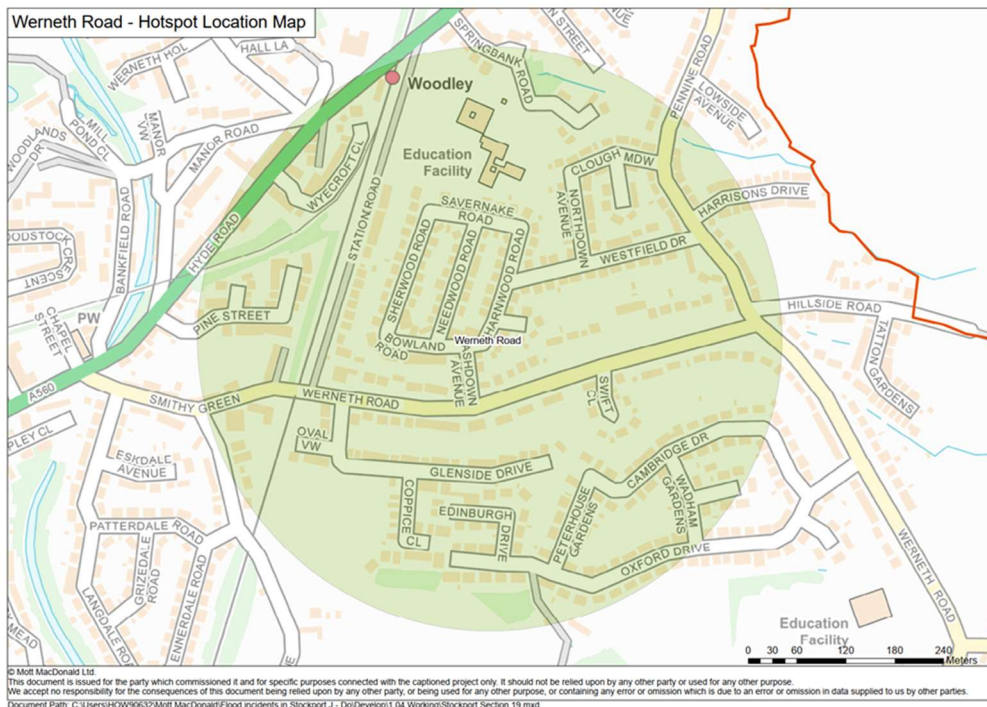
**Figure O.32: Hot Spot Location Plan, Glenside Drive and Werneth Road**

Figure O.23 indicates the extent of this flooding hotspot and the relevant street names. The hot spot comprises locations of property flooding linked to overland flows along Werneth Road. The eastern end of Werneth Road receives surface water runoff from steep rural land and the steep Werneth Low Road. In storm conditions these overland flows exceed the capacity of highway drainage gullies and flow down Werneth Road adjacent to both kerbs. At various locations where drop kerbs and low pavement heights exist some flow is spilled to adjacent property. At Glenside Drive the road profile is such that much of the exceedance flow against the southern kerb flows off to the low spot at the bend in Glenside Drive; causing flooding to gardens and garages.

Glenside Drive reported flooding of gardens and garages on 31/07/2019 and 09/08/2019 and overflows from manhole in garden that contained sewage. Similar flooding has been experienced many times and has been reported again in July 2020.

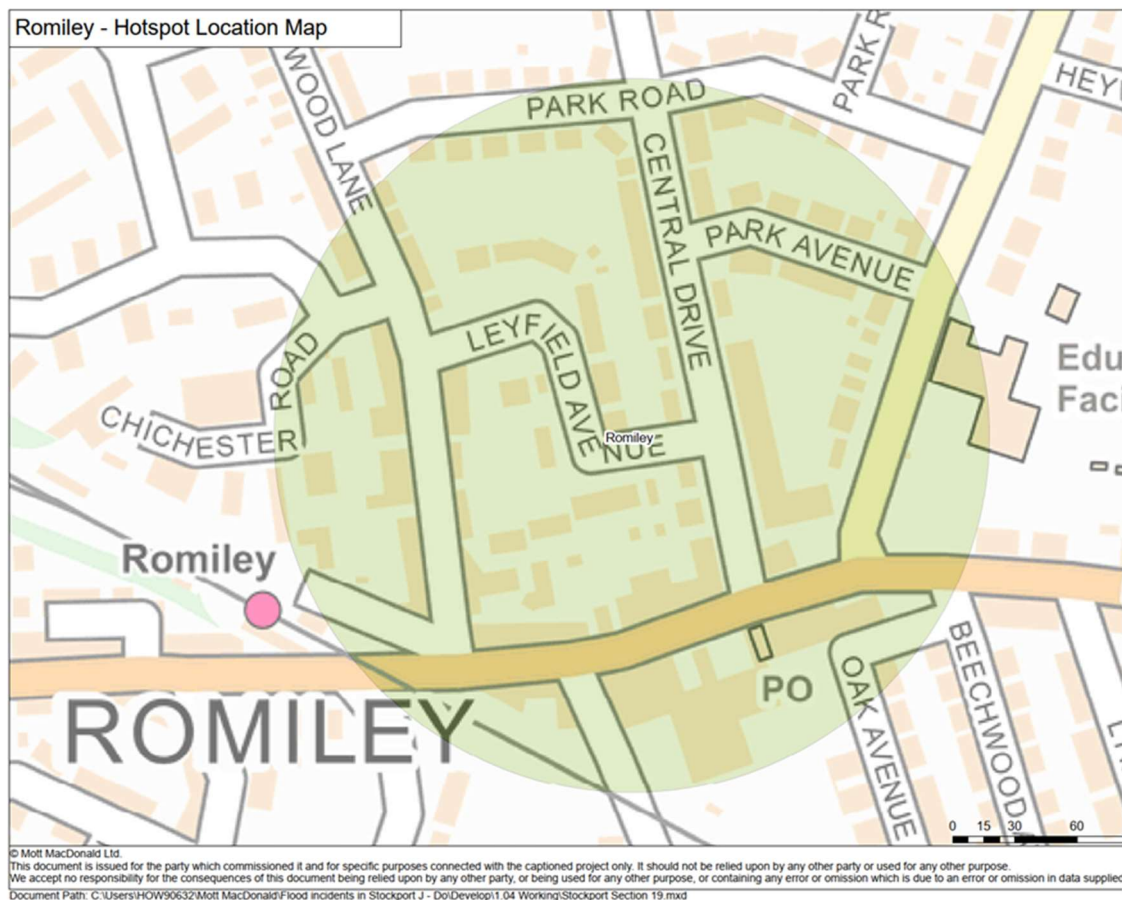
**Figure P.34: Hot Spot Location Plan, Romiley**

UU SW and combined sewer networks appear to have overflowed onto roads (Guywood Lane, Central Drive and Sandy Lane). Manhole covers have been reported to have 'blown off' and fountains of water discharged. Residents replaced some covers to try to reduce the flows released to local roads. These exceedance flows combined with direct runoff have flowed along roads to reach the local low-spot at Leyfield Avenue where ponding occurred. Exceedance flows were unable to drain via highway gullies because these were either surcharged or blocked with debris.

Accordingly, although exceedance flows are along the highways a significant contribution to the floodwater came from overflowing of UU's surface water drainage system.

- Develop area-wide understanding of drainage networks and overland flow routes and identify all discharge routes to Main River (R. Etherow). Joint action LLFA and UU.
- Develop area-wide integrated above-ground and below-ground drainage network model as basis for evaluation of improvement actions. Joint action LLFA and UU.
- Promote appropriate FRMS for the area; prioritise actions giving benefit for Leyfield Avenue.

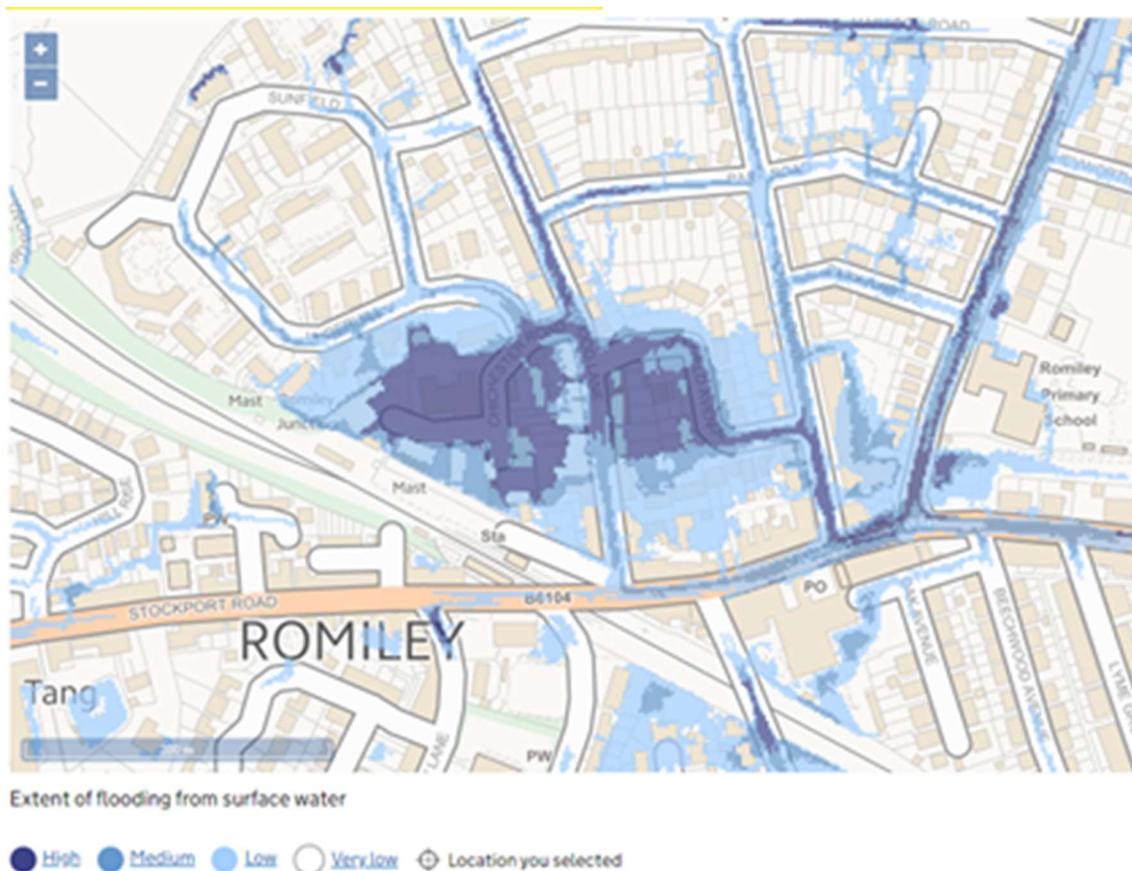
**Figure P.35: Romiley; EA Pluvial Flood Map**

Flooding in Guywood Lane, Central Drive, Sandy Lane, Compstall Road and Leyfield Avenue are all interlinked; some SW flows overland from high ground and SW exceedance flows on for example Sandy Lane flow along Compstall Road and off into Central Drive and compound the problems there. The UU surface water network was clearly overwhelmed and frequently spills to roads. Road gullies are reported blocked by debris which is not surprising given the frequency of exceedance conditions that bring silt and debris onto the road surface. All exceedance flows focus on Leyfield Avenue.
