Section 19 Flood Investigation Report for July 2019 Event

Stockport Metropolitan Borough Council

1 December 2020

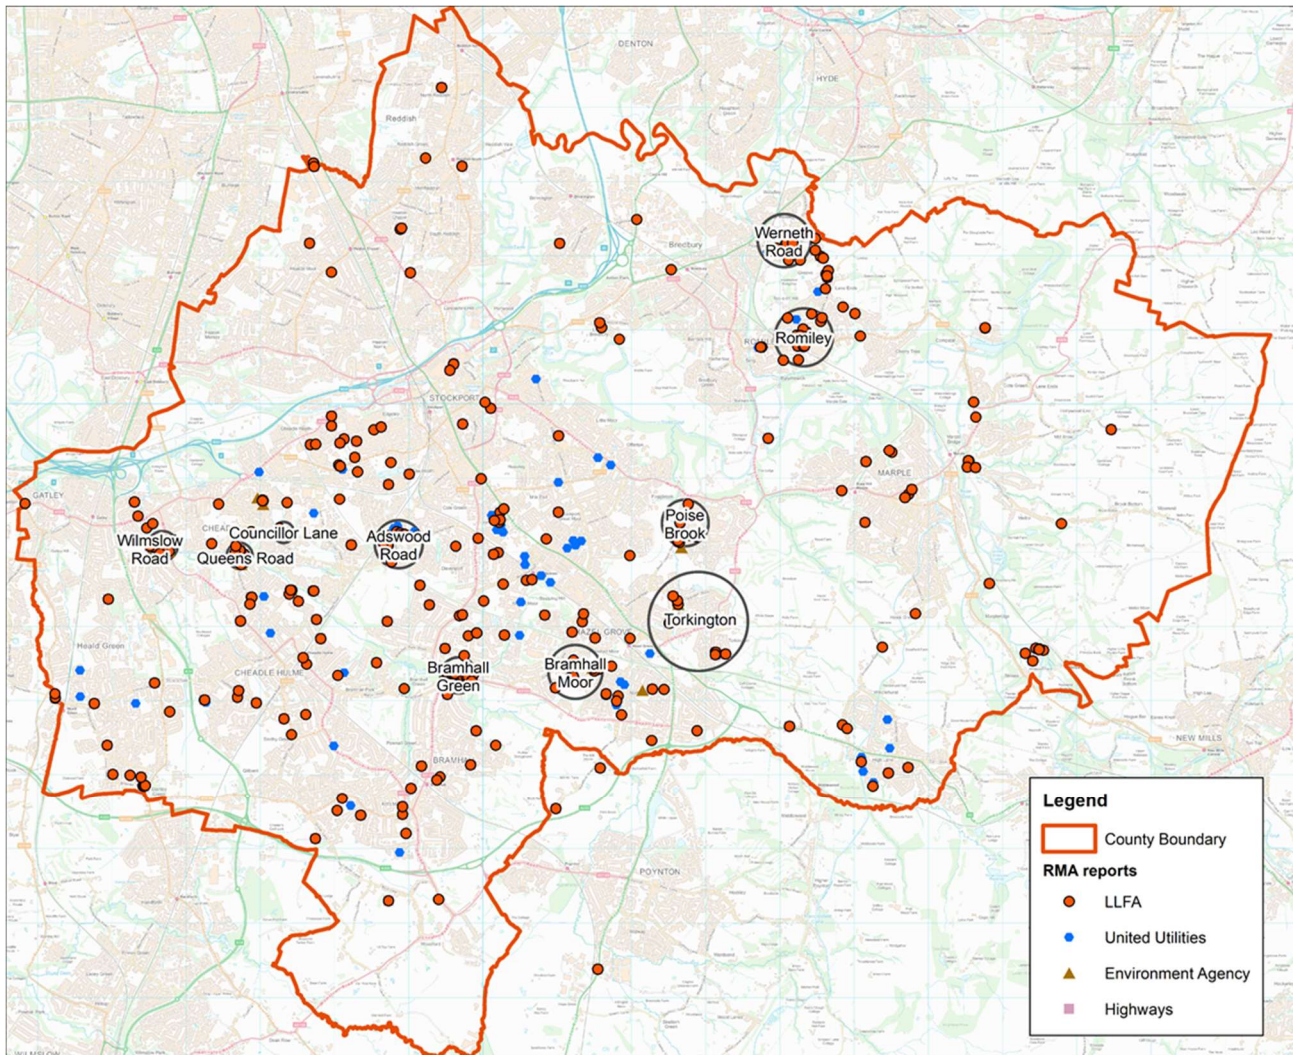
Figure 2.1: All July 2019 reported flooding plotted by postcode; showing flooding 'hotspots'.

Figure 2.1 Indicates the locations of all 776 reported incidences of property flooding; the figure plots reported flooding by postcode and as such a spot on the figure is plotted at the central postcode location and does not locate individual properties affected. Accordingly, there are multiple spots overlaid in some locations giving the impression of fewer than 776 occurrences. The figure serves to indicate:

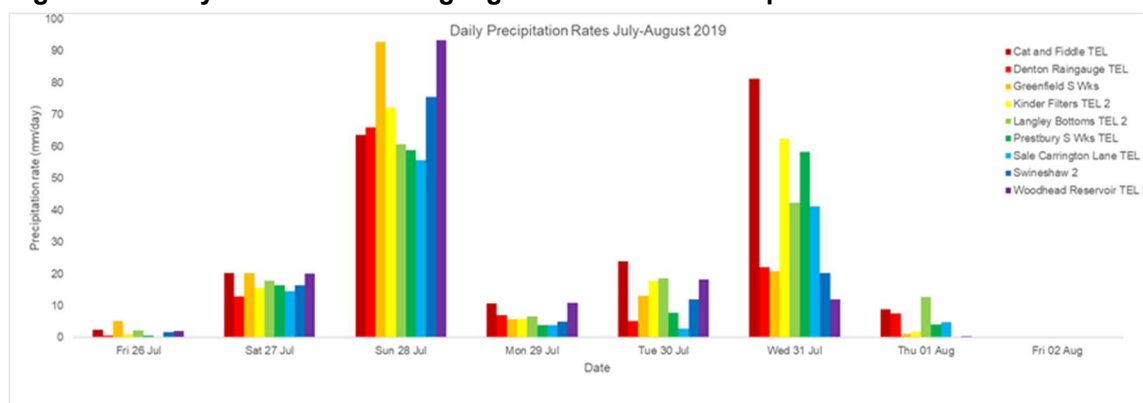
Figure 2.4: Daily rainfall totals for gauge sites local to Stockport

Figure 2.4 shows that, with the exception of Cat and Fiddle, all 1-day rainfalls were greater on the 28th than on 31st July, although some locations e.g. Prestbury received similar rainfall. Figure 2.6 shows the hourly distribution of the Prestbury rainfalls indicating that the 28th was characterised by steady but heavy rain whereas on the 31st there were pulses of intense rainfall.

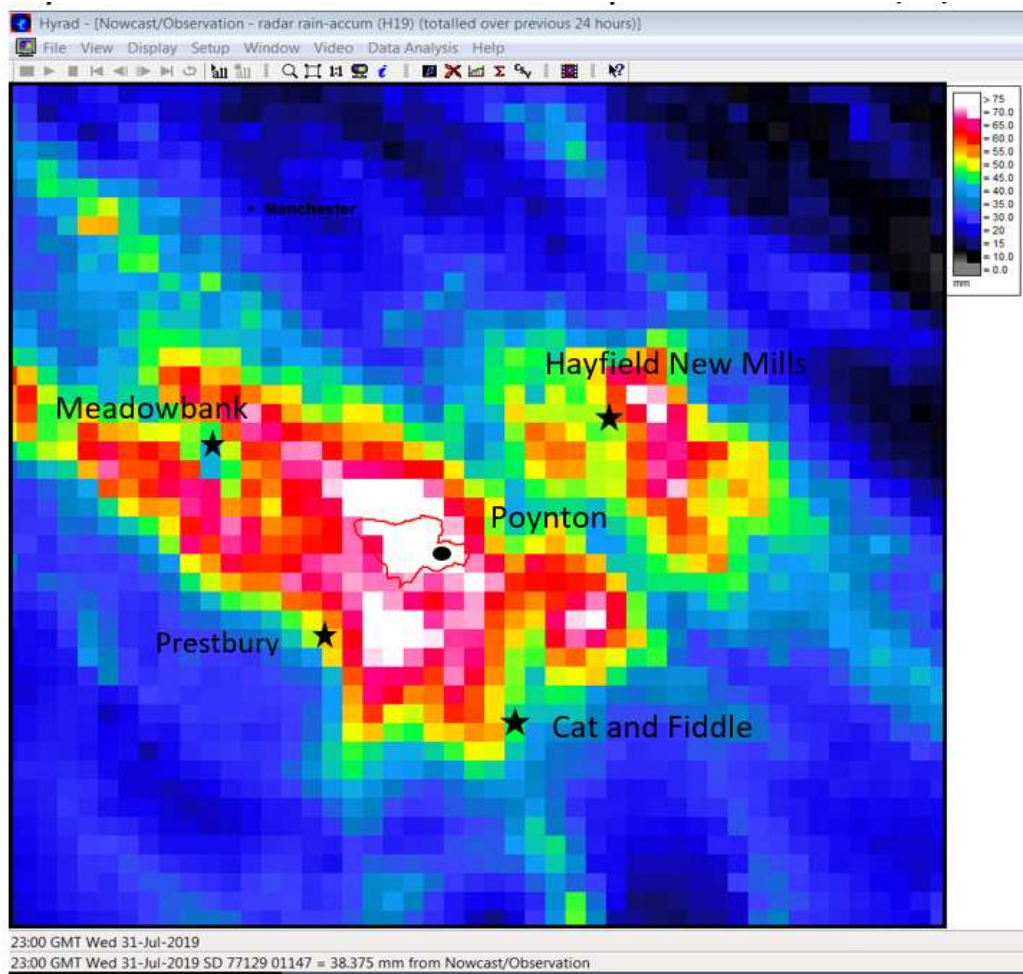
Figure 2.5: Poynton rainfall radar accumulation 24 hours prior to 23:00 GMT 31/07/2019.

The location of the key rain gauge sites is shown on Figure 2.5; this also shows for 31st July 2019 the distribution of 24 hour rainfall across the borough based upon rainfall radar measurements. This indicates that the highest total rainfall, in excess of 75mm (white area), was centred around Poynton which lies just upstream of the critical watercourse of Lady Brook/ Micker Brook.

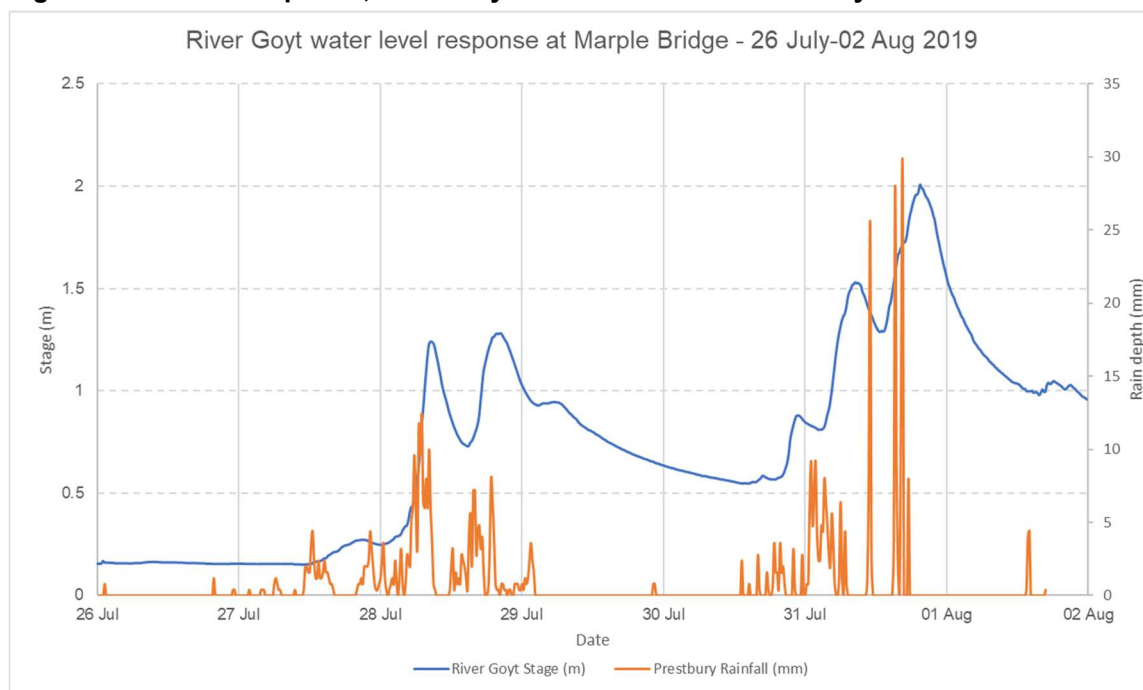
Figure 2.7: Runoff response; River Goyt Flood levels with Prestbury Rainfall data

For the River Goyt flood levels, Figure 2.7, hourly rainfall is also shown to indicate the response in gauged flow depth. We have used the rainfall data from Prestbury to illustrate the behaviour but the actual catchment response is relative to the distribution of rainfalls across the whole catchment; in this case from the Cat and Fiddle in the south and east right down to the gauge site at Marple Bridge. The figure serves to show how the flood levels rise rapidly to spikes of rainfall and then decline more slowly. Also relevant in all of Figures 2.6, 2.7 and 2.8 is that the flow level between 28th and 31st almost returns to the starting condition; indicating for these watercourses, which have a rapid rainfall to runoff response, that the events of 28th and 31st are almost independent. It is relevant however that the 31st rainfall would have fallen on saturated ground and most likely a higher percentage would have immediately runoff to watercourses.

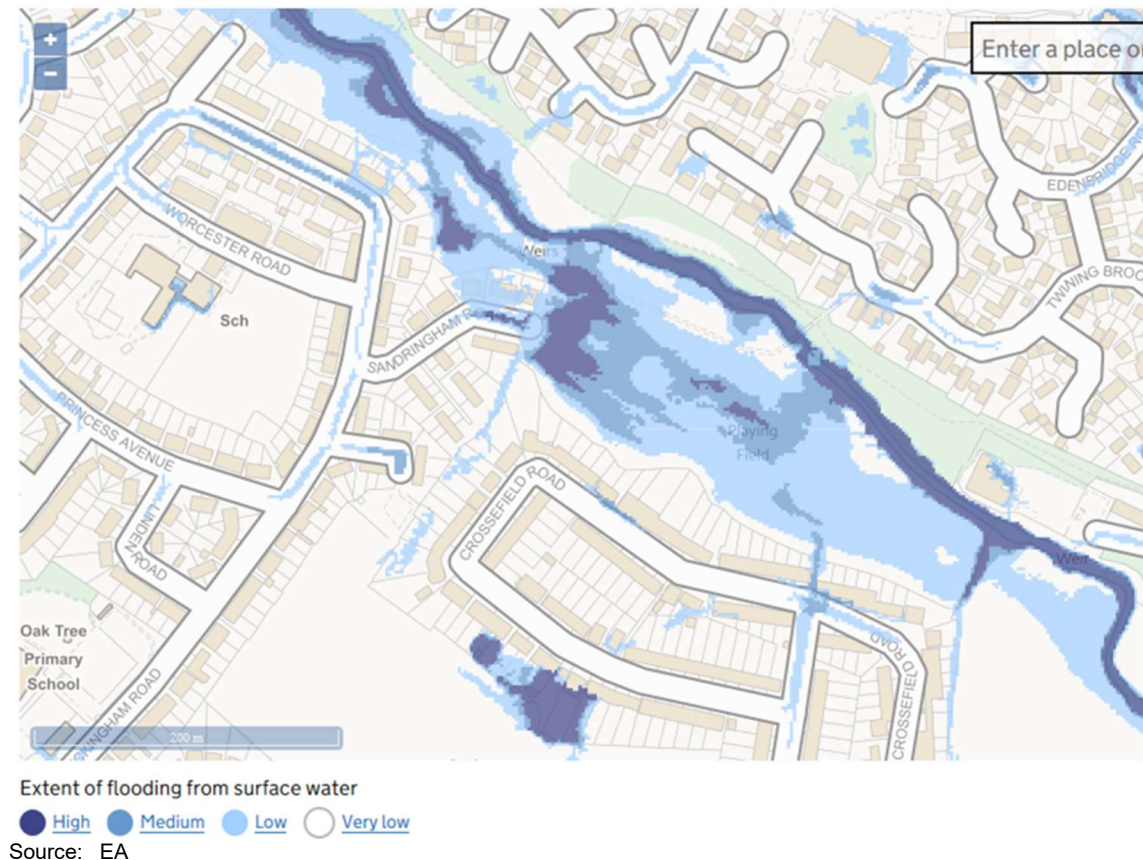
Figure E.10: EA, Sandringham Road; Pluvial Flood Map

Given the methodology of modelling, the underlying assumptions and the topographic data source used for the production of the 'pluvial' or surface water flood maps it is surprising that this map replicates the July 2019 flood flow in Micker Brook. The hydraulics of the main river channel will dominate flood water levels and these should be much better represented in the fluvial modelling.

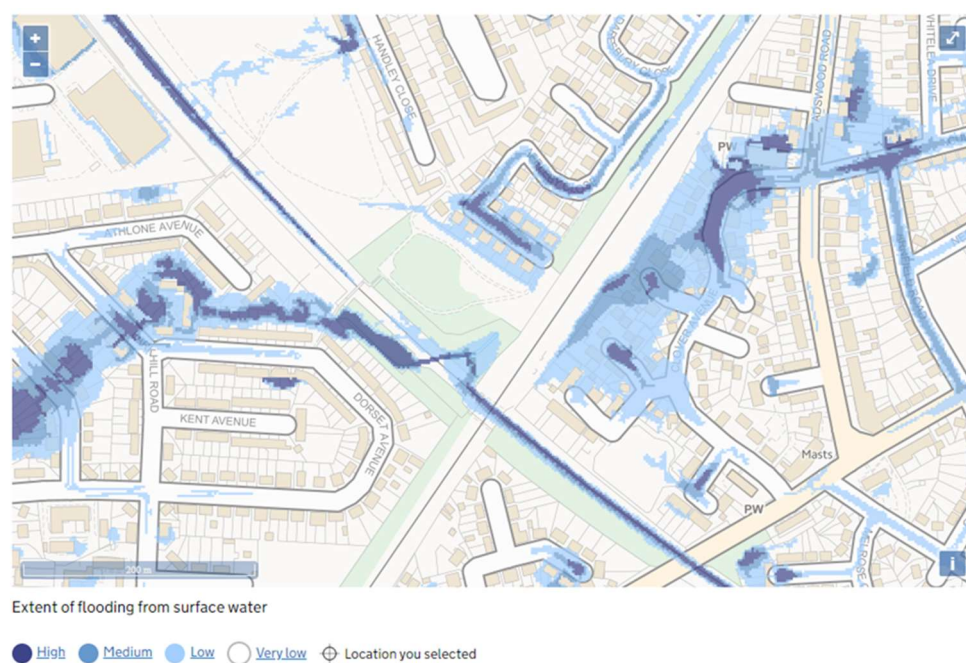
Figure L.29: Adswood Road; EA Pluvial Flood Map

Accordingly, the pluvial mapping is only an indication of the flooded extent if the railway culvert were to become completely blocked. Nevertheless, the areas of highest flood risk are indicative of the areas flooded in July 2019 and earlier events.

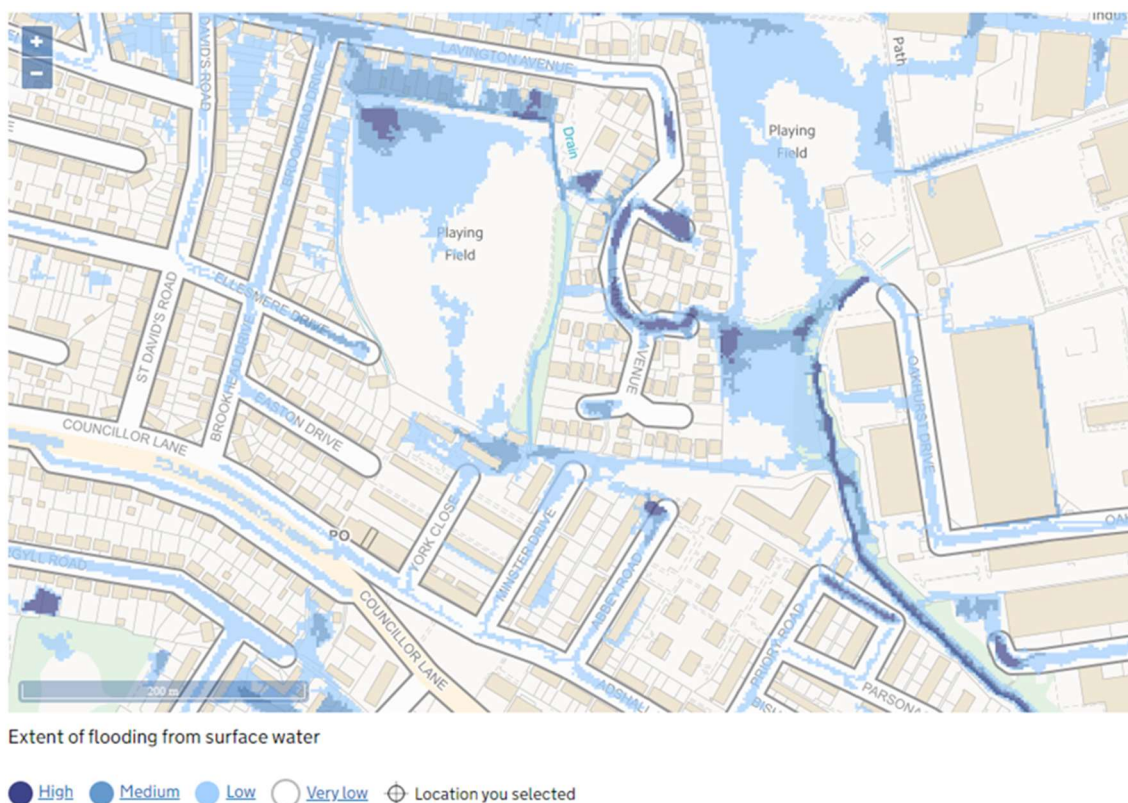
Figure M.31: Councillor Lane; EA Pluvial Flood Map

The EA produces flood mapping from 'Pluvial' sources; this is shown in Figure M.31. The pluvial flood map shows property at the north end of York Avenue to be at low to medium flood risk from local SW runoff.
